Diagnosis, Repair, Strengthening and Monitoring of a Postindustrial Heritage Site: Flyover of the Odra Cement Factory

Keywords: historical structure, reinforced concrete, diagnosis, strengthening, flyover

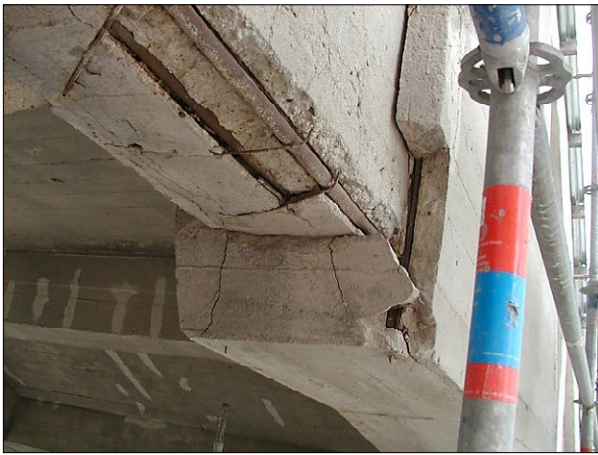
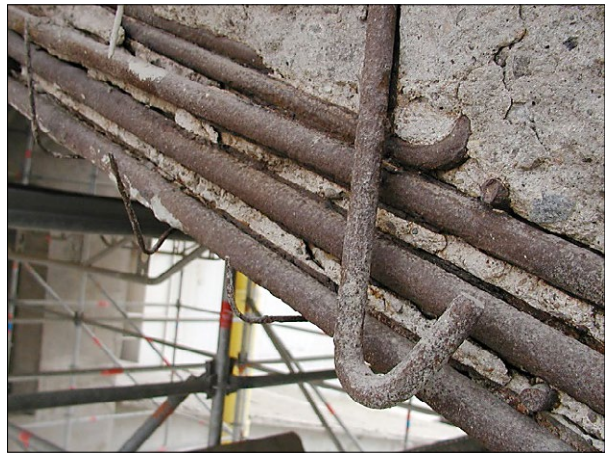
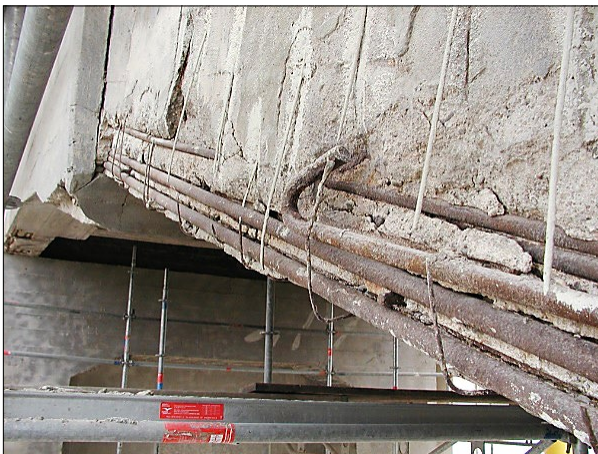
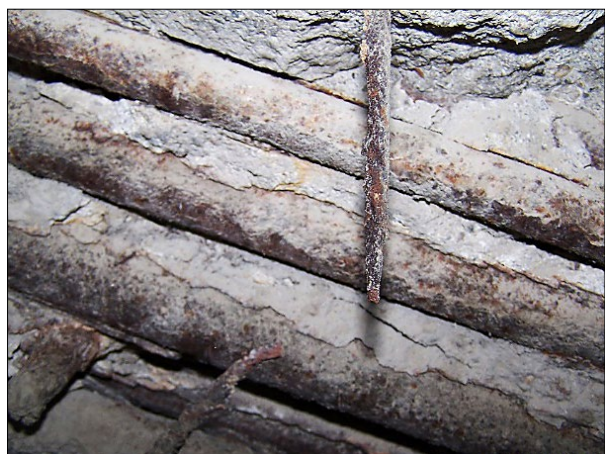
The technical condition of the lower chords of the trusses had to be considered poor and in parts completely bad. They contained numerous indented cavities and cracks, while the reinforcing bars were deeply corroded and were exposed due to missing lagging (some of the stirrups no longer existed). The large disproportion between the longitudinal reinforcement inserts and the stirrups ($\varnothing 25/\varnothing 30$ versus $\varnothing 5/\varnothing 4$ mm)

was of particular concern during the survey. Damage to the concrete and corrosion of the bars (Fig. 9) was caused by very intensive fluctuations in moisture and temperature with large amplitudes and values (day, night, summer–winter), lack of insulation, and the loss of plaster also contributed to this.

No traces of salt crystallization were found on the surfaces of the chipped concrete, but very numerous spalling and losses of both small particles and larger pieces of concrete were visible here. Some of the bars formed bundles of reinforcement with no spacing; i.e., they were interlocked in groups without proper covering, which would not be acceptable today. A serious threat to the entire structure of the building was posed by the lack of stirrups, damaged by corrosion. Even visually (without taking measurements), the excessive deflection of the west span of the flyover was already evident.

Fig. 9. View of the damage; photos by D. Bajno, Ł. Bednarz
Ryc. 9. Widok uszkodzeń; zdj. D. Bajno, Ł. Bednarz

The entire reinforced concrete structure of the flyover had to be repaired and reinforced. The concrete in

the reinforced concrete elements did not have a uniform structure and uniform strength. Non-destructive tests of the concrete class in the lower chords (apart from areas of corrosion) showed that it was of a high class of C20/25 (the flyover structure was built around 1910). These elements had to be urgently repaired in terms of bar cover and filling the cavities between the reinforcing bars with a material compatible with concrete and steel.

The structure could continue to operate safely, provided adequate protection and strengthening was carried out. The following section discusses how to reinforce the reinforced concrete structure of the flyover. The first thing to do was fill the gaps in the concrete. As the cross section of the lower reinforcement had been reduced by corrosion, it was absolutely necessary to reinforce the structure of the lower flange. No provision was made to expand the reinforcement by adding additional bars due to the large concrete voids and the heterogeneity of the concrete, as well as the considerable compaction of the concrete. Another reason for not reinforcing the structure with additional bars was the lack of data on the grade and properties of the steel from which the bars in the load-bearing sections of the damaged structure were made, i.e., their brittleness, load-bearing capacity, and weldability. Based on our own investigation and an analysis of the literature,

Finally, the repair works included the reprofiling of damaged concrete, preceded by the cleaning and preservation of existing original bars. Due to the lack of stirrups, a substitute for them was used. The main reinforcement is a spatial internal steel truss that does not disturb the authenticity of the building.

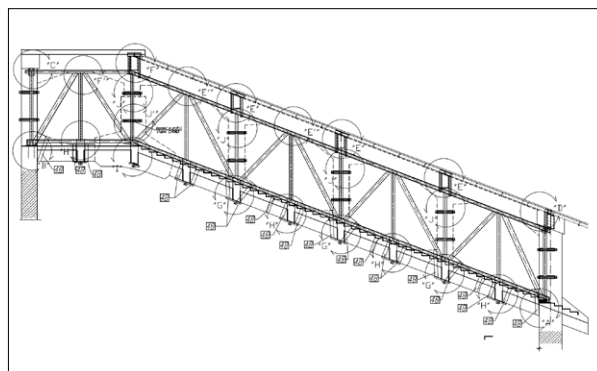
Fig. 10. The repair solution; by D. Bajno

weight steel structure that does not obstruct the original (Fig. 10). The functional requirements for this facility have not changed since its inception in 1910, and were therefore taken into account in the development of the reinforcement of its structure. The calculations considered the current quantities and weights of the excavated material transported in the adoption of quasi-static loads. For this reason, the reinforcement method presented was adopted with the aim of leaving the original as authentic as possible. The introduction of the additional structure allowed the bending moments in the individual chord bays of the truss to be significantly reduced, while the increased magnitudes of the compressive and tensile forces were transmitted through the horizontal steel sections. Due to the considerable values of these forces, 18 G2 steel was used in the proposed solution. Until the structure was repaired, the building had to be taken out of service and traffic had to be restricted in the immediate vicinity of the building.

The reinforcement described above used two new internal steel lattice trusses to reinforce the historical reinforced concrete structure; the combined solution was based on two internal steel lattice trusses. The trusses were connected to each other in the upper and lower nodes by transverse steel beams. Thus connected, the structure already formed a spatially rigid system, which was practically entirely “introduced” into the interior of the flyover.

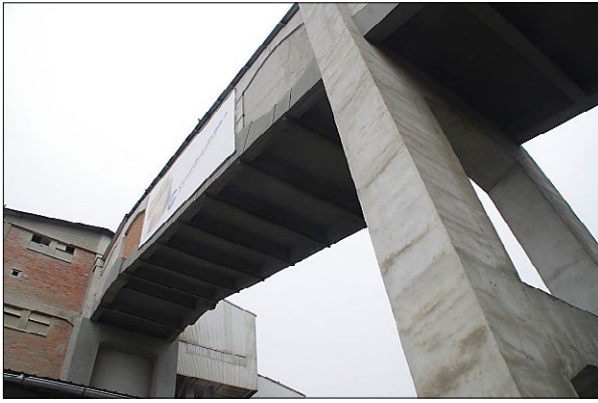
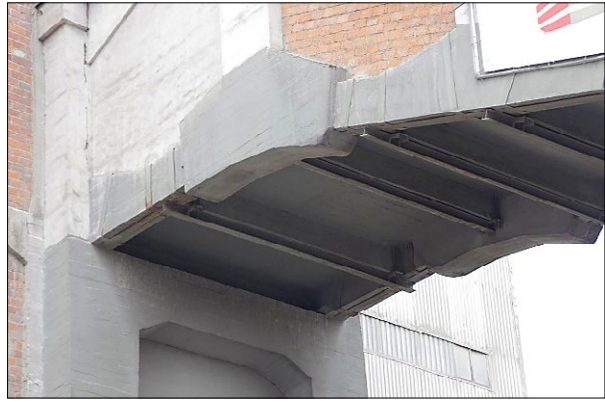
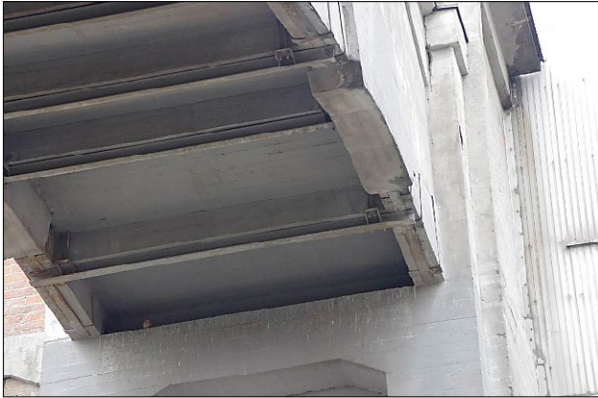
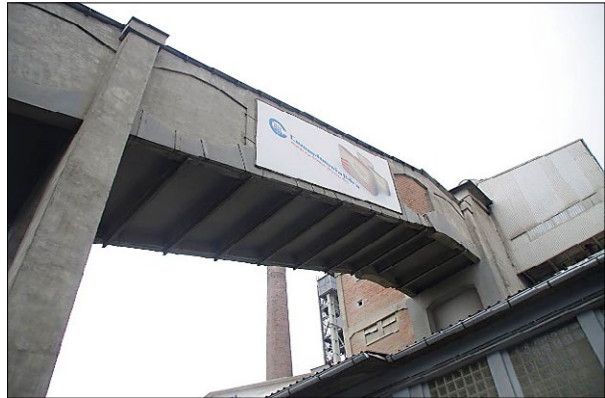
Fig. 11. View of reinforcements; photo by Ł. Bednarz
Ryc. 11. Widok wzmocnienia, zdj. Ł. Bednarz

Due to the possibility of dislocation of the upper chord members (I140HEB), it was necessary to rein-

force it with elements (clamps or glued connectors) to prevent it from losing stability, at distances of no more than 1 m, and this also applied to the transverse roof and floor ribs. Some of these showed cracks transverse to the beam direction, including where the stirrup lagging was missing. Therefore, it was recommended that these elements be reinforced in the tension and shear zones with C-FRP carbon fiber strips. The use of fiber-based composite materials in the form of meshes, for example, carbon C-FRCM, tightened with mineral mortars, would also need to be considered at this time [Bednarz 2021, pp. 22–24] in accordance with conservation doctrines and ICOMOS/ISCARSAH recommendations [ICOMOS/ISCARSAH *Recommendations for the analysis, conservation and structural restoration of architectural heritage* 2019].

Additional steel suspension and support beams (I140HEB) were also used and attached to reinforced concrete ribs, at intervals of approximately 1 m. The visible reinforcement in the still functioning flyover is shown in Fig. 11. The choice of colors of the reinforcing elements depended on the owner of the building and was agreed with the conservation services. The
