Research paper

Evaluation of the functionality of seepage prevention structures of dam bodies after a long period of operation – a case study of Otmuchów and Nysa reservoirs

Maksymilian Połomski¹, Mirosław Wiatkowski²

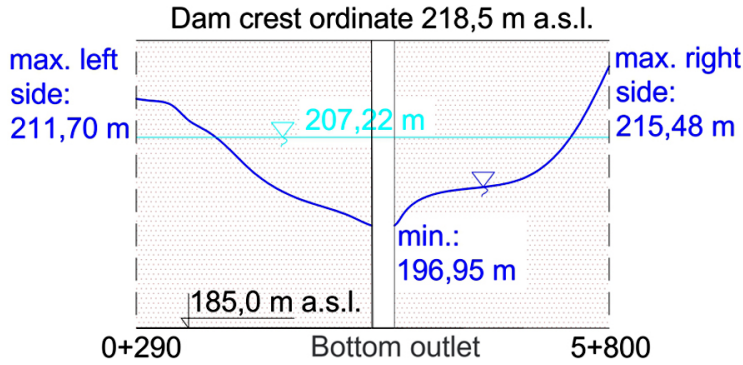
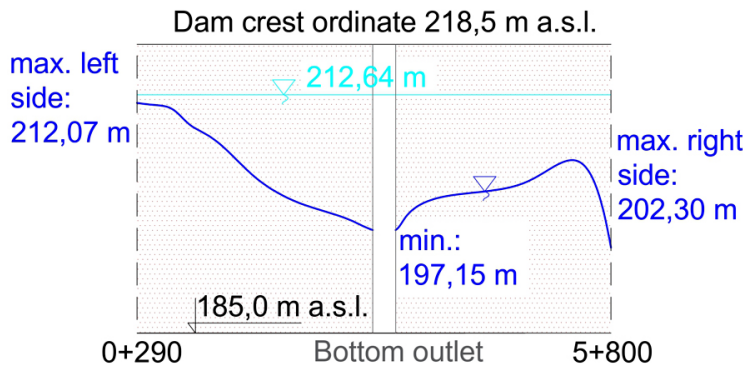
Pressure measurements in piezometers indicate that the water level in the dam body of the Otmuchów reservoir remains constant regardless of the volume and height of water stored in the reservoir. In the section from 0+000 to 1+100, the water level is high, decreasing along the embankment between 7 and 10.5 m below the ordinate of the dam crest. The water level then drops sharply to a depth of approx. 21.5 m in the vicinity of the bottom outlet, after which it gradually rises up to cross-section 4+800 reaching a depth of approx. 16 m. The

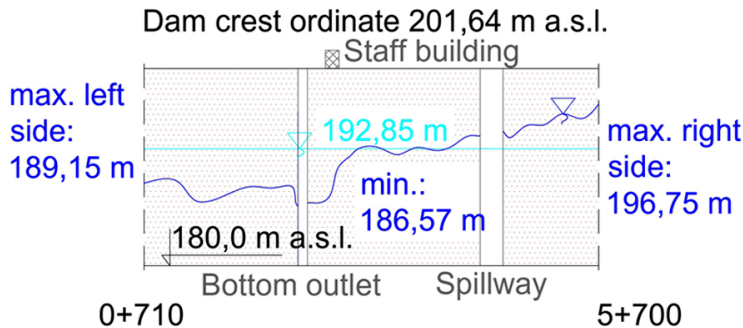
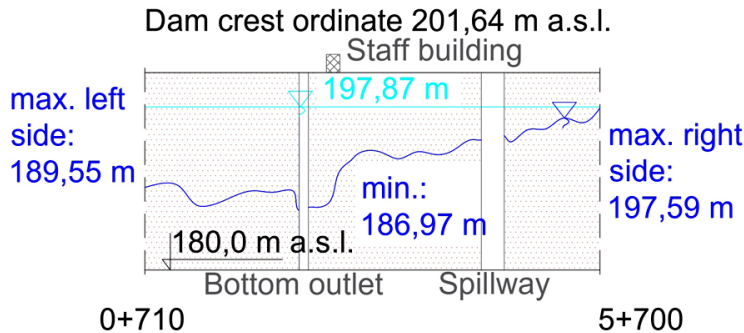
As in the case of the Otmuchów reservoir, for the Nysa reservoir, no significant changes were observed in the shape of the water level distribution in the dam body depending on the height of the water table accumulated in the structure's bowl. The depth of water in the embankment in the section from 0+000 to 2+700 ranges from 12.5 to 15 m, with the lowest point reached at the height of the bottom outlet, the latter circumstance corresponding to the situation in the Otmuchów reservoir. A sudden jump in the water level of 3.8 m was observed between cross sections 2+700 and 2+800, i.e., at the height of the technical facilities building. Subsequently, until the end of the dam at cross-section 5+700, a rounded linear drop in depth is recorded, with no significant interference of the surface overflow, finally stopping at a level of approx. 5 m below the crest ordinate.

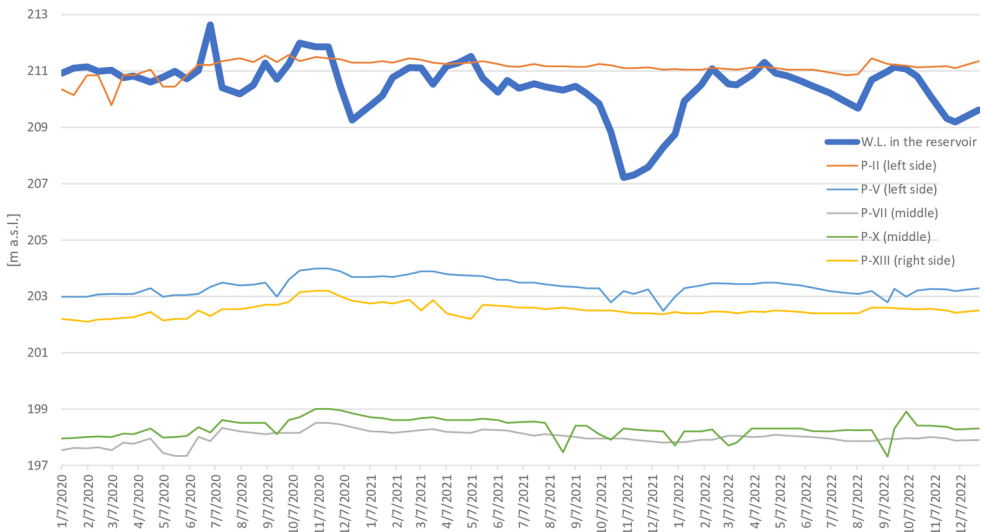
Fig. 10. Data from selected piezometers at the Otmuchów reservoir dam between 2020 and 2022

In the case of the Otmuchów reservoir, only a slight correlation was observed between the fluctuation of the water level in the reservoir and the vertical displacement of the water level in the dam body. A sudden change in the amount of water in the reservoir does not cause sudden jumps in pressure in the piezometers, but only a gradual increase or decrease. During the observed period, the damming height ranged from 207.22 to 212.64 m above sea

level, remaining at 210.42 m above sea level on average. In the piezometers on the left side, the situation was different for cross-sections II and V, where for the former, the water level was above the water level in the reservoir most of the time, indicating a connection with the general groundwater level in the area and the absence of a significant influence of seepage on the recharge of the ground. In cross-section V, the difference between the lowest and highest water levels was 1.5 m. The lowest level of filtered water was maintained in the middle part of the body, and the highest pressure values for cross-sections VII and X were reached on

18 November 2020, i.e., after a period when the amount of retained water was noticeably higher. Subsequently, the level gradually decreased from that day onwards; however, without any apparent relation to the changes in the water level in the reservoir and only in the range of 0.6 m for cross-section VII and 0.7 m for cross-section X. On the right side, in cross-section XIII, a similar shape of pressure distribution was recorded as for cross-sections II, V, VII, and X. Statistical analysis of the correlation between the water table level in the reservoir and the water level in individual cross-sections showed a low positive correlation (Pearson coefficient <0.2) for all cross-sections except V, where it was slightly higher, but did not exceed the Pearson coefficient of 0.37.

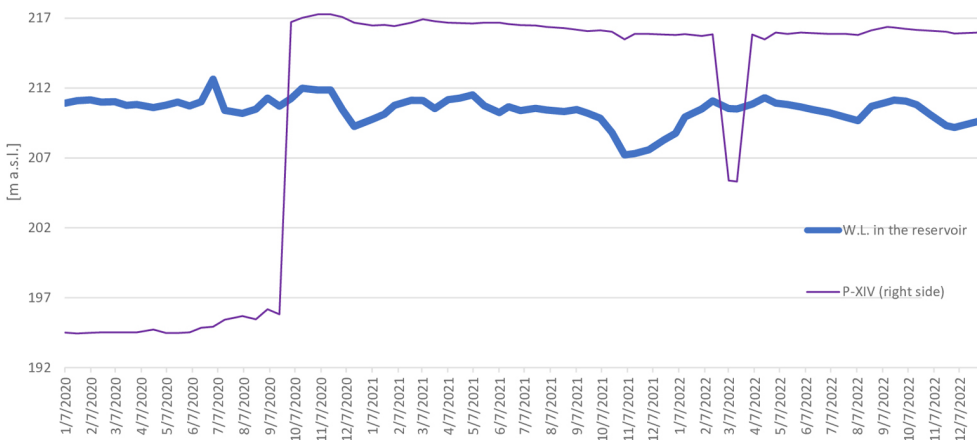
Fig. 11. Piezometer data from cross-section XIV of the Otmuchów reservoir dam for the years 2020–2022

water level in cross-section 5+800 fluctuates considerably (further on in Figure 11) which, due to the lack of correlation with the height of the water table in the reservoir, may be directly related to fluctuations of the groundwater level in the vicinity of the right end of the embankment or is the result of a malfunctioning measuring device. Incorrect (in relation to

The anomalies apply to cross-section XIV, as indicated in separate Figure 11. The sudden jump in pressure in the piezometer at cross-section XIV, indicating an increase in the level of seeping water in the embankment of approx. 21 m, is not related to a fluctuation in the amount (height) of water stored in the reservoir. Such a circumstance could be explained by a local rise in the groundwater level, but a jump from 195.82 m above sea level to 216.73 m above sea level within a maximum of 14 days would have to be indicative of sudden and intense rainfall, which is not confirmed by the data on the weather conditions occurring at the time. Furthermore, the subsequent persistence of such a high water level for a period of approx. 1.5 years, the sudden drop to an ordinate of approx. 205.00 m above sea level on 7 September 2022 and 17 September 2022, followed by a return to the previously read high values of approx. 216.00 m above sea level. The lack of rational justification for this phenomenon leads to the conclusion that the measuring device in section XIV is malfunctioning [31] and should be repaired or replaced once this hypothesis is confirmed.

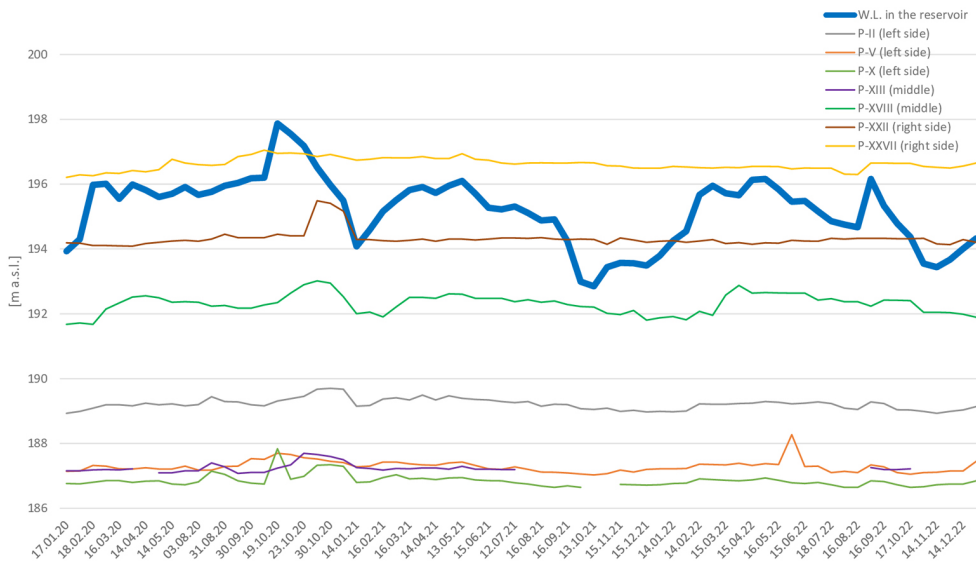
Fig. 12. Data from selected piezometers of the Nysa reservoir dam between 2020–2022

The Nysa reservoir experienced fluctuations in dammed water levels between 2020 and 2022, ranging from 192.85 m above sea level on 13 October 2021 to 197.87 m above sea level on 19 October 2020. At all analysed measurement cross-sections, except for cross-section XXVII, a response was observed to the sudden surge in water height that took place in October 2020. On the left side, this response did not result in significant changes in the water table level, and in the piezometer pressures for cross-sections II, V, and X indicated fluctuations of 0.77 m, 1.24 m, and 1.19 m, respectively, for the entire analysed period. In the middle section, especially for cross-section XVIII, the correlation between the water level in the reservoir and the water level in the embankment is clear and indisputable, and the piezometer reacted to both increases and decreases in the amount of water retained. In the case of cross-section XIII, the measuring device ceased to function properly after 12 July 2021, which is a circumstance indicating some wearing out of the functioning control and measurement system. On the right, the water level in cross-section XXII rose markedly after the water level peak on 19 October 2020, after which it stabilised at a height of approx. 194.30 m above sea level and did not react further to further movements of the water level. The readings for the piezometer in cross-section XXVII showed no significant correlation with the water level in the reservoir.

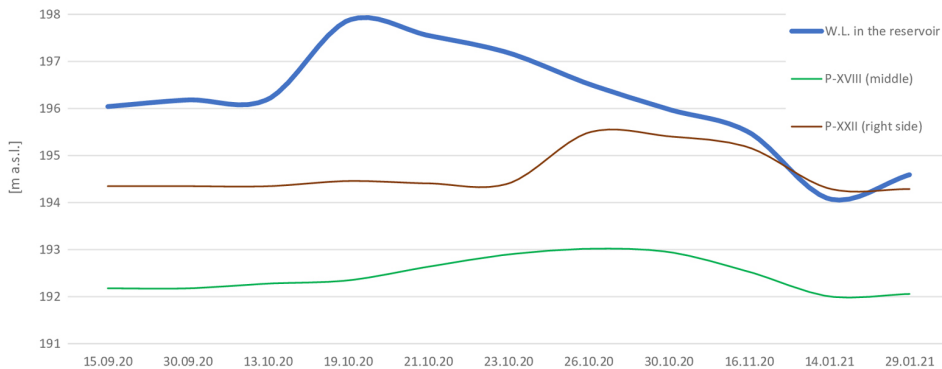
Fig. 13. Data from piezometers at cross sections XVIII and XXII of the Nysa reservoir dam during the period after increased damming height

There is also a noticeable delay in the peak height of the water table in the embankment in relation to reaching the maximum damming height in the reservoir, as illustrated in Figure 13 on the example of cross sections XVIII and XXII for the period from 15 September 2020 to 29 January 2021.

The sudden increase in water level from 196.2 m above sea level to 197.87 m above sea level between 13 October 2020 and 19 October 2020 caused movement of the water level in the dam body resulting in its rise by approx. 1 m in cross-section XXII and 0.7 m in cross-section XVIII. The peak heights in both of these cross sections were reached at most on 26 October 2020, when the amount of retained water was already lower. This indicates that approximately one week is needed for the seeping water to get from the upstream slope to the width of the downstream edge of the dam crest. This is also confirmed by statistical analysis of the relationship between the water table level in the reservoir and the water level in cross-section XVIII. When values

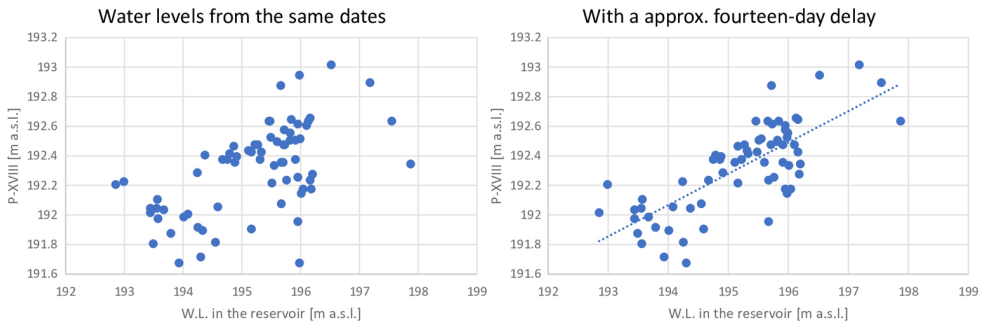
Fig. 14. Diagrams of the dependence of the water level in section XVIII on the water level in the reservoir

from the same day are adopted for both of these heights, a graph with an indistinct linear relationship and a Pearson correlation coefficient of 0.58 is obtained. Examining the same relationship, however, adopting the values of the water level in the embankment with a delay of about 14 days, a graph indicating an indisputable linear relationship with a Pearson correlation coefficient of 0.76 is obtained. The graphs are presented in Figure 14.
