Sebastian GRONEK, Paweł SZCZEPANIAK, Grzegorz JASTRZĘBSKI,
 Urszula WINIARSKA, Maciej KAMIŃSKI, Marek KRUKOWSKI
Air Force Institute of Technology (Instytut Techniczny Wojsk Lotniczych)

STUDYING THE WEAR OF TITANIUM THREAD OF AIRCRAFT FUEL FILTER

During the operation of aircraft, failure of aircraft engine occurred, due to which it was damaged. One of the hypotheses on the reasons for this can be a failure of the fuel filter. According to this hypothesis, the filter was unsealed due to the thread on the titanium shank being sheared. The above-mentioned thread was a structural element of the filter. Tests that were conducted to examine analogous filters revealed increased wear of threads, which developed due to shearing. It is estimated that this wear reduces the thread's shear strength, which can result in it being sheared due to loads directed along the shank's axis and as a consequence, total damage of the filter.

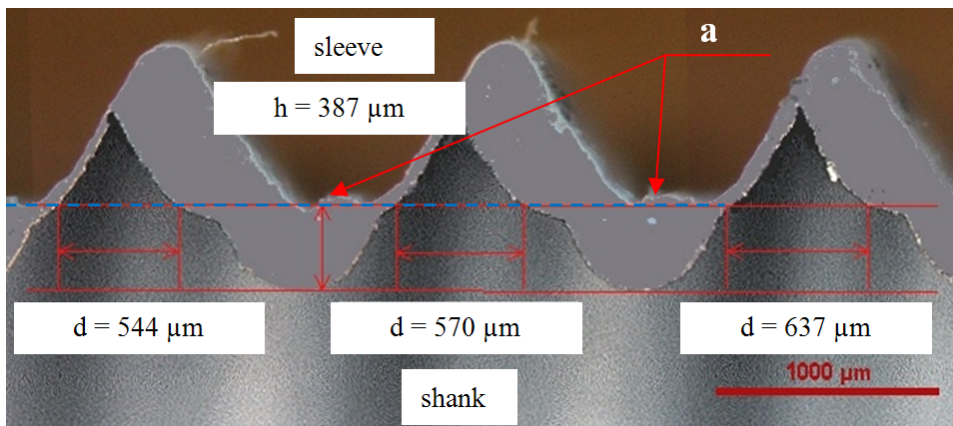
The shapes of the coils on the thread connection of shank to sleeve were illustrated in the following figures (fig. 4, 5 and 6). In all of these three examples, significant deformation of the thread's coils is observed in the form of narrowing the coil's upper part. This narrowing can be highly asymmetric, as it was in the case of the shank No. II. The change in the coil shape, which reduces the surface area of coils in the predicted shearing surface (interrupted blue line in fig. 4, 5 and 6) results in the decrease of the shear strength. The distance of the predicted shearing surface from the bottom of notches of thread's coils for shanks No. I, II and III amount to 387 μm , 418 μm and 407 μm respectively. The widths of the predicted shearing surface for three coils of the thread were illustrated in figures for each shank (dimension d in fig. 4, 5 and 6). Deformation of the coils in the sleeve's thread is significantly smaller. What is evident is a groove located in the middle of the upper surface of thread's coils (' a ' in fig. 4, 5 and 6), which can be the result of the manufacturing process or operational loads on the working surface of the thread. Verification of this hypothesis is not possible due to the lack of the possibility to examine the unused sleeve.

Fig. 4. Simulation of meshing for shank No. I and the mating sleeve

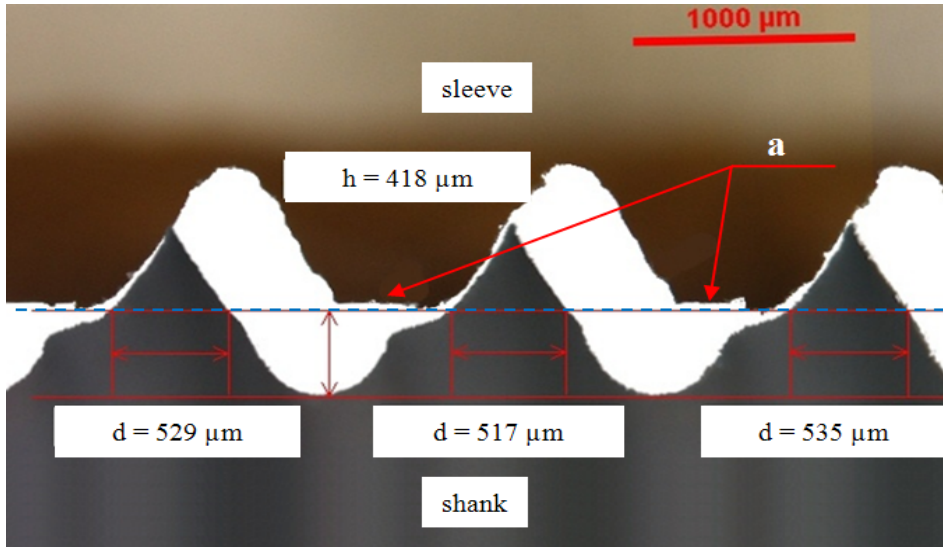
Fig. 5. Simulation of meshing for shank No. II and the corresponding sleeve

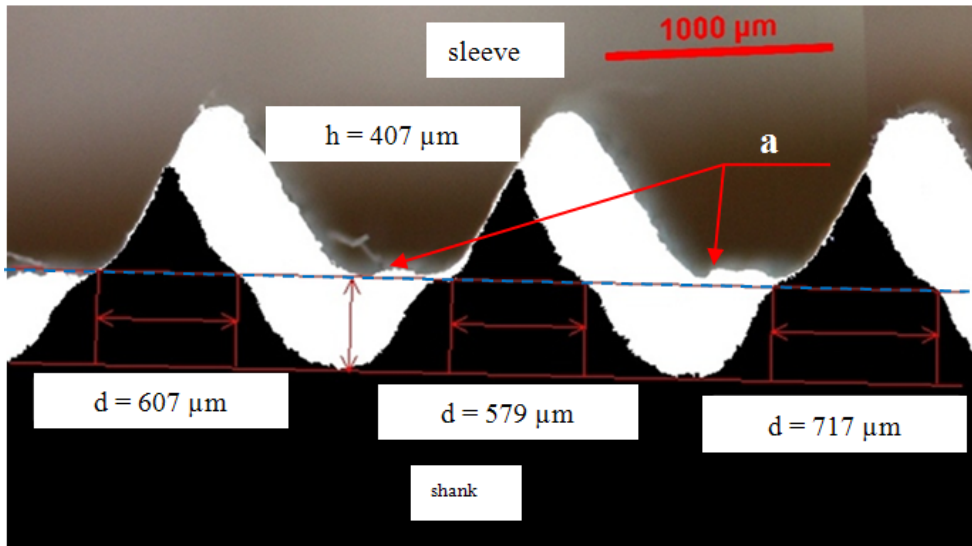
Fig. 6. Simulation of meshing for shank No. III and the corresponding sleeve

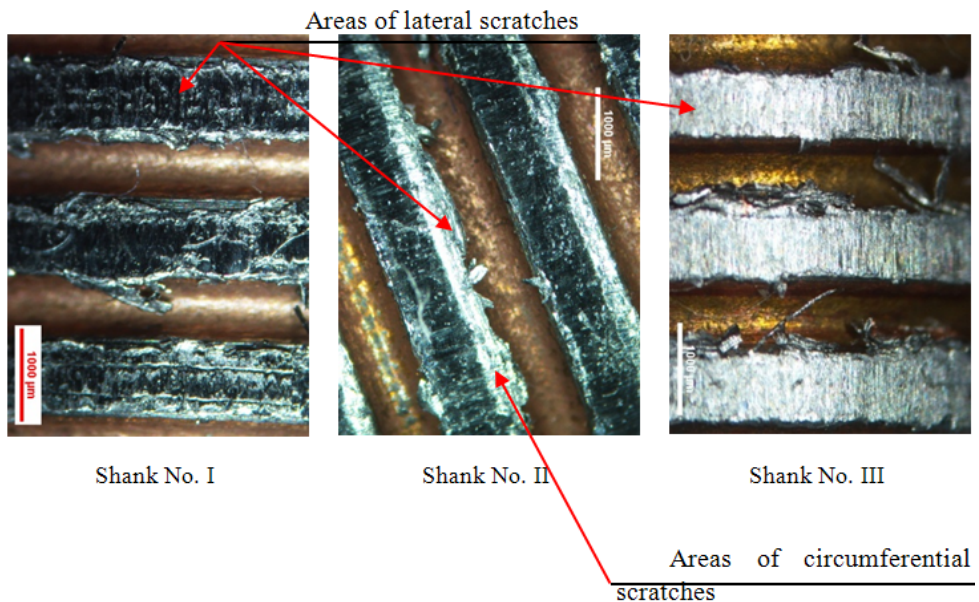
Observations of the thread coils following pressure tests (fig. 7) revealed the existence of significant plastic deformations. They demonstrate areas of lateral scratches, which were formed due to the conducted test (sheared areas) and areas of circumferential scratches, which probably stem from the friction between the thread's coils on the shank and the sleeve during opening and closing of the filter (conducted during filter's operation). Dimension measurements of the threads from test pairs after rupture indicate that the threads were sheared at the height of 400 μm from the bottom of notches between threads. This height is similar to the value of the height of the shearing surface of the thread connection of shank to sleeve, which were estimated in meshing simulations. (fig. 4, 5 and 6). Measurement results of the width of the shearing surface are significantly higher (range 790 μm -870 μm^2) from the values predicted in simulations (range 520 μm -720 μm – fig. 4, 5 and 6). It is caused by the occurrence of plastic deformation of thread areas in the vicinity of the shearing surface, generated by the increased force.

Fig. 7. The condition of the threads tested after the pressure test

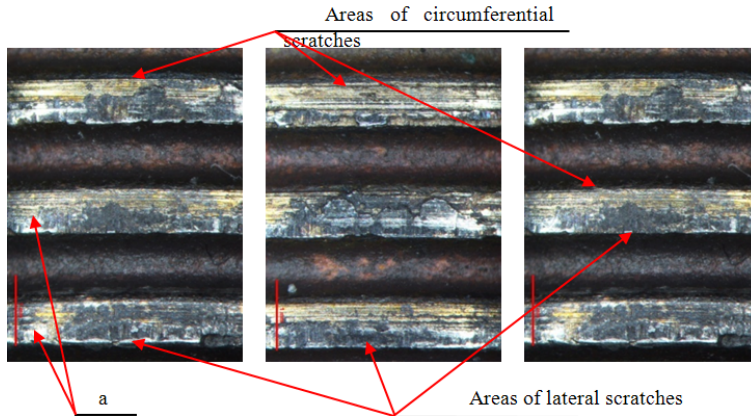
Observation of thread's coil on the shank of the filter, which was broken (fig. 8) did not demonstrate the existence of significant plastic deformation. The surface of the thread's coils on this shank is also distinguished by areas of lateral and circumferential scratches.

The surface of lateral scratches is, however much smaller than in the case of the analogous areas on shanks subjected to pressure tests. Moreover, these areas represent a variety of discontinuities (fig. 8), which indicates that in some fragments, of the thread's coils of the emergency filter, there was no shearing.

Fig. 8. The condition of the emergency filter shank's thread

The comparison of the condition of thread's coils on the shank from test pairs with the shank's thread from the broken filter can imply that in the second case, the thread underwent significant wear during operation. This wear decreased the surface area of coils in the shearing surface, leading to the decrease of the thread's shear strength. Due to this, it is assumed that the pressure needed to damage the thread on the shank in the emergency filter was smaller than in the case of the filters from test pairs.

The suggested future direction of the research would be a simulation of the thread condition from the emergency filter, accomplished by conducting wear tests of the shank's thread by friction. The test would consist of a cyclic closing and opening the filter in such a way as to simulate tribological simulations, to which the thread connection of shank to sleeve is subjected during the filter's operation. The shank's thread would be subjected to macroscopic observation at the initial stage in order to monitor for wear after a specific number of cycles. Simulations performed under these conditions would be useful in estimating which wear rates of the filter would result in its destruction by the application of pressure that is similar to operational conditions.

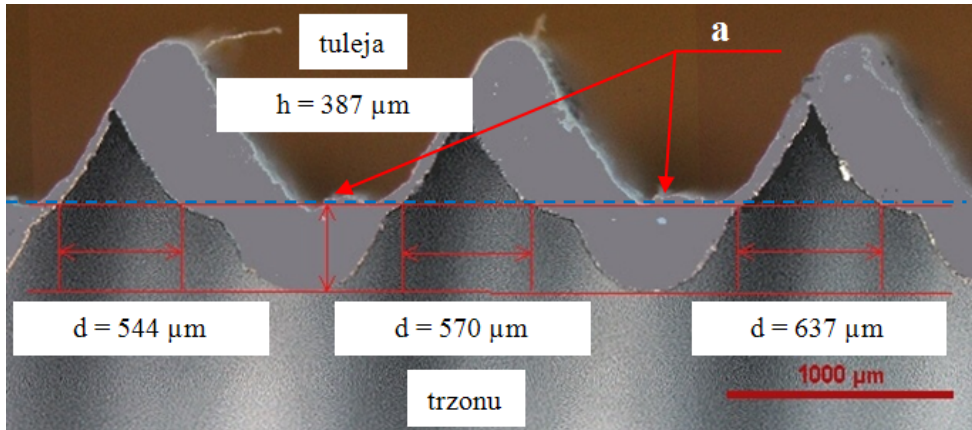
Kształty nitek gwintów par trzon-tuleja przedstawione zostały na poniższych rysunkach (rys. 4, 5 i 6). We wszystkich trzech przypadkach widoczna jest wyraźna deformacja nitki gwintu trzonu w postaci zwężenia górnej części nitki. Zwężenie to może być silnie asymetryczne, tak jak w przypadku gwintu z trzonu nr II. Zmiana kształtu nitki, zmniejszająca pole powierzchni nitki w przewidywanej płaszczyźnie ścinania (przerywana, niebieska linia na rys. 4, 5 i 6), skutkuje obniżeniem wytrzymałości na ścinanie. Odległość przewidywanej płaszczyzny ścinania od dna wrębów nitki gwintu dla trzonów nr I, II i III wynosi odpowiednio 387 μm , 418 μm i 407 μm . Wyznaczone szerokości przewidywanej płaszczyzny ścinania dla trzech nitek gwintu zostały dla każdego trzonu zaznaczone na rysunkach (wymiar d na rys. 4, 5 i 6). Deformacja nitki gwintu tulei jest wyraźnie mniejsza. Zauważalna jest bruzda występująca na środku górnej powierzchni nitki gwintu („a” na rys. 4, 5 i 6), która może być efektem procesu wytwarzania lub nacisków eksploatacyjnych na roboczą powierzchnię gwintu. Zweryfikowanie tej hipotezy nie jest możliwe ze względu na brak możliwości zbadania tulei w stanie nieużywanym.

Rys. 4. Symulacja zazębienia dla trzonu nr I i współpracującej z nim tulei

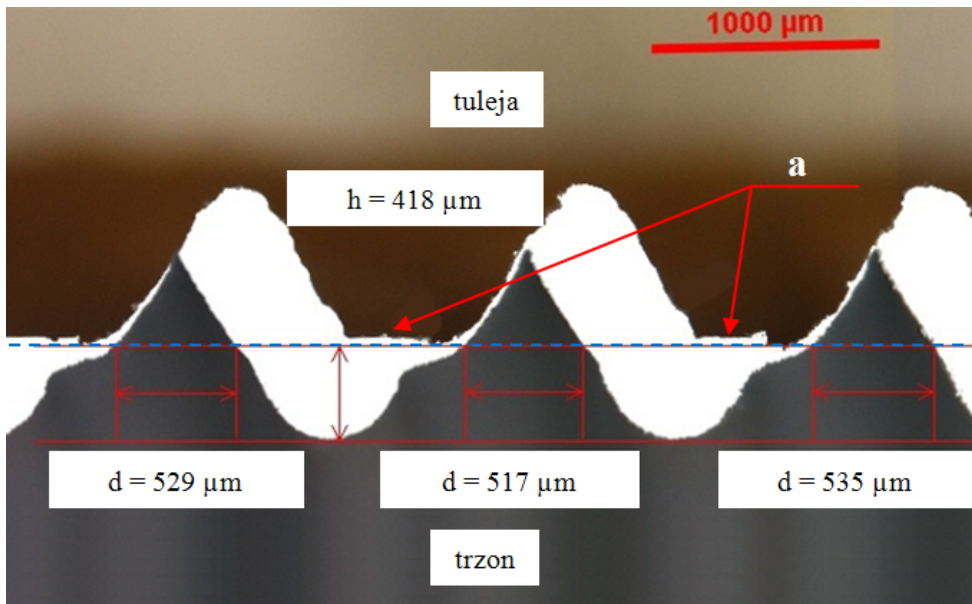
Rys. 5. Symulacja zazębienia dla trzonu nr II i odpowiadającej mu tulei

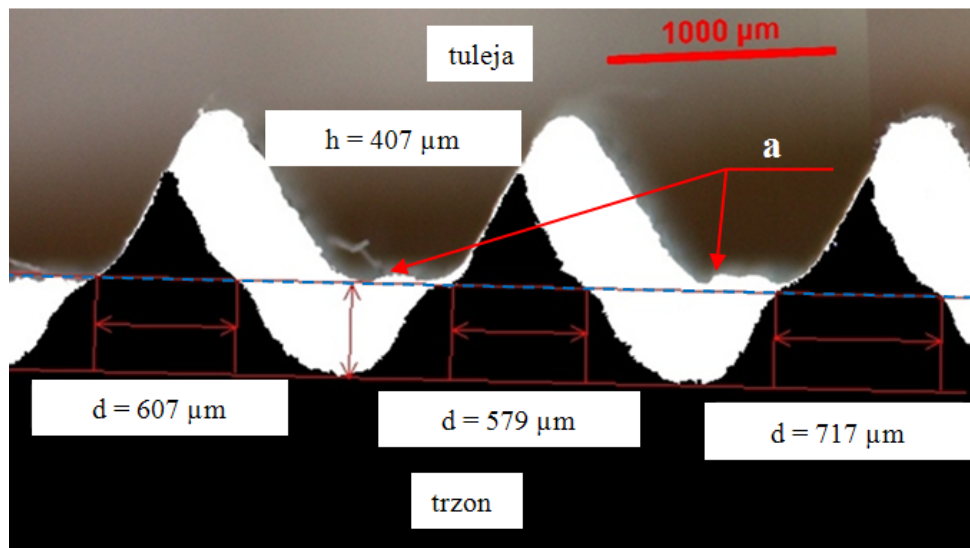
Rys. 6. Symulacja ząbienia dla trzonu nr III i odpowiadającej mu tulei

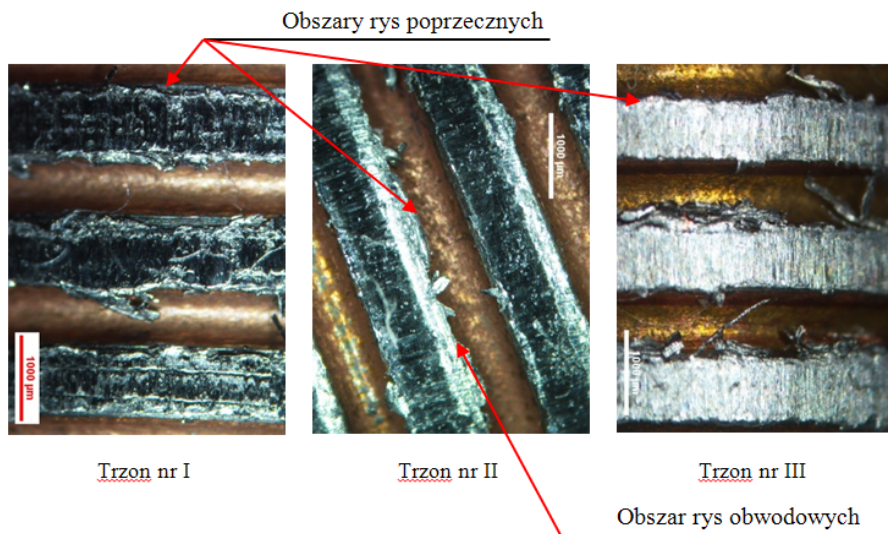
Observacje nitki gwintów po próbach ciśnieniowych (rys. 7) wykazały występowanie znacznych odkształceń plastycznych. Widoczne są na nich obszary rys poprzecznych, powstałych w wyniku przeprowadzonej próby (obszary ścięte), oraz obszary rys obwodowych, które prawdopodobnie są skutkiem tarcia pomiędzy nitkami gwintów trzonu i tulei w czasie zamykania i otwierania filtra (przeprowadzanych w trakcie eksploatacji filtra). Pomiar średnic gwintów trzonów z par badawczych po zerwaniu wskazują, że gwinty uległy ścięciu na wysokości około 400 μm od dna wrębów pomiędzy gwintami. Wysokość ta jest zbliżona do wartości wysokości płaszczyzny ścięcia oszacowanych w symulacjach zazębienia gwintów par trzon-tuleja (rys. 4, 5 i 6). Wyniki pomiarów szerokości płaszczyzny ścinania są jednak wyraźnie wyższe (przedział 790 μm – 870 μm^2) od wartości przewidzianych w symulacjach (przedział 520 μm – 720 μm – rys. 4, 5 i 6). Jest to spowodowane wystąpieniem odkształcenia plastycznego obszarów gwintu w pobliżu płaszczyzny ścinania, wywołanego działaniem znacznej siły.

Rys. 7. Stan powierzchni gwintów trzonów badanych po próbie ciśnieniowej

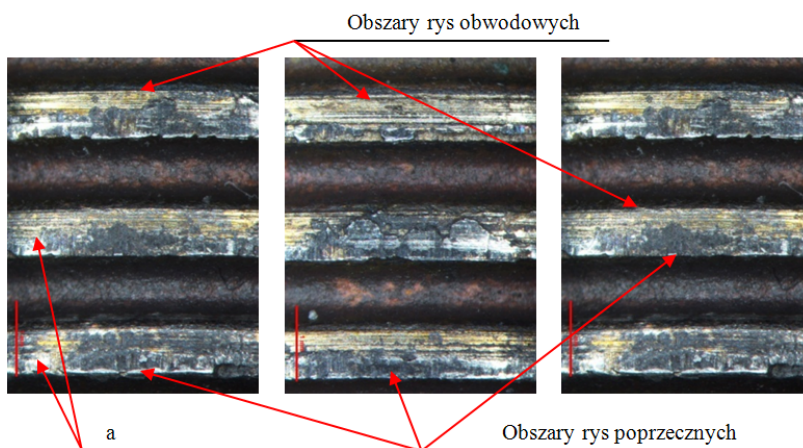
Obserwacja nitki gwintu trzonu z filtra, który uległ awarii (rys. 8) nie wykazała obecności znacznych odkształceń plastycznych. Na powierzchni nitki gwintu tego trzonu również występują obszary rys poprzecznych oraz obszary rys obwodowych. Powierzchnia obszarów rys poprzecznych jest jednak znacznie mniejsza, niż w przypadku analogicznych obszarów z trzonów poddanych próbom ciśnieniowym. Ponadto w obszarach tych występują nieciągłości (a na rys. 8), co wskazuje, że w niektórych fragmentach nitki gwintu filtra awaryjnego nie doszło do ścinania.

Rys. 8. Stan gwintu trzonu z filtra awaryjnego

Porównanie stanu nitek gwintów trzonów z par badanych z gwintem trzonu z filtra, który uległ awarii może wskazywać, iż w drugim z wymienionych przypadków gwint uległ w trakcie eksploatacji znacznie większemu zużyciu. Zużycie to zmniejszało pole przekroju nitek w płaszczyźnie ścinania, przez co obniżając wytrzymałość gwintu na ścinanie. Z tego względu ocenia się, że ciśnienie potrzebne do zniszczenia gwintu trzonu w filtrze awaryjnym było mniejsze, niż w przypadku filtrów z par badawczych.

Proponowanym dalszym kierunkiem badań byłoby zasymulowanie stanu gwintu z filtra awaryjnego poprzez przeprowadzenie prób zużycia gwintu trzonu przez tarcie. Próba polegałaby na cyklicznym zamykaniu i otwieraniu filtra w taki sposób, aby zasymulować obciążenia trybologiczne, jakim poddawane jest połączenie trzonu z tuleją w trakcie eksploatacji filtra. Gwint trzonu poddany byłby obserwacji makroskopowej w stanie wyjściowym oraz po wykonaniu określonej liczby cykli celem monitorowania zużycia. Symulacje wykonane na podstawie tych obserwacji umożliwiłyby oszacowanie, jaki poziom zużycia filtra umożliwi jego zniszczenie poprzez działanie ciśnienia zbliżonego do warunków eksploatacyjnych.
