CONSTRUCTION DISASTER HAZARD CAUSED BY A DEFECTIVE BUILDING STRUCTURAL SURVEY

Leopold KRUSZKA, Alicja OSTROWSKA¹

Faculty of Civil Engineering and Geodesy, Military University of Technology, Warsaw, Poland

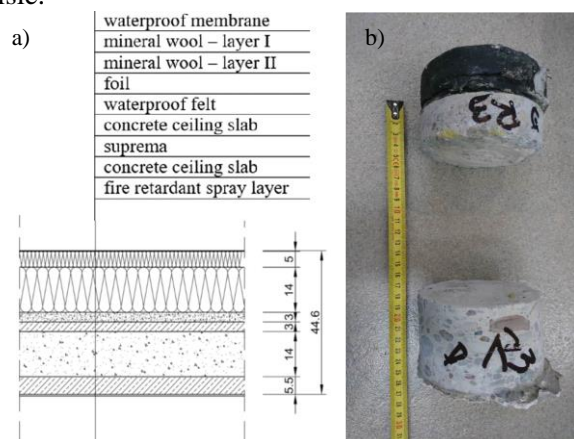
As a result of these investigations, significant errors (defects) were found in expert opinions and the survey. These errors included both incorrect thicknesses of the reinforced concrete floor and roof assembly slabs of the central aisle and side aisles. The survey documentation [9, 10] specified the thickness of the reinforced concrete floor and ceiling assembly slabs to be 8 cm, in reality the thickness is 7.5 cm for the central aisle and 5.5 cm for the side aisles. In addition, an incorrect – incomplete – arrangement of the flat roof layers was found: only two layers of felt were specified as waterproofing, while in reality there were additional layers under the felt: for the side aisles (lower parts) – 10 cm thick *suprema* panels and a 6 cm thick concrete (levelling) layer, and for the central aisle – 8 cm thick *suprema* panels and a 7 cm thick concrete (levelling) layer. Figure 2 below shows an example of the layout of the roof layers above a side aisle.

Fig. 2. Layers over the side aisle, a) layering, b) drill-hole elements

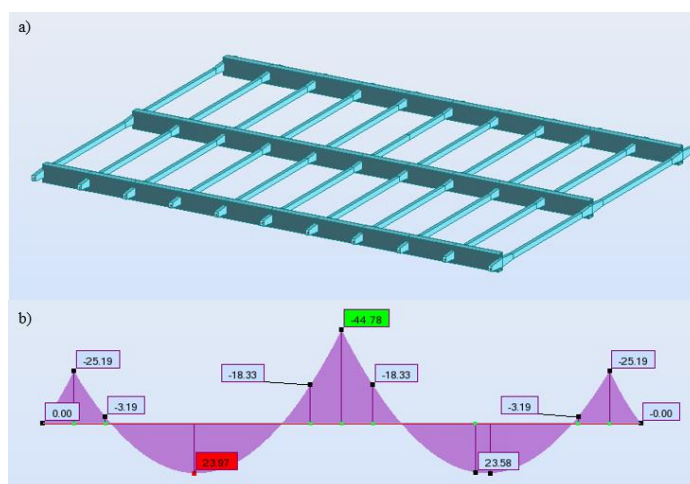
A computational analysis of the roof load bearing structure was carried out during the next stage. A schematic diagram of the bar numerical model of the reinforced concrete roof grid of the side aisles, together with the results of the numerical analysis, are presented in Fig. 3.

Fig. 3. a) Schematic diagram of the reinforced concrete grid of the roof of the side aisles, b) calculation results – determination of the maximum rib span moment [11]

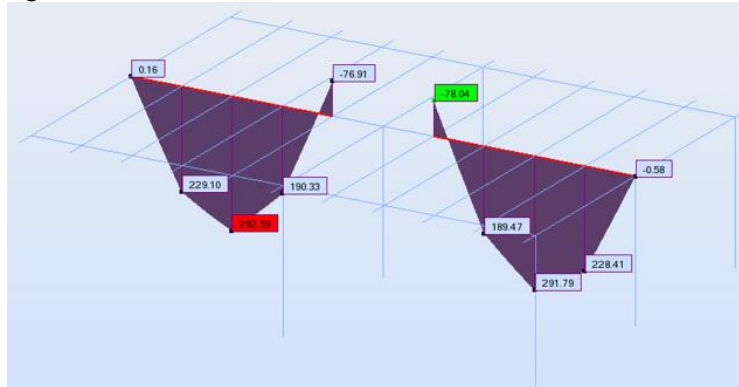
Then the maximum moment value for the roof rafters was calculated by adding columns to the numerical model – Figure 4.

Fig. 4. Analysis results - maximum span moment of a side aisle roof rafter [11]

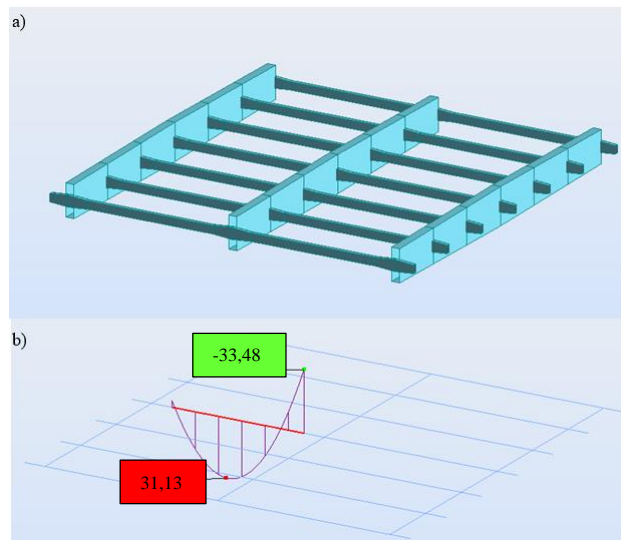
Fig. 5. a) Schematic diagram of the reinforced concrete grid of the roof of the central aisle, b) calculation results – determination of the maximum rib span moment [11]

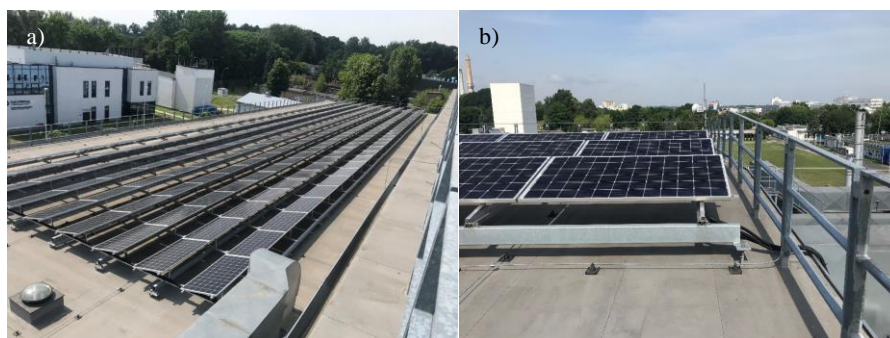
A photovoltaic system was installed on building F20, on both the side aisles and the centre aisle (Figure 6). The total specific load from the photovoltaic system and its support structure is 0.22 kN/m².

Fig. 6. Roof of building F20 after the modernisation and installation of photovoltaic panels, a) side aisle, b) central aisle

A refurbishment to the proposed extent was carried out in 2019 using the current Eurocode standards. The layering over the side aisles is currently as follows:

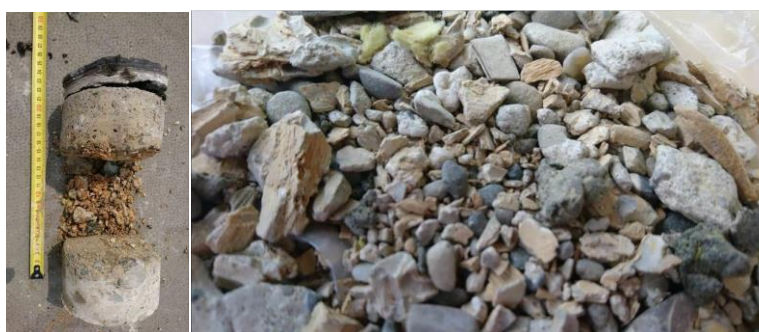
The existing F20 building in question, characterised by a reinforced concrete roof structure, was designed when the specific snow load was 0.6 kN/m^2 . The installed insulation comprised a heavy layer of suprema with an additional pressure and levelling layer of concrete. In the case analysed, the term suprema was an exaggeration, as this layer in the test-holes consisted of loose aggregate with pieces of mortar and concrete admixed with sawdust [12] – Figure 7.

Fig. 7. Roof thermal insulation layer, a) sample taken, b) insulation material
