ANALYSIS OF APPLICABILITY OF THERMOGRAPHY TO ASSESS HEALTH OF GAS TURBINE BLADES

Artur Kułaszka

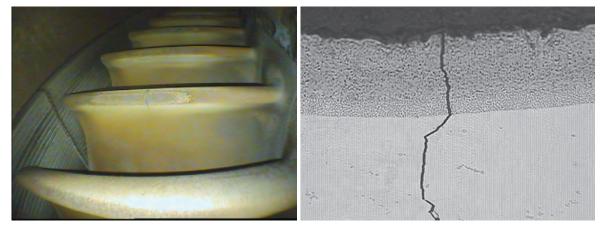
Fig. 1. Image of a crack of the protective coating with crack propagation into the parent material of the blade body [5]: videoscopic image – a) microscopic image, magn. x 450

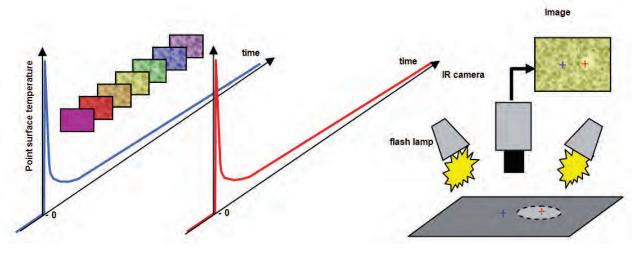
Fig. 2. The diagram for application of the Pulse Thermography [3]

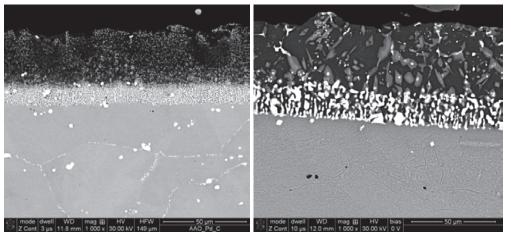
Fig. 3. Surface layer of a new blade and the one preheated to the temperature of 1423K

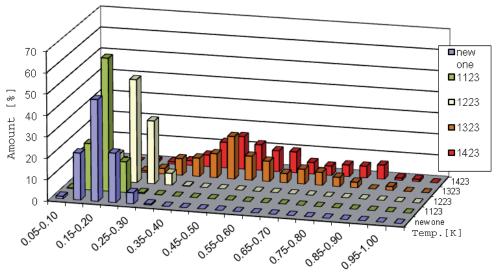
Class of the object size expressed by the equivalent diameter [µm]
