## Redevelopment of the Old Waste Incineration Plant in Poznań: Contribution to the Discussion on the Approach to Post-Industrial Cultural Property

**Cytowanie / Citation:** Marciniak P. Redevelopment of the Old Waste Incineration Plant in Poznań: Contribution to the Discussion on the Approach to Post-Industrial Cultural Property. *Wiadomości Konserwatorskie – Journal of Heritage Conservation* 2021, 68S:102–111

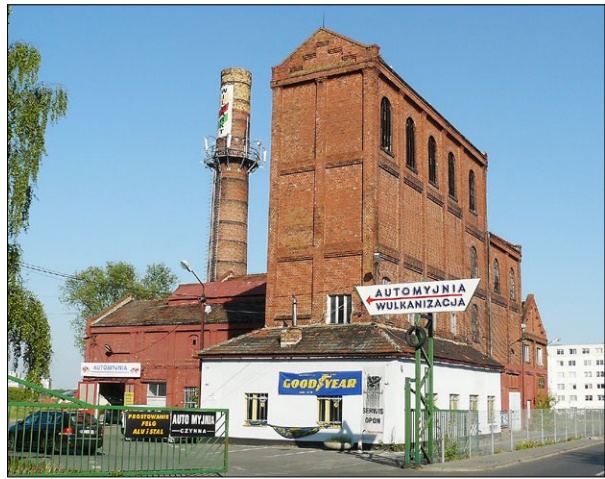
Fig. 4. Incineration Plant, image from 2007 showing the missing smokestack top and the additions on the ground level; photo courtesy of Litoborski+Marciniak.  
Ryc. 4. Spalarnia, zdjęcie z roku 2007 ukazujące brakujący wierzchołek komina oraz dobudówki na poziomie parteru; fotografia dzięki uprzejmości Litoborski+Marciniak.

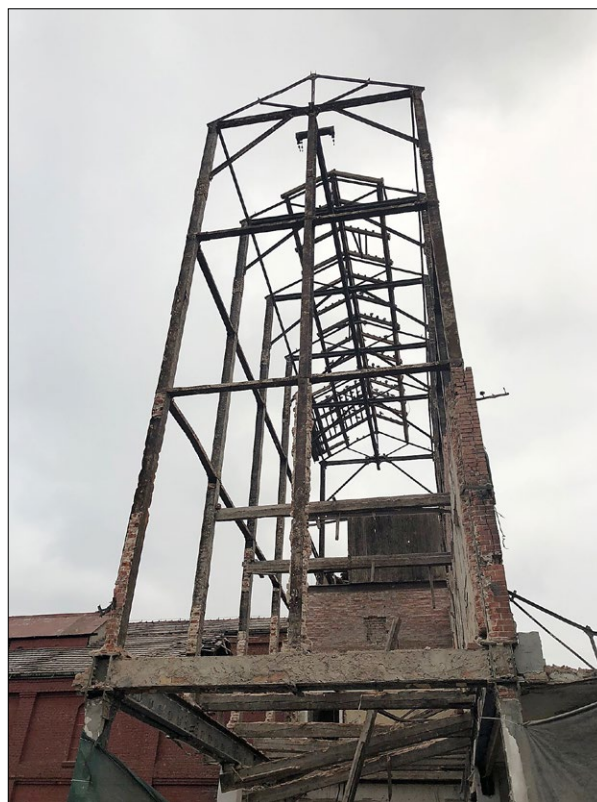
Another expert survey of 2017 confirmed the property's dramatic technical condition, including a threat to the structural stability of the high part of the incinerator building and the smokestack, which deviated from the vertical by 13 cm. Of crucial significance was the deterioration of the "existing steel structure

which [was] coupled with the column structure of the walls,<sup>20</sup> as well as numerous vertical cracks in the plasters reinforcing the external walls.

*Fig. 5. The high section during the demolition of the deformed and cracked walls with visible corroded steel structure; photo by P. Paradziński.*

3. Due to the building's poor technical condition, the highest north-western large-volume part, the roof structure and cladding, and the smokestack were demolished. They were then reconstructed retaining the layout of the block and facade but using modern construction techniques (layered walls with ceramic cladding).

solutions. The deteriorated inner steel structure was replaced by a reinforced concrete one, which met strict fire safety regulations. A few internal walls were also demolished and rebuilt. The foundation of part of the reconstructed section was made on a reinforced concrete slab. The internal foundations under the columns and under the new internal walls were made of reinforced concrete footings and benches, respectively. The building's structural system, due to fire protection requirements (for a mid-high building), was designed as a massive structure using the spatial formwork calculation model. This featured reinforced concrete columns and binders, and 18-cm-thick multi-area Filigree floor slabs. The walls of the upper stories were made of 20-cm-thick reinforced concrete. The existing outer brick walls were fixed to the new reinforced concrete structure with steel ties (anchors).

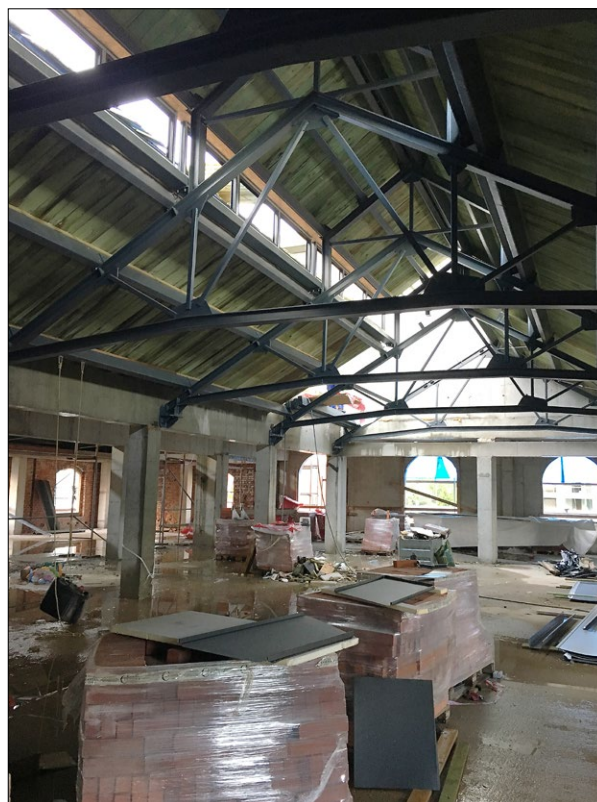
Another difficult feature was the roof. The existing roof covering, and above all the steel structure, were corroded and did not meet modern strength standards. The existing purlin and rafter roof based on steel lattice girders was dismantled and replaced with new steel lattice trusses meeting the current, revised regulations

*Fig. 8. Second floor interior of the lower part of the plant, visible reconstructed steel structure of the roof; photo by P. Marciniak*  
Ryc. 8. Wnętrze pierwszego piętra niższej części spalarni, widoczna odtworzona konstrukcja stalowa dachu; fot. P. Marciniak.

for snow and wind loads, as well as taking into account the need for roof insulation and adequate fire protection. Roof pitches and truss heights were modelled on the original trusses, as were the purlin and rafter structures. The roofing was made of graphite-colored coated steel with a standing seam. The gutters, downpipes, roofing and other details were adapted to the color and architectural expression of the roof and its structure and were made of similar material.

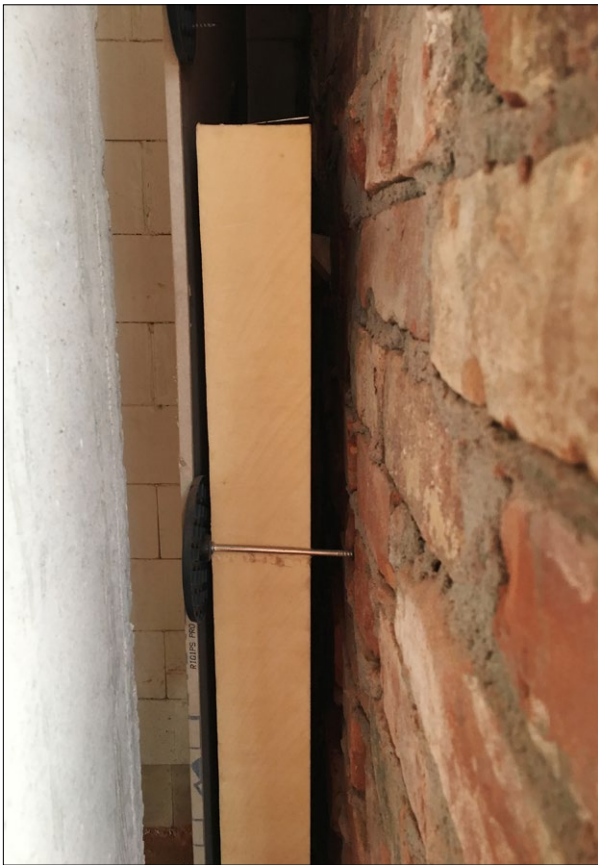
Fig. 9. Thermal wall insulation installed from the inside; photo by P. Marciniak.  
Ryc. 9. Izolacja termiczna ścian mocowana od wewnątrz; fot. P. Marciniak.

The remaining external brick walls, after appropriate treatment (replacing missing bricks and damaged sections, removing dirt and light red paint coating, etc.) were preserved to serve as wall cladding, strengthened from the inside with a new reinforced concrete support structure. The entire facade of the building, after repairing the bricks, producing new ones and restoring the old openings, was grouted to obtain a uniform, coherent architectural expression, whilst preserving and exposing the historical layers.
