Qualitative Assessment of the Defects in Metal Casting Prosthetic Restorations

Summary

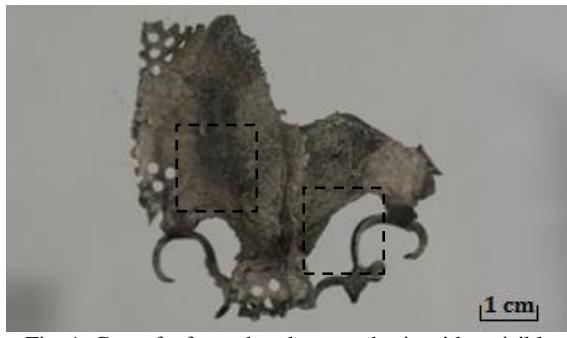
Fig. 1. Cast of a frame bracket prosthesis with a visible casting defect in the form of blisters

This type of casting defect is a result of the presence of a gas in the alloy during its solidification or an insufficient release of the air and gases filling the mould cavity (Fig. 1). In order to prevent the occurrence of this type of casting defects, one should assure a proper degasification and purification of the metal [24-27].

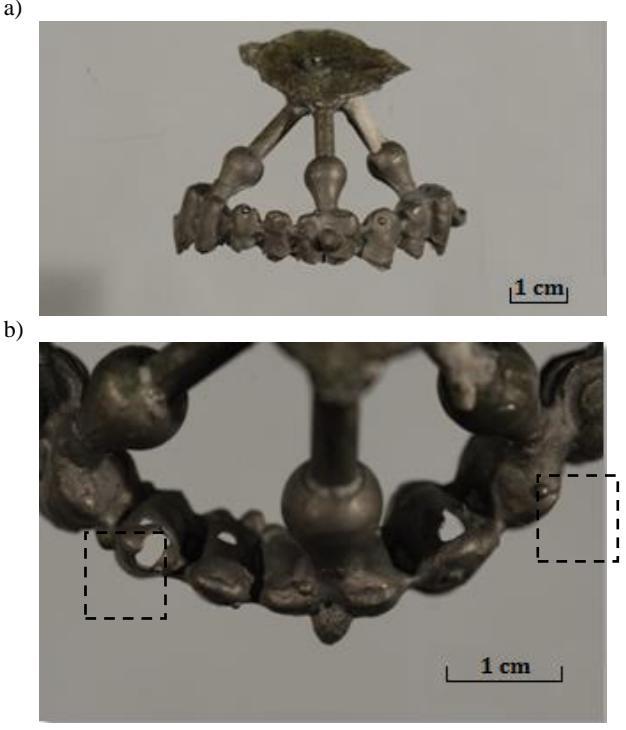
Fig. 2. Structure of a circular bridge with visible uncut feed channels (a) and casting defects in the form of blisters and misruns in the upper and side part of the substructure (b)

A misrun is a casting defect which is formed at an insufficiently high casting temperature and with an insufficient metal castability (Fig. 2). The cause of the occurrence of this type of defect is a badly-designed system of gates. In order to eliminate such defects in cast alloys, one should raise the casting temperature or implement a different design of the gating system construction [27].

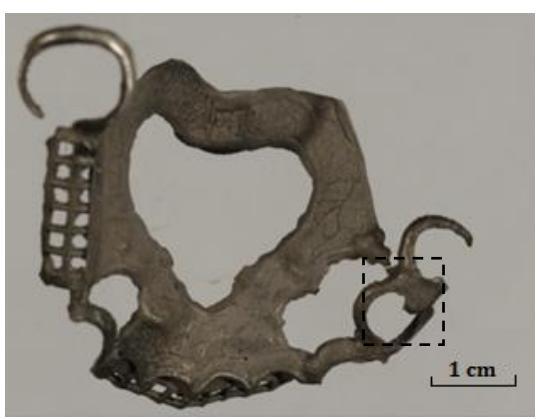
Fig. 3. Frame prosthesis with a visible cold fracture on the side of the bracket

The defect presented in Figure 3 occurs in the areas undergoing stresses, that is in those sections of the cast which solidify last. In order to avoid the occurrence of this defect in the cast prosthetic element, one should apply slow cooling in the mould and carefully knock the cast out [27].

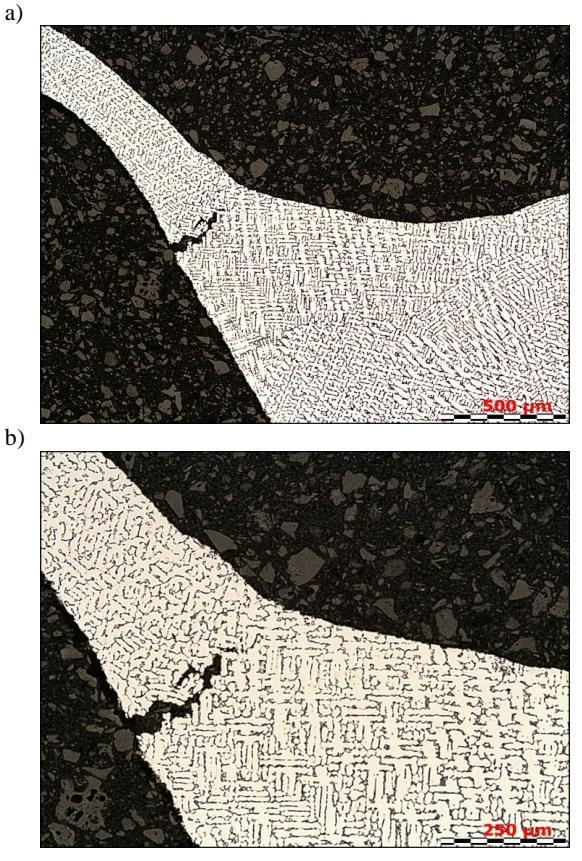
Fig. 4. Microstructure of the Co-Cr-Mo alloy with a visible casting defect - intercrystalline crack: a) magnification 50x, b) magnification 100x

The microstructure revealed during the etching consists of a matrix constituted by a solid heterogeneous solution of chromium, molybdenum and carbon in β -Co matrix (Fig. 4). At the crystallite boundary and in the interdendritic spacings, we can observe the presence of dispersive carbide precipitates of a continuous character of the M₂₃C₆ (Cr₂₃C₆) or (MoCr)₆C type. The basic element which undergoes segregation is chromium; molybdenum segregates to a lesser degree [2-6]. The microscopic observations revealed a defect in the form of a crack running along the dendrite

axis (Fig. 4b). The most frequent cause of the occurrence of this defect is an improper course of the cast alloy solidification process [8].

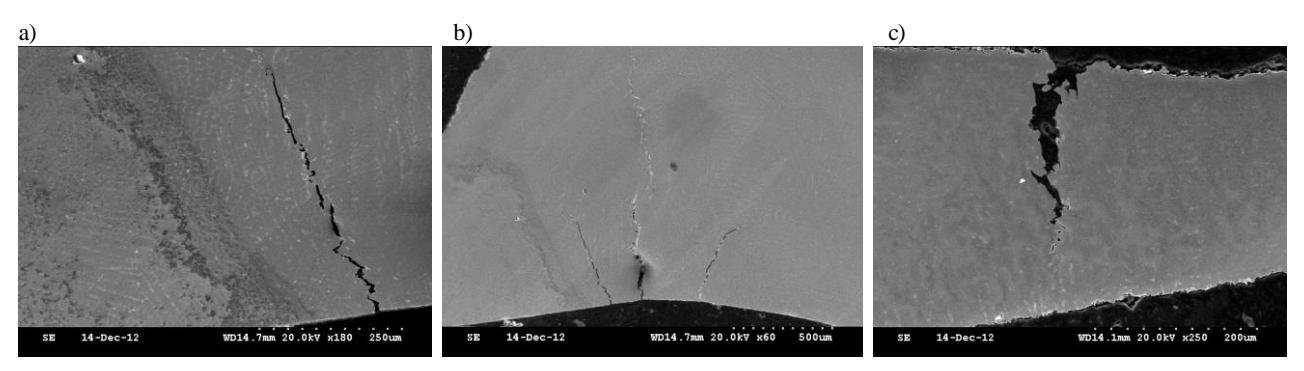
The SEM observations confirmed the presence of cast defects in the form of microshrinkages and pores occurring in the dendrite arms (Fig. 5a) as well as microcracks running along the dendrite axis (Fig. 5a-c).

Fig. 5 Scanning images with visible casting defects in the form of microshrinkages and pores as well as cracks, with different magnifications (a), (b) and (c)

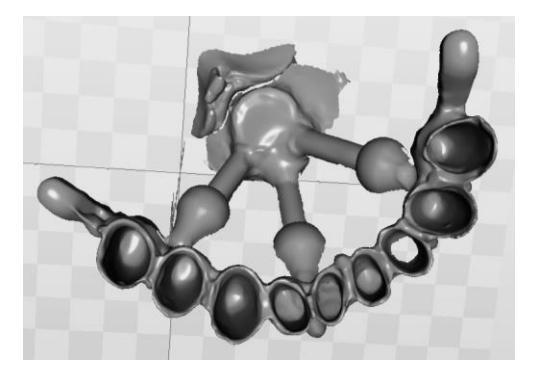
Fig. 6. Visualization with the use of a 3D ATOS scanner of a circular bridge structure with a visible casting defect (misrun)

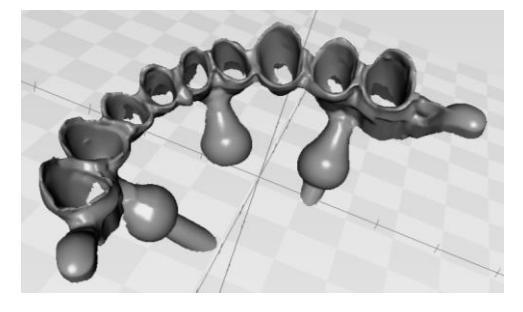
Fig. 7. Three-dimensional image of a circular bridge structure with a visible "series" of misruns revealed by means of a 3D ATOS scanner

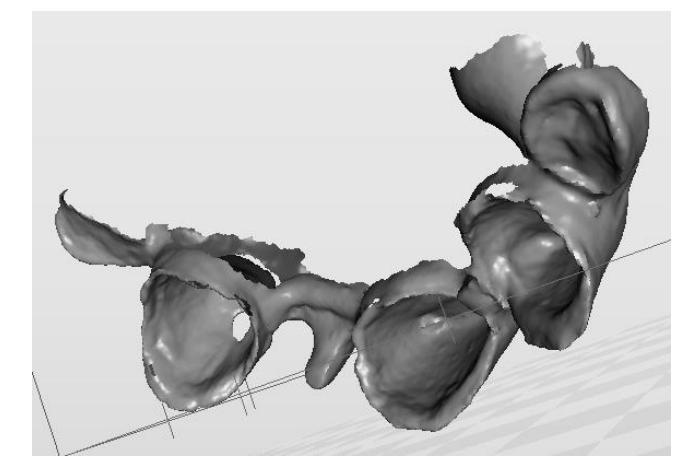
Fig. 8. 3D visualization with the use of a ATOS 3 scanner of a substructure with a casting defect (misrun)

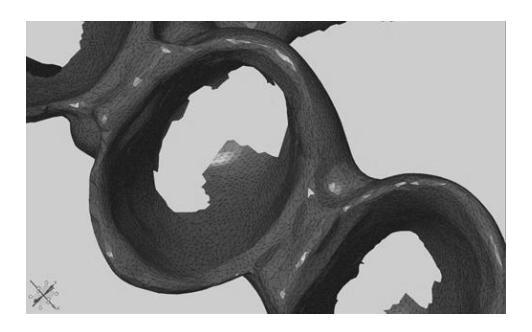
Fig. 9. 3D visualization of a triangle network showing the measured surface fragments of a circular bridge structure
