Geomatics, Landmanagement and Landscape No. 3 • 2018, 7-22

APPLICATION OF SOUND TOMOGRAPHY IN THE REVITALIZATION OF THE AREA SURROUNDING THE NATIVITY OF THE BLESSED VIRGIN MARY ORTHODOX CHURCH IN WŁODAWA

Margot Dudkiewicz

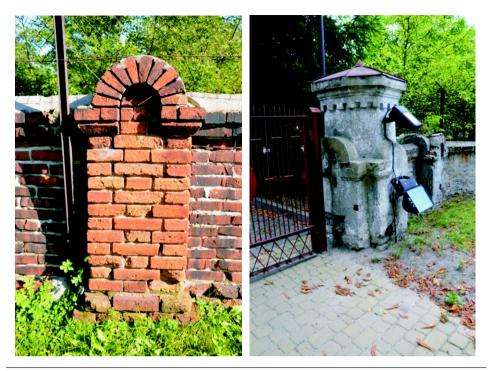
Photos 9 and 10. The oldest fragments of the former fence (photos by M. Dudkiewicz, 2017)

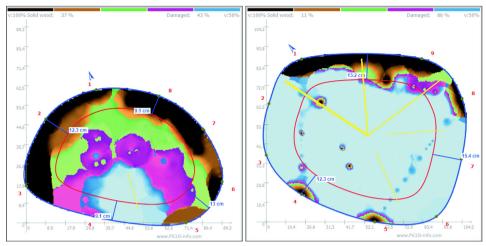
-	Aesculus hippocastanum L. Horse-chestnut	Trunk diameter at the height of 1.3 m: 252 cm Height: 14.4 m Crown spread: 8 m Crown spread: 8 m Approximate age: 91 years From the West side, on the section from 0.5 to 2 meters of height, there is a deep cavity left by the fragment of the trunk breaking off, sized 50 × 150 cm, partially healed by the edge of the wound. There is damp muck inside the cavity. From the North side, there is clear damage to the trunk with the protruding bark on a 3.5-meter long section, and unhealed fragments of the removed boughs in the crown. The single-stem crown is directed to the South. The centre of gravity is located high up. There is substantial share of deadwood (30%) in the branches. The tomogram shows that the damaged area occupies 43% of the cross-sectional area of the trunk with continued increasing trend. Technically efficient wood occupies only 37% of the surface (Fig. 2). There is high risk of breaking the trunk due to the critical factor of its mechanical strength. The t/R coefficient is 0.26.	To be removed for sanitary reasons, and for the safety of the users of the area

- **Fig. 2.** Tomogram of the *Aesculus hippocastanum* horse chestnut tree No. 1
- Source: developed by the author, 2017
