Robert **STACHNIEWICZ**

USE OF THERMOGRAPHY FOR DETERMINING PLACES IN DANGER OF THE MOLD GROWTH IN RESIDENTIAL BUILDINGS

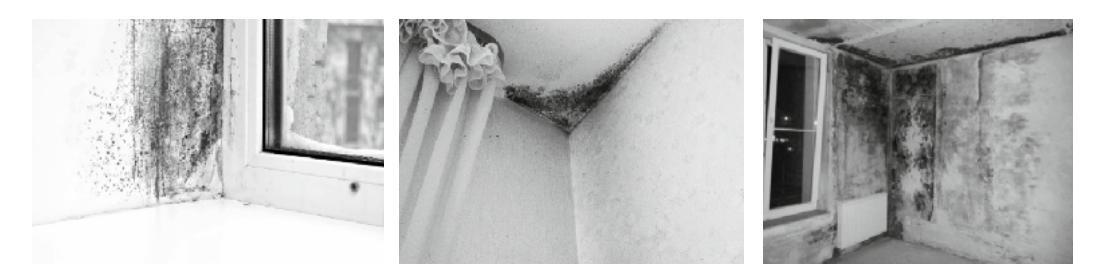
Figure 1. Examples of mold locations in apartments (window reveal, upper corner of the room, behind the curtains and furniture)

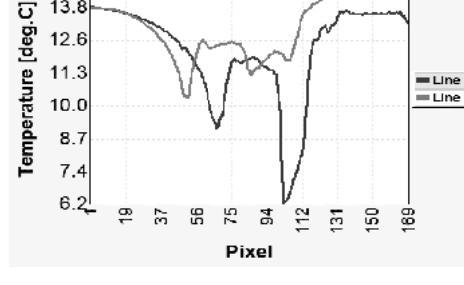
Figure 5. Temperature distribution in the profiles Li1 and Li2 at the threshold of the balcony door

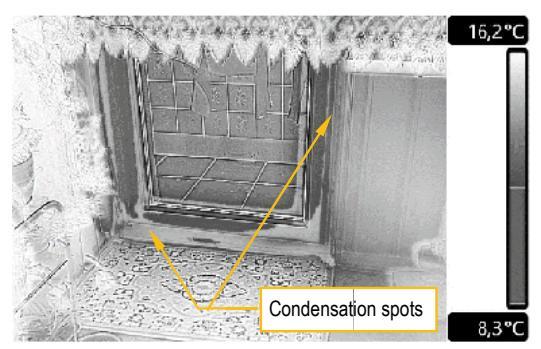
Figure 6. Thermogram of the surface condensation site at the balcony door – a condition for dew point $\theta_{\rm s}$

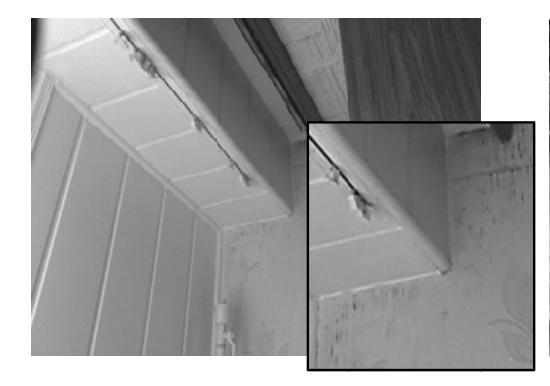
Figure 8. Photograph of upper corner connection gable wall – curtain wall with mold traces visible on the wallpaper

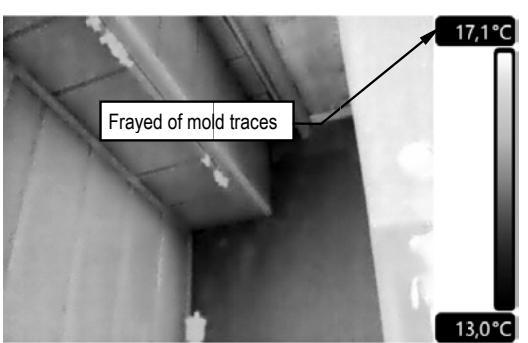
Figure 10. Thermogram of the site endangered by surface condensation in a room corner – a condition for dew point

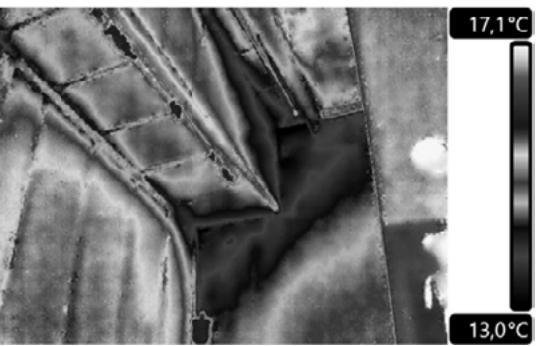
Figure 9. Thermogram of the upper corners with a visible temperature reduction in the corner

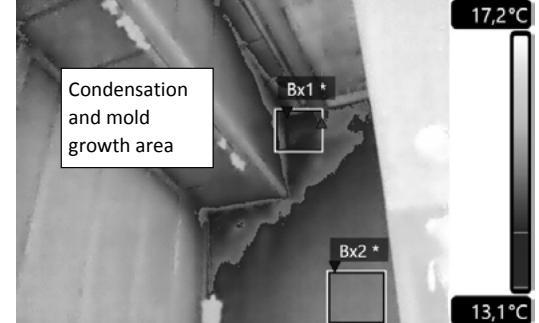
Figure 11. Thermogram of the site endangered by surface condensation in a room corner – a condition for critical temperature

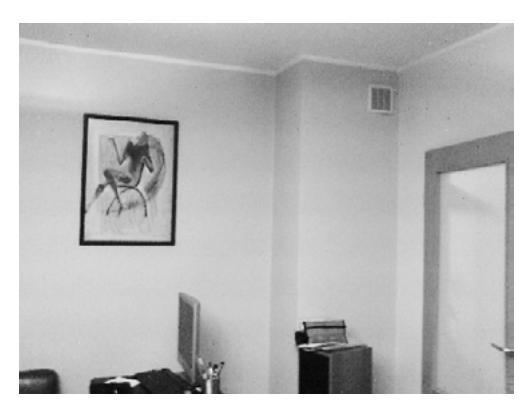
Figure 12. The natural ventilation channels in the room on the top floor of the building
