DOI 10.2478/ntpe-2020-0012

## Analysis of Gas-Geodynamic Phenomena During the Preparatory and Mining Works in Seam 358/1 at KWK "Budryk"

Marian Zmarzły JSW S.A. KWK "Jastrzębie-Bzie", Poland Michał Schubert JSW S.A. KWK "Budryk", Poland Krystian Salamon JSW S.A. KWK "Borynia-Zofiówka" Ruch Zofiówka, Poland

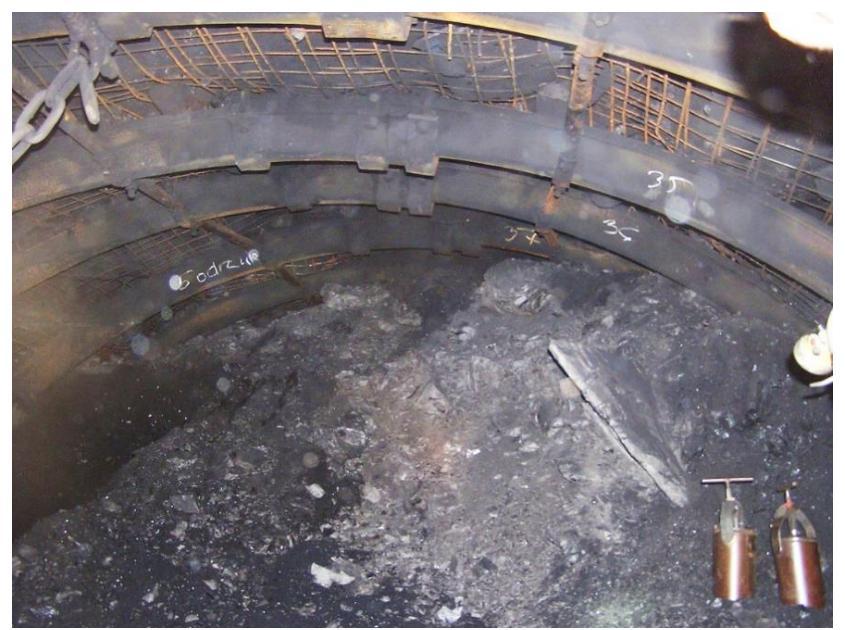
Fig. 1 Heading face after the outburst of gases and rocks in transport gallery D-6, seam 409/4 – "Zofiówka" mine (November 22, 2005)

During the excavations conducted with the AM-50 road header, approximately 350 Mg of crushed mined rock was thrown into area near the working face, which formed a heap of approx. 30 m in length. Three employees – the cutter loader operator and two miners were killed.

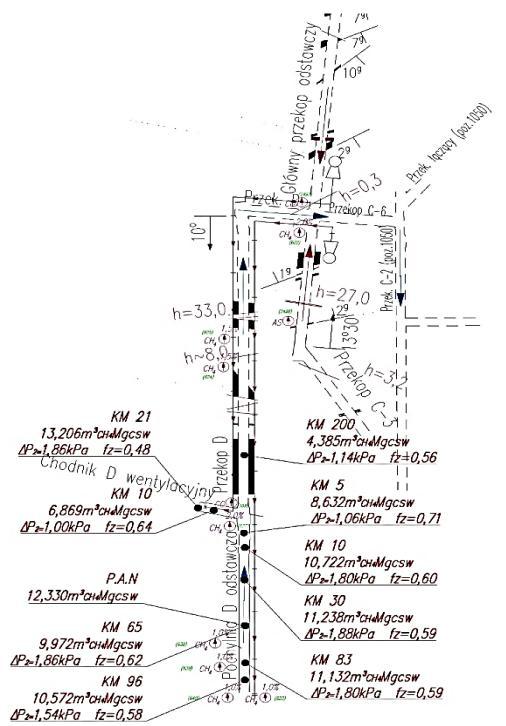
In 2012, ramp D in seam 358/1 turned out to be a particularly dangerous working. Fig. 2 presents the value of methane-bearing capacity of seam 358/1 in the area of ramp D. The maximum value of methane-bearing capacity of seam 358/1 in this area of ramp D before the outburst reached max. 13,206 m<sup>3</sup>/Mg<sub>csw</sub>, whereas the maximum value of desorption intensity was 1.88k Pa.

Fig. 2 Values of the methane-bearing capacity of seam 358/1 in the vicinity of the excavated ramp D

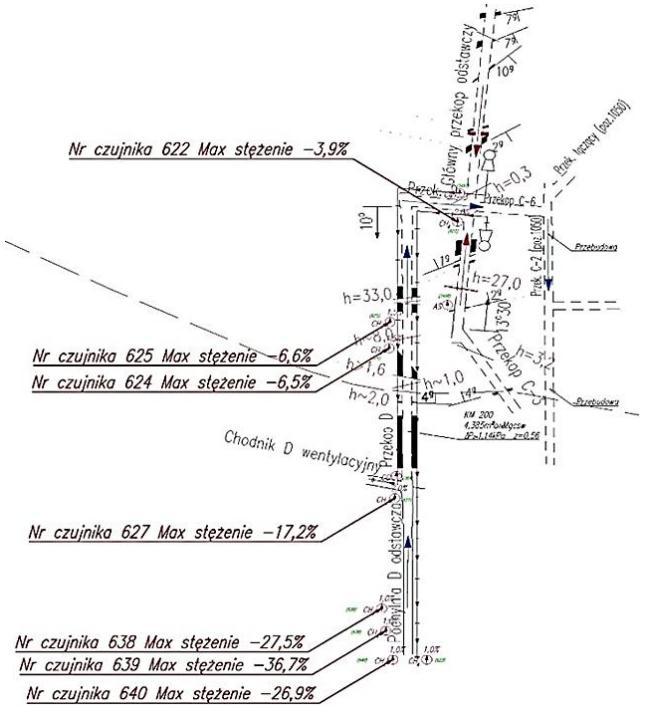
Fig. 3 Methane concentrations during the outburst in the area of ramp D in seam 358/1

The maximum methane content recorded by the sensors in the face reached 36.7%. The workers employed in ramp D and tunnel D retreated to the flow of air without using escape apparatuses. None of the workers sustained injuries. Despite introducing a number of rigours and preventive measures, there was an outburst of gases and rocks. The view of the heading face after the outburst in ramp D in seam 358/1 has been presented in Figures 4 and 5.

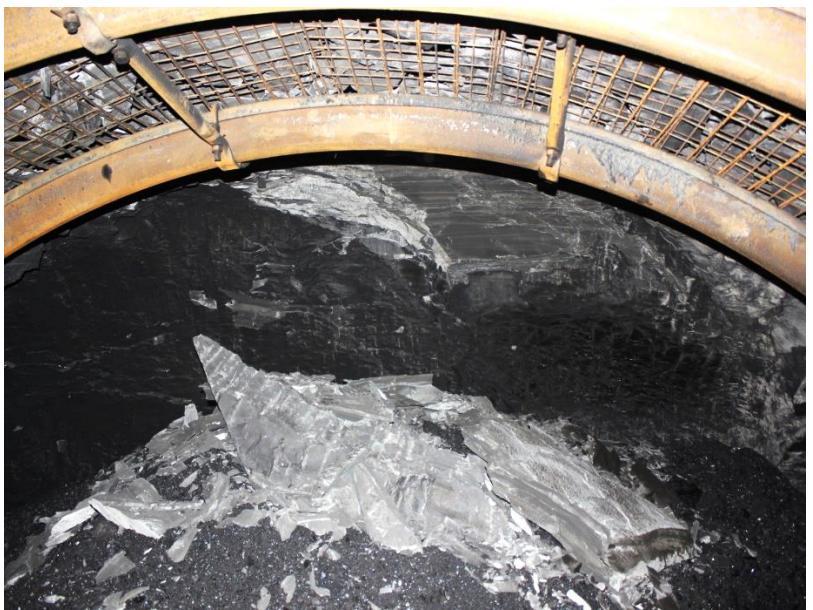
During the incident, 17 employees were carrying out excavating works. As a result of the outburst, approximately 340 m<sup>3</sup> of methane with ca 35 m<sup>3</sup> of fine coal was thrown into the zone near the face; the coal formed a heap in the working face over a length of approximately 3.5 m and a height of ca 2.75 m. Figure 3 shows the values of methane concentrations recorded by the automatic methanometric sensors during the outburst in ramp D of seam 358/1.

Fig. 4 Heading face after the outburst of gases and rocks in ramp D in seam 358/1 (11.05.2012)

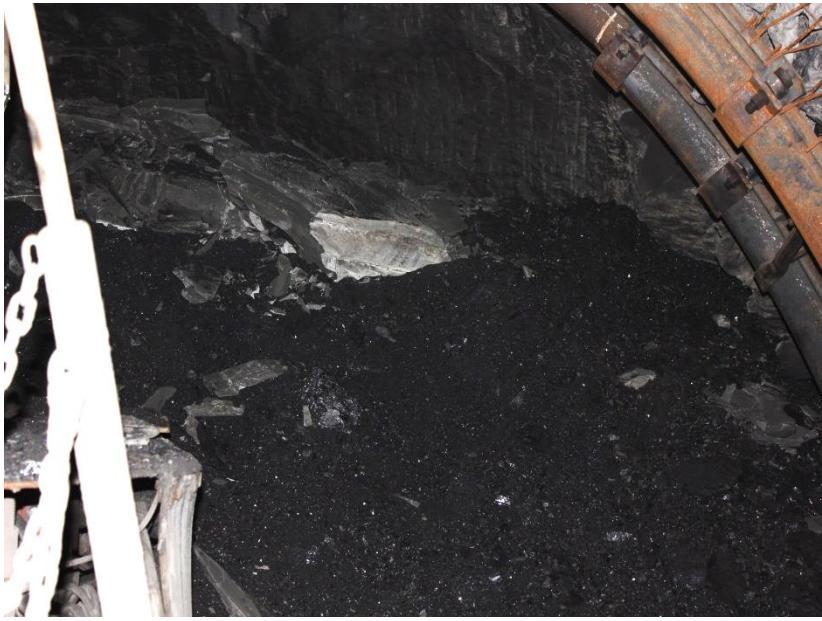
Fig. 5 Heading face after the outburst of gases and rocks in ramp D in seam 358/1 (11.05.2012)

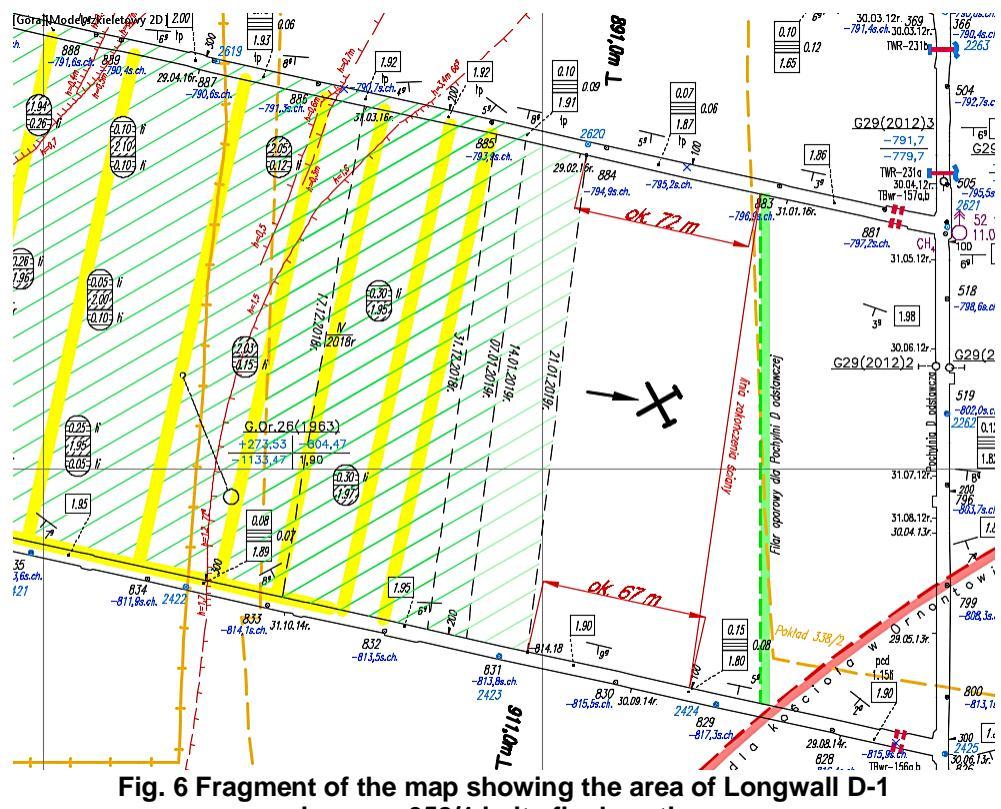
During the exploitation of the final section of Longwall D-1, seam 358/1, in the vicinity of ramp D (in which an outburst occurred in 2012) there were numerous methane outflows. The mining situation in Longwall D-1 seam 358/1 in its final section has been shown in Fig. 6.

in seam 358/1 in its final section

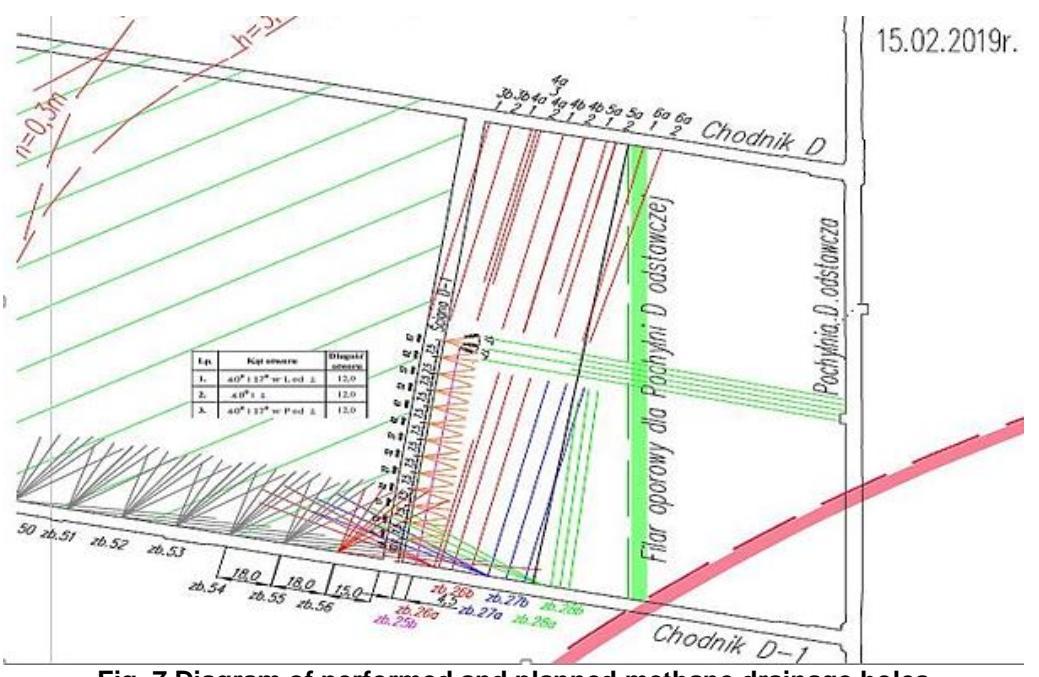
Fig. 7 Diagram of performed and planned methane drainage holes in the final section of longwall D-1, seam 358/1

Due to the high values of methane-bearing capacity in the discussed area, a decision was taken to start additional methane drainage collections over the last 100 m of the panel length. The diagram of the methane drainage bores deployment is shown in Fig. 7. Five methane drainage collections were carried out in the seam, two in boreholes at a mutual distance of approx. 24 m and a length of apertures of approx. 70 m. During the meeting of the Mine's Team for Identifying and Counteracting Methane Threat on 04.01.2019, a decision was taken to increase the number of methane drainage holes between the existing collections in Gallery D with parameters analogous to those previously made.

As agreed, on the same day, extended methane prophylaxis began, which among others involved shock blasting for each 3m of face advance, from section number 70 towards Gallery D, at a mutual distance every 10 sections of the powered support, with a series of holes about 3 m long.
