#### Tomasz ROCHATKA

POZNAN UNIVERSITY of TECHNOLOGY, Institute of Machines and Motor Vehicles Piotrowo 3, 60-965 Poznań

# **Calculation of Heat Damage Losses of Cooling Bodies**

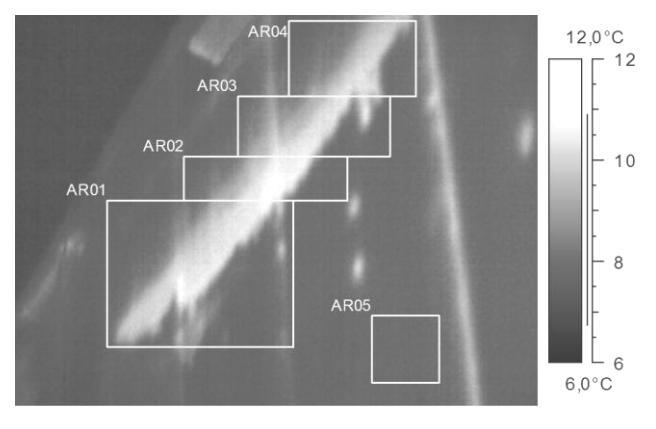
Fig. 1. Thermogram of service heat bridge with perforation of the plate on the side wall

rab. 1. Summary of the near 1055 analysis of the damage presented in the rig. 1						
	$AR_{01}$	$AR_{02}$	$AR_{03}$	$AR_{04}$	∑ARi	
Heat bridge area m <sup>2</sup>	0.114	0.030	0.039	0.040	0.223	
Heat losses of body fragment without heat bridge Q,W for <i>K</i> =0.40 W/(m <sup>2</sup> K), ∠ <i>t</i> =25 K	1.1	0.3	0.4	0.4	2.2	
Calculated increase of heat losses for heat bridge $Q_{\rm HB}$ W	1.3	0.5	0.6	0.4	2.8	
Relative heat loss increase of area	116%	163%	159%	102%	127%

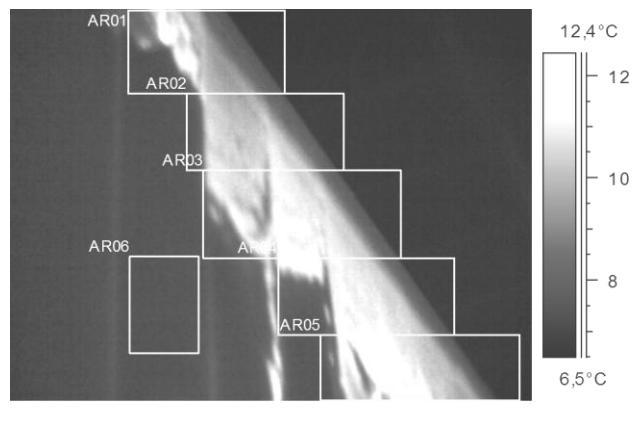
Another analysis was carried out for a fragment of the damaged joining of the side wall with the body roof. This type of damage is particularly dangerous for the deterioration of insulating properties because water from atmospheric precipitation can penetrate the damage site and further into the insulating material.

Fig. 2. Thermogram of service heat bridge occurred in the effect of damage in joining of a side wall and a roof

$AR_{01}$	$AR_{02}$	$AR_{03}$	$AR_{04}$	$AR_{05}$	∑ARi
Heat bridge area, m <sup>2</sup>	0.109	0.101	0.145	0.113	0.109	0.577
Heat losses of body fragment without heat bridge $Q$ , W for K=0.40 W/(m <sup>2</sup> K), $\Delta t$ =25 K	1.1	1.0	1.5	1.1	1.1	5.8
Calculated increase of heat losses for heat bridge $Q_{\rm MC}$ W	1.9	2.4	4.5	3.1	3.4	15.4
Relative heat loss increase of area $AR0x Q_{MC}/Q$ %	175%	241%	312%	274%	313%	266%

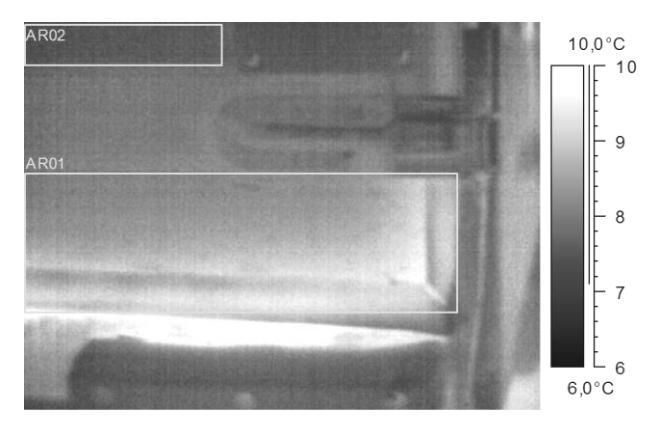
A fragment of the body susceptible to damage is the door leaf. The driver, before the ride to the loading dock opens the rear door with an angle of 270° and having so prepared the isothermal or refrigerating body for loading or unloading the body, arrives to the dock. Open doors are the first to be damaged. The picture in Fig. 3 shows the fragment of the door leaf damaged at the driveway to the dock and Table 3 presents the results of the analysis of this heat bridge. 54

Fig. 3. Thermogram of service heat bridge occurred in the effect of damage in open door leaf when approaching the loading dock

$AR_{01}$
Heat bridge area m <sup>2</sup>	0.094
Heat losses of body fragment without heat bridge $Q$ W for $K$ =0.40 W/(m <sup>2</sup> K), $\Delta t$ =25 K	0.9
Calculated increase of heat losses for heat bridge $Q_{\rm HB}$ W	1.6
Relative heat loss increase of area AR0x $Q_{\rm HB}/Q$ %	172%
