# PLANT COMMUNITIES IN DRAINAGE DITCHES – CONDITIONS, CHARACTERISTICS AND ENVIRONMENTAL FUNCTIONS

Aleksander Kiryluk

Department of Technology in Environmental Engineering, Faculty of Civil Engineering and Environmental Sciences, Białystok University of Technology, Wiejska 45E Str., 15-351 Białystok, Poland; e-mail: a.kiryluk@pb.edu.pl

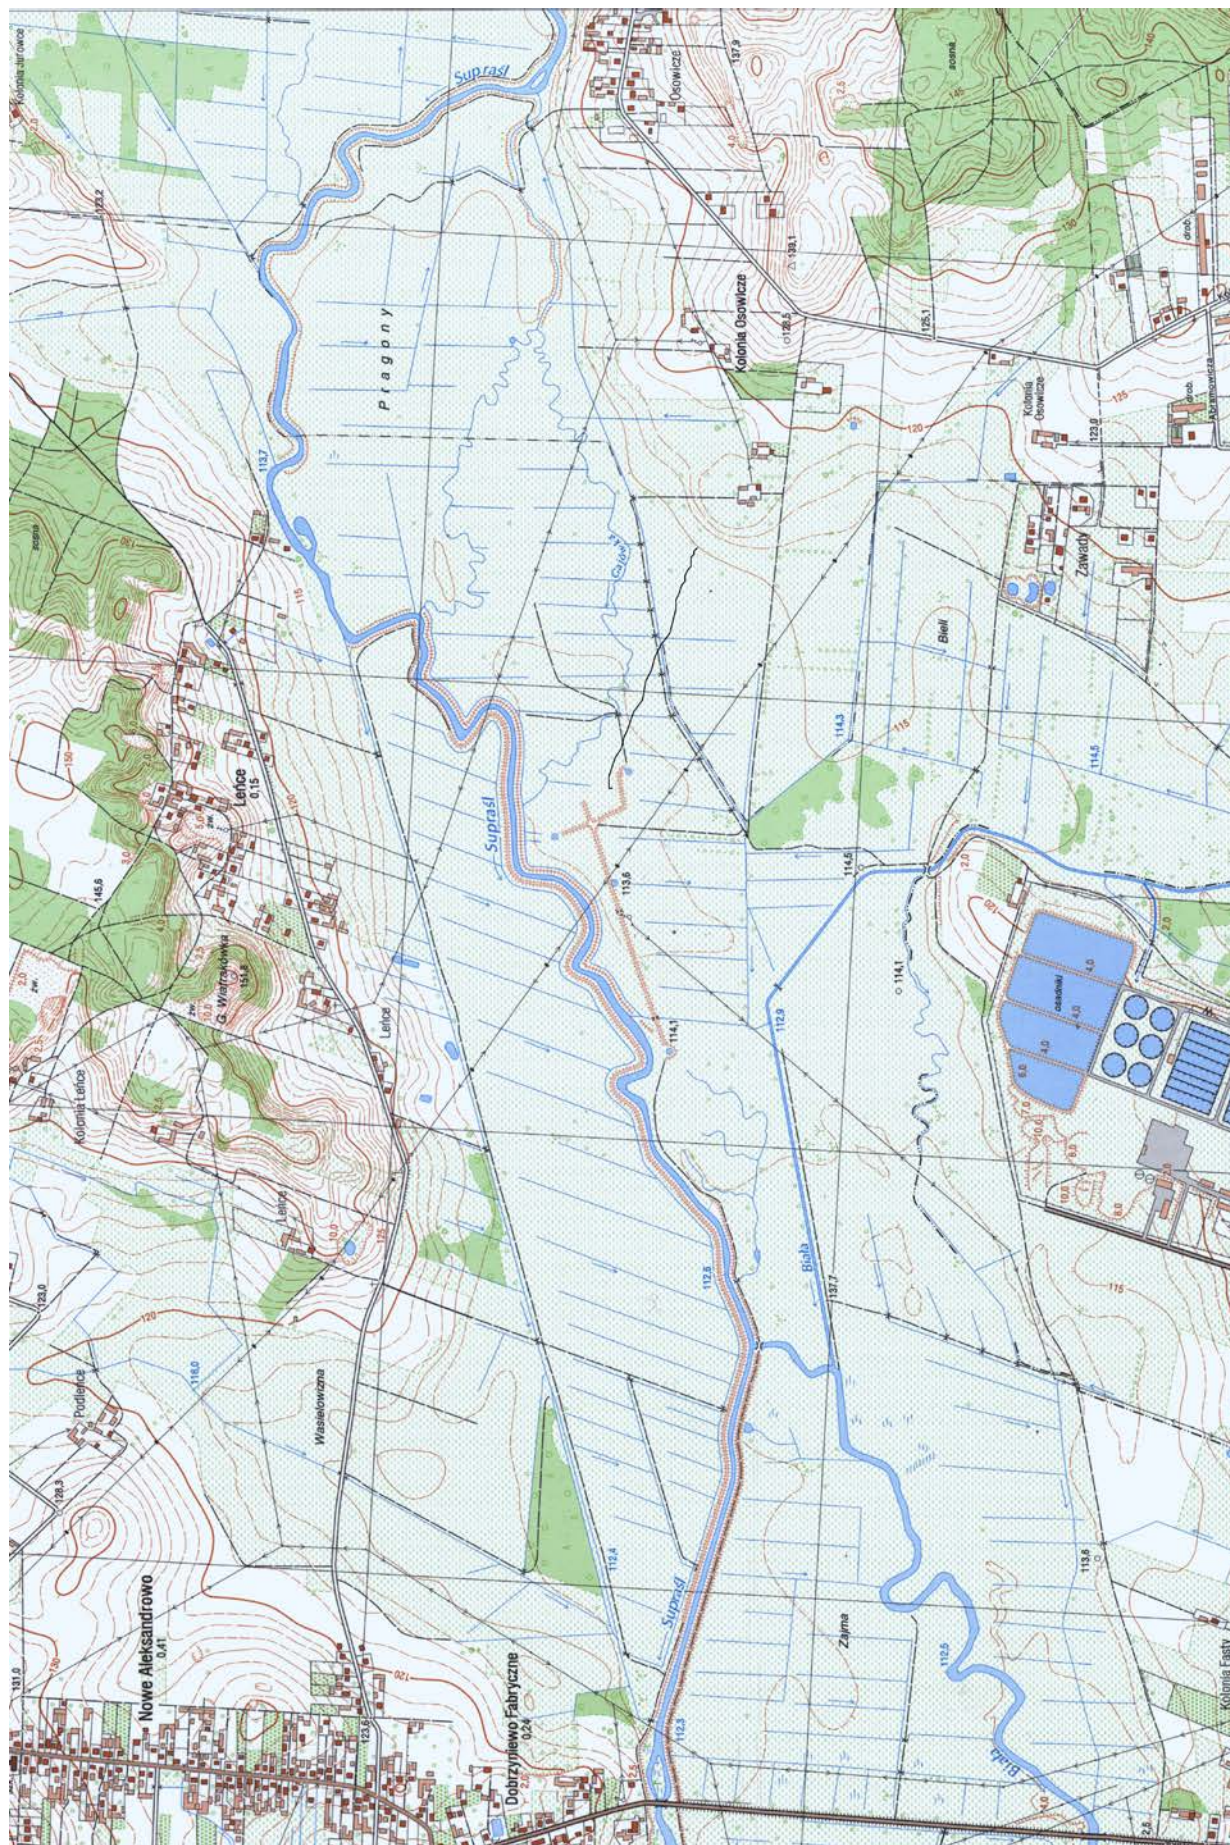
Fig. 1. Land reclamation system in the Supraśl Dolna valley (km: 7+500 to 15+300). Source: own elaboration based on GUGIK topographic map Nowe Aleksandrowo N-34-107-A-c-4.

The research was carried out in the lower section of the Supraśl River. The Supraśl river valley and the water system (Fig. 1) fulfill important environmental and economic functions due to their location between the Białystok agglomeration and the Knyszyńska Forest complex). The economic functions comprise providing water for irrigation of post-bog meadows in the area of approximately 5000 ha, drainage of meadows in the early spring and heavy rainfall in summer. Environmental functions include mainly protection of large areas of post-bog against their degradation and protection of valuable natural plant communities. There are also water abstraction points for the Białystok agglomeration by the Supraśl River.

In 2010, 2015 and 2020, floristic lists of plant communities in selected drainage ditches were prepared (Fig. 1). The research was carried out in three main drainage ditches named: Ditch A, Ditch B, Ditch C. Direct measurements of the parameters of water-drainage devices were performed according to the method of Kaca and Interwicz (1991). The results of the obtained floristic tests were calculated using the Microsoft Excel package. Due to the occurring processes of silting, shallowing and overgrowing of ditches, historical parameters (relating to the period before 2000) and current data are provided.

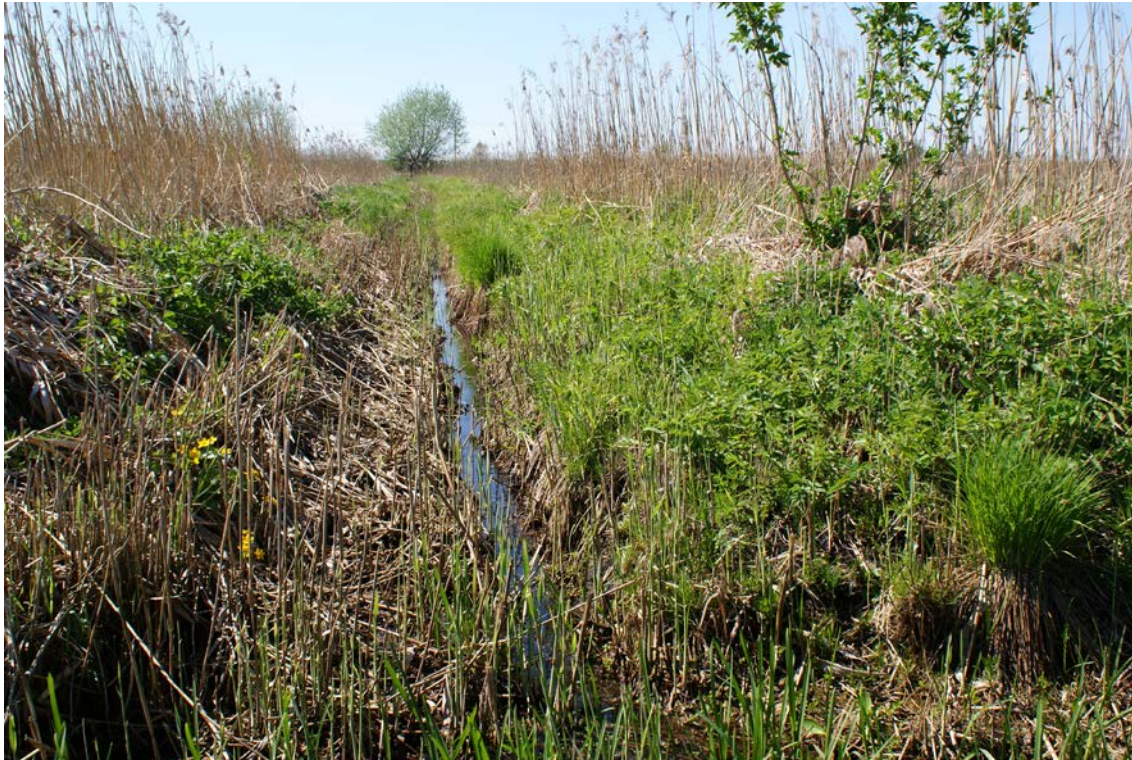
Fig. 2. The slopes of the ditch are overgrown with rushes. *Phragmites australis* (Phot. A. Kiryluk).

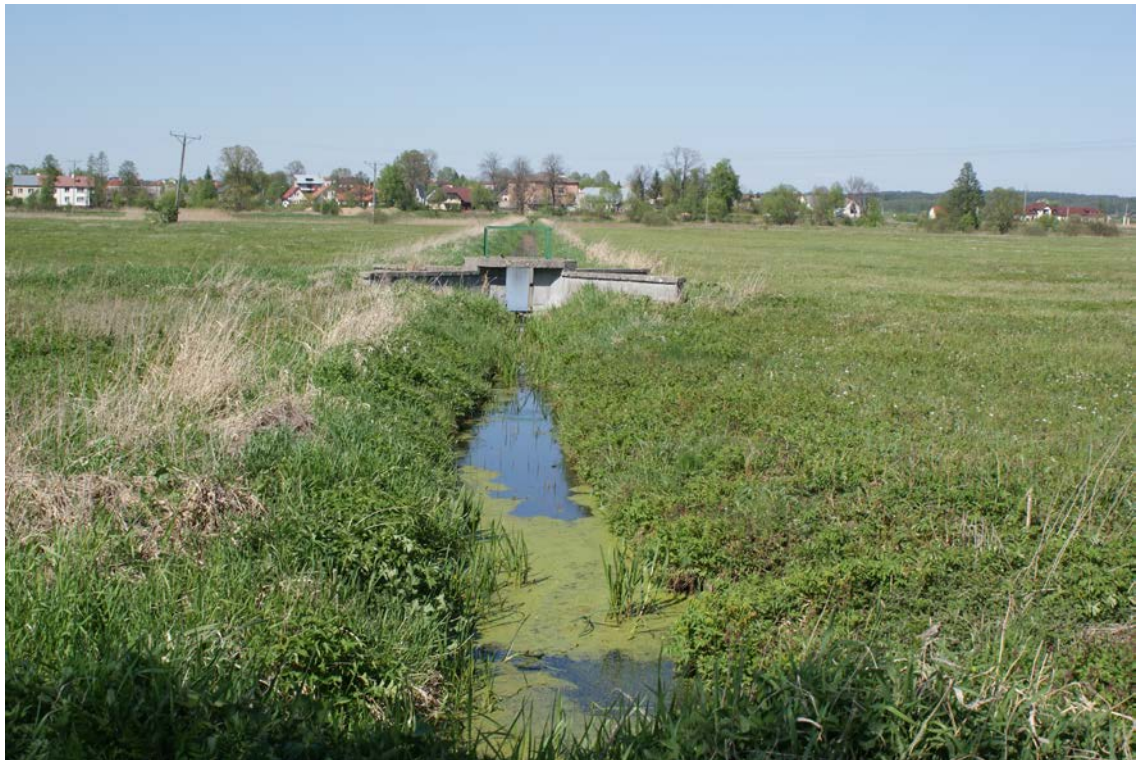
**Fig. 3.** Fields of *Urtica dioica* on the slopes of ditches (Phot. A. Kiryluk).

Throughout the research period, the presence of field communities of *Urtica dioica* was found, indicating nitrogen release in rotting peats (Fig. 3).

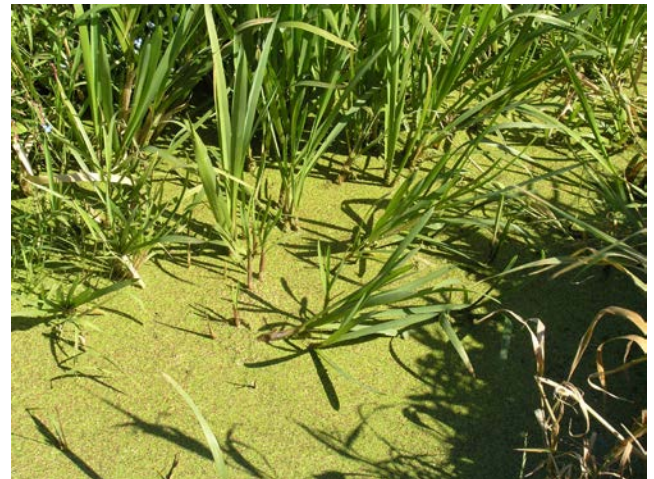
**Fig. 4.** *Lemna minor* on the bottom, indicating a strong eutrophication of the water in the ditch (Phot. A. Kiryluk).

The width and longitudinal slope of the bottoms of the ditches decreased over the period considered. Narrowing of the trench and reduced water flow contributed to increased water eutrophication (Fig. 4). Bottoms of the ditches have been significantly narrowed, mainly due to the lack of the so-called thorough conservation, removing silts (Bondar-Nowakowska *et al.*, 1997). The deterioration of the water conditions in ditches resulted in a reduced quantity of species *Caltha palustris*, *Ranunculus repens*, *Acorus calamus*, *Cardamine pratensis*, *Iris pseudacorus* and the expansion of *Lemna minor* (Table 3; Figs 4–5). The viability of the species remained at a good level (1.24–1.36).

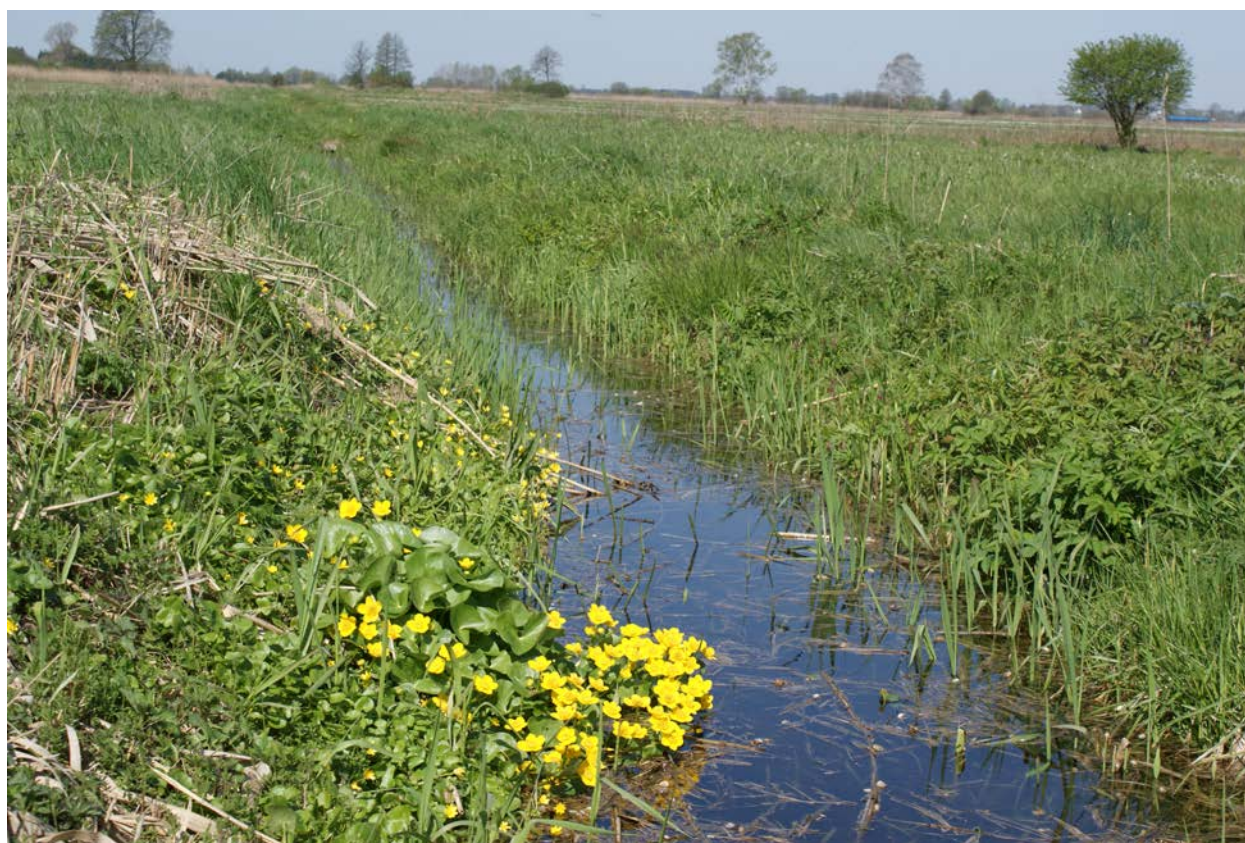
Fig. 5. Declining quantity of *Caltha palustris* and *Ranunculus repens* in the ditch (Phot. A. Kiryluk).

Due to abandonment in the following years, the maintenance of ditches and periodic or long-lasting water shortages, the development cycle was limited. It mainly affects *Caltha palustris* and *Ranunculus repens*.

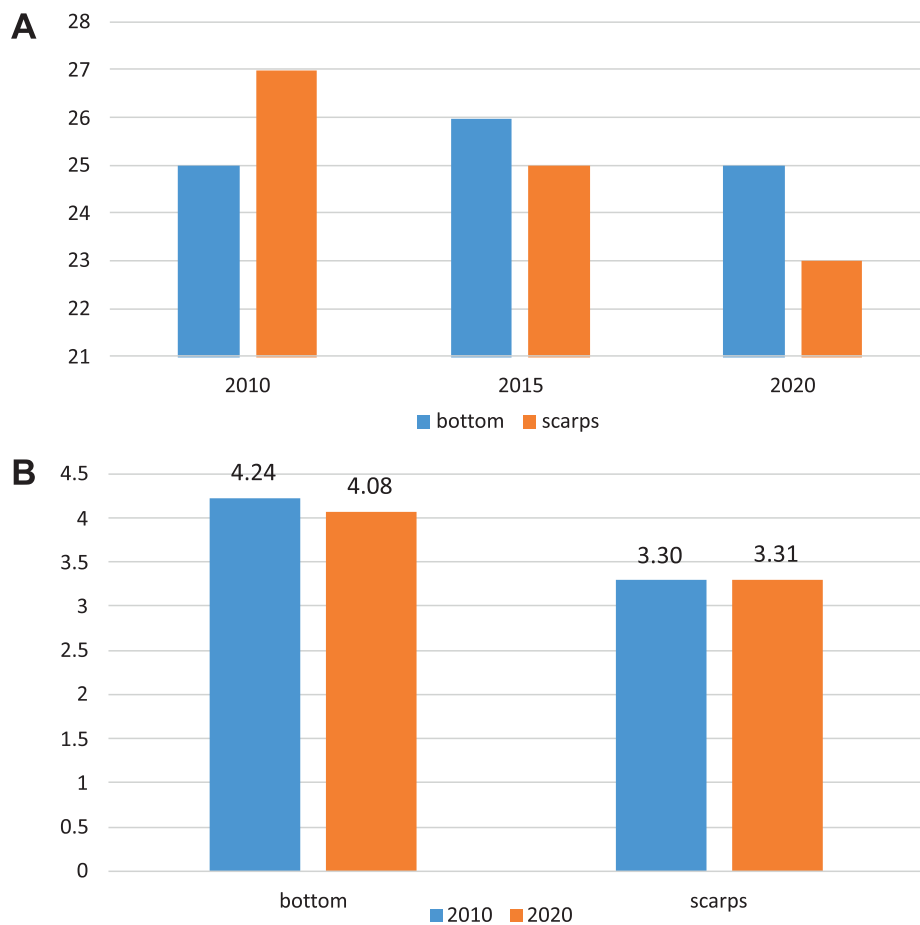
**Fig. 6.** A. Changes in the quantity of species occurring in the bottom and on the slopes of ditches in 2010–2020. B. Changes in the valorization indexes of plant communities in 2010–2020.

Research on the species composition of plant communities showed a decrease in number of species on slopes of the ditches in 2015 and 2016 (Fig. 6B). One of the reasons for the reduction was a reduced rainfall in summer (Kiryluk, 2019). In the studied period, the mowing of vegetation on scraps was also limited, which prevented the growth and development of low-growing species.

A lower valorization index was found on the slopes of ditches (Fig. 6B). The reduction in the index was caused by
