# INFLUENCE OF HEAT TREATMENT ON THERMO-MECHANICAL FATIGUE AND HIGH TEMPERATURE CREEP PROPERTIES FOR 316L STEEL

**Keywords:** 316L steel, thermo-mechanical fatigue, high temperature creep, heat treatment

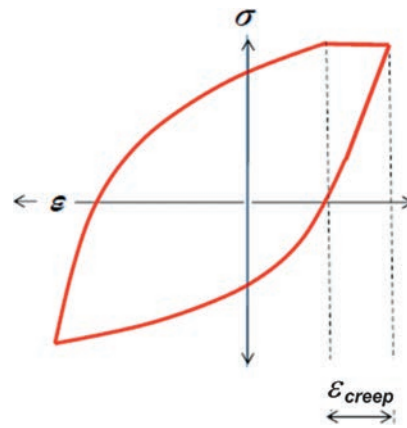
Fig. 1. Schematic drawing illustrating the idea of combining fatigue related cycle with that causing creep process

The cyclic deformation experiments were conducted by combining the fatigue related cycles with the ones causing the creep process (Fig. 1) at elevated temperature, using the Gleeble 3800-GTC metallurgical simulator. The use of this type of combination of fatigue cycles with the creep process reflects the real working conditions much better. The simulation of this type of processes, additionally at an increased temperature of the process, was only possible with the use of a metallurgical process simulator. The view of a specially designed test sample and the mounting of the samples in the Gleeble simulator were shown in Figure 2. The characterisation of the structure in the as-delivered condition and

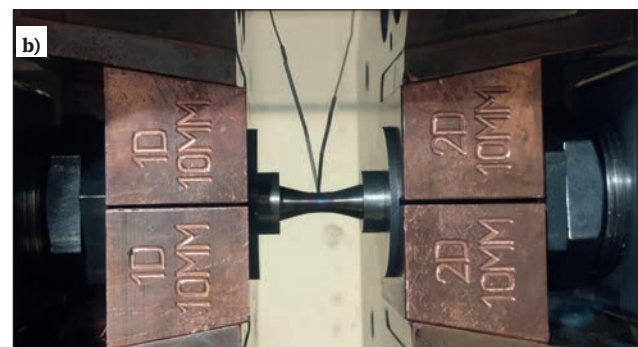
Fig. 2. Specially designed test sample (a) and the sample placed in simulator handles (b)

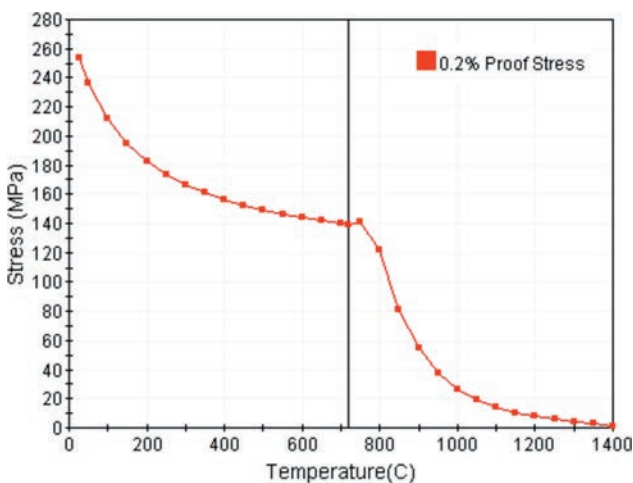
Fig. 4. High-temperature properties of 316L steel calculated with JmatPro program

Due to a large drop in the strength of 316L steel above 800°C (Fig. 4), the experiments were carried out at 600°C (this temperature also coincides with the maximal operating temperature for this steel under operating conditions).

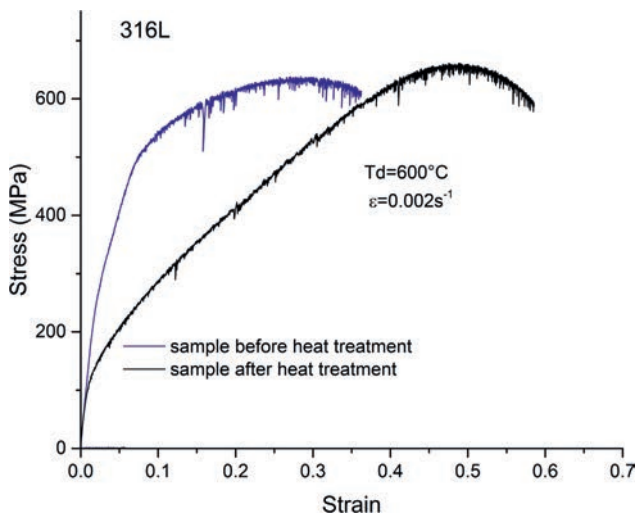
Fig. 5. Results of static tensile test

In the first stage of the investigation, a static tensile test was carried out. The static tensile test was carried out at 600°C with a strain value equal to 1, and a strain rate of 0.002 s<sup>-1</sup>. The results are shown in Fig. 5.

The analysis of the static tensile test results shows that in the initial stage of deformation, the sample in the delivery condition was characterised by a work hardening rate comparable to the sample after heat treatment. However, with strain increase, this tendency changed. Moreover, the sample in the delivery conditions exhibits a lower deformation at the fracture.

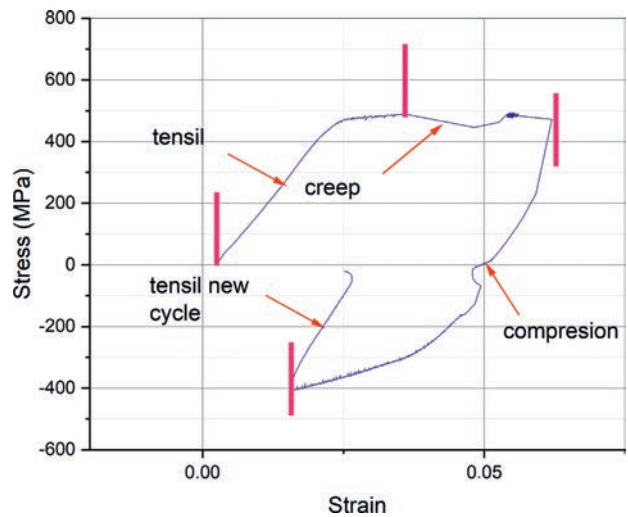
Fig. 6. Material flow during creep process

In the subsequent stages of the research, cyclic strain tests were carried out, in which, after stretching for 60 seconds, creep (stabilisation of the stress value) was applied. Figure 6 shows a detailed methodology of fatigue tests with creep process. During the experiment, the value of compressive stress was constant during the creep process.

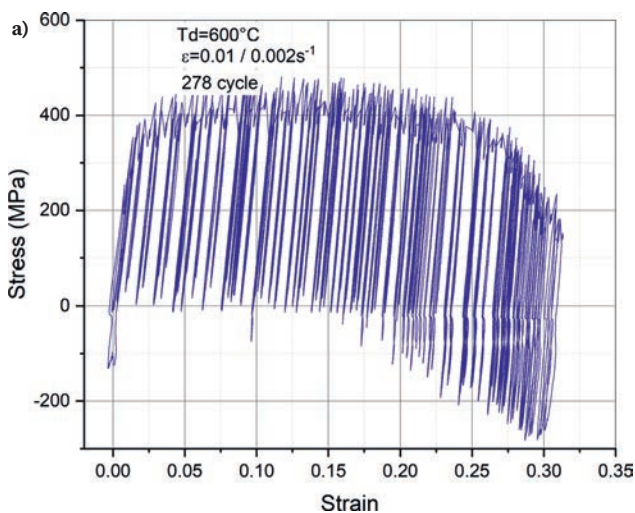
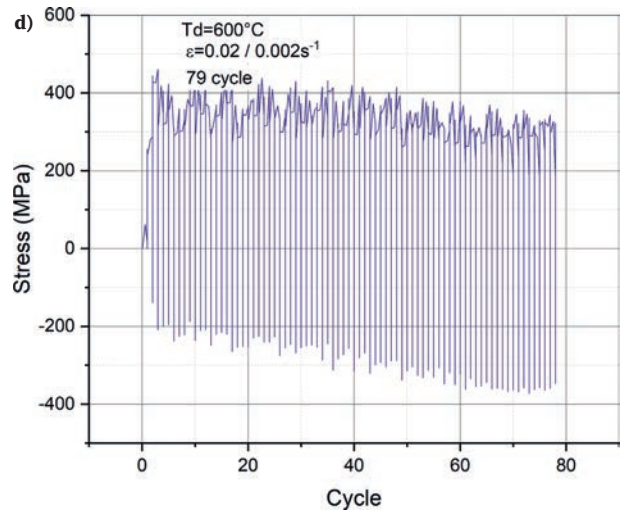
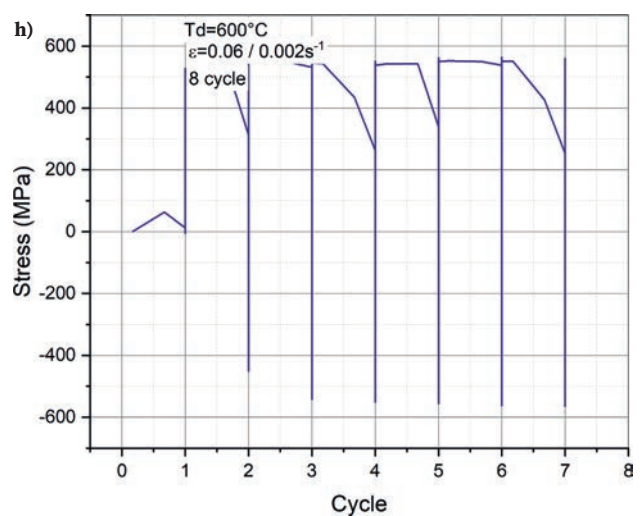
Fig. 7. Results of cyclic fatigue before HT along with creep process after deformation; a, b) 0.01

Fig. 7 cont. Results of cyclic fatigue before HT along with creep process after deformation: c, d) 0.02; e, f) 0.04; g, h) 0.06

The research plan for cyclic fatigue in each case included tests with different deformation values: 0.01, 0.02, 0.04 and 0.06 at a constant deformation rate of 0.002 s<sup>-1</sup> at 600°C. The obtained test results are presented in Table 2 and in Figures 7 and 8 in the form of changes in the value of defor-

mation as a function of deformation and in the form of changes in the value of the maximum stress for subsequent cycles of deformation.

During cyclic fatigue, the strain values were controlled. It was noticed, however, that during the experiments there was some influence of the elastic deformations of grips. In general, the heat-treated specimens sustained a greater number of cycles to failure for all strain values. The biggest difference was observed with the strain value  $\epsilon_1 = 0.01$ . This sample withstood 1,881 cycles to fracture. In any case, increasing the strain value in a single cycle leads to a faster sample rupture. The analysis of the maximum stress changes during subsequent deformation cycles showed

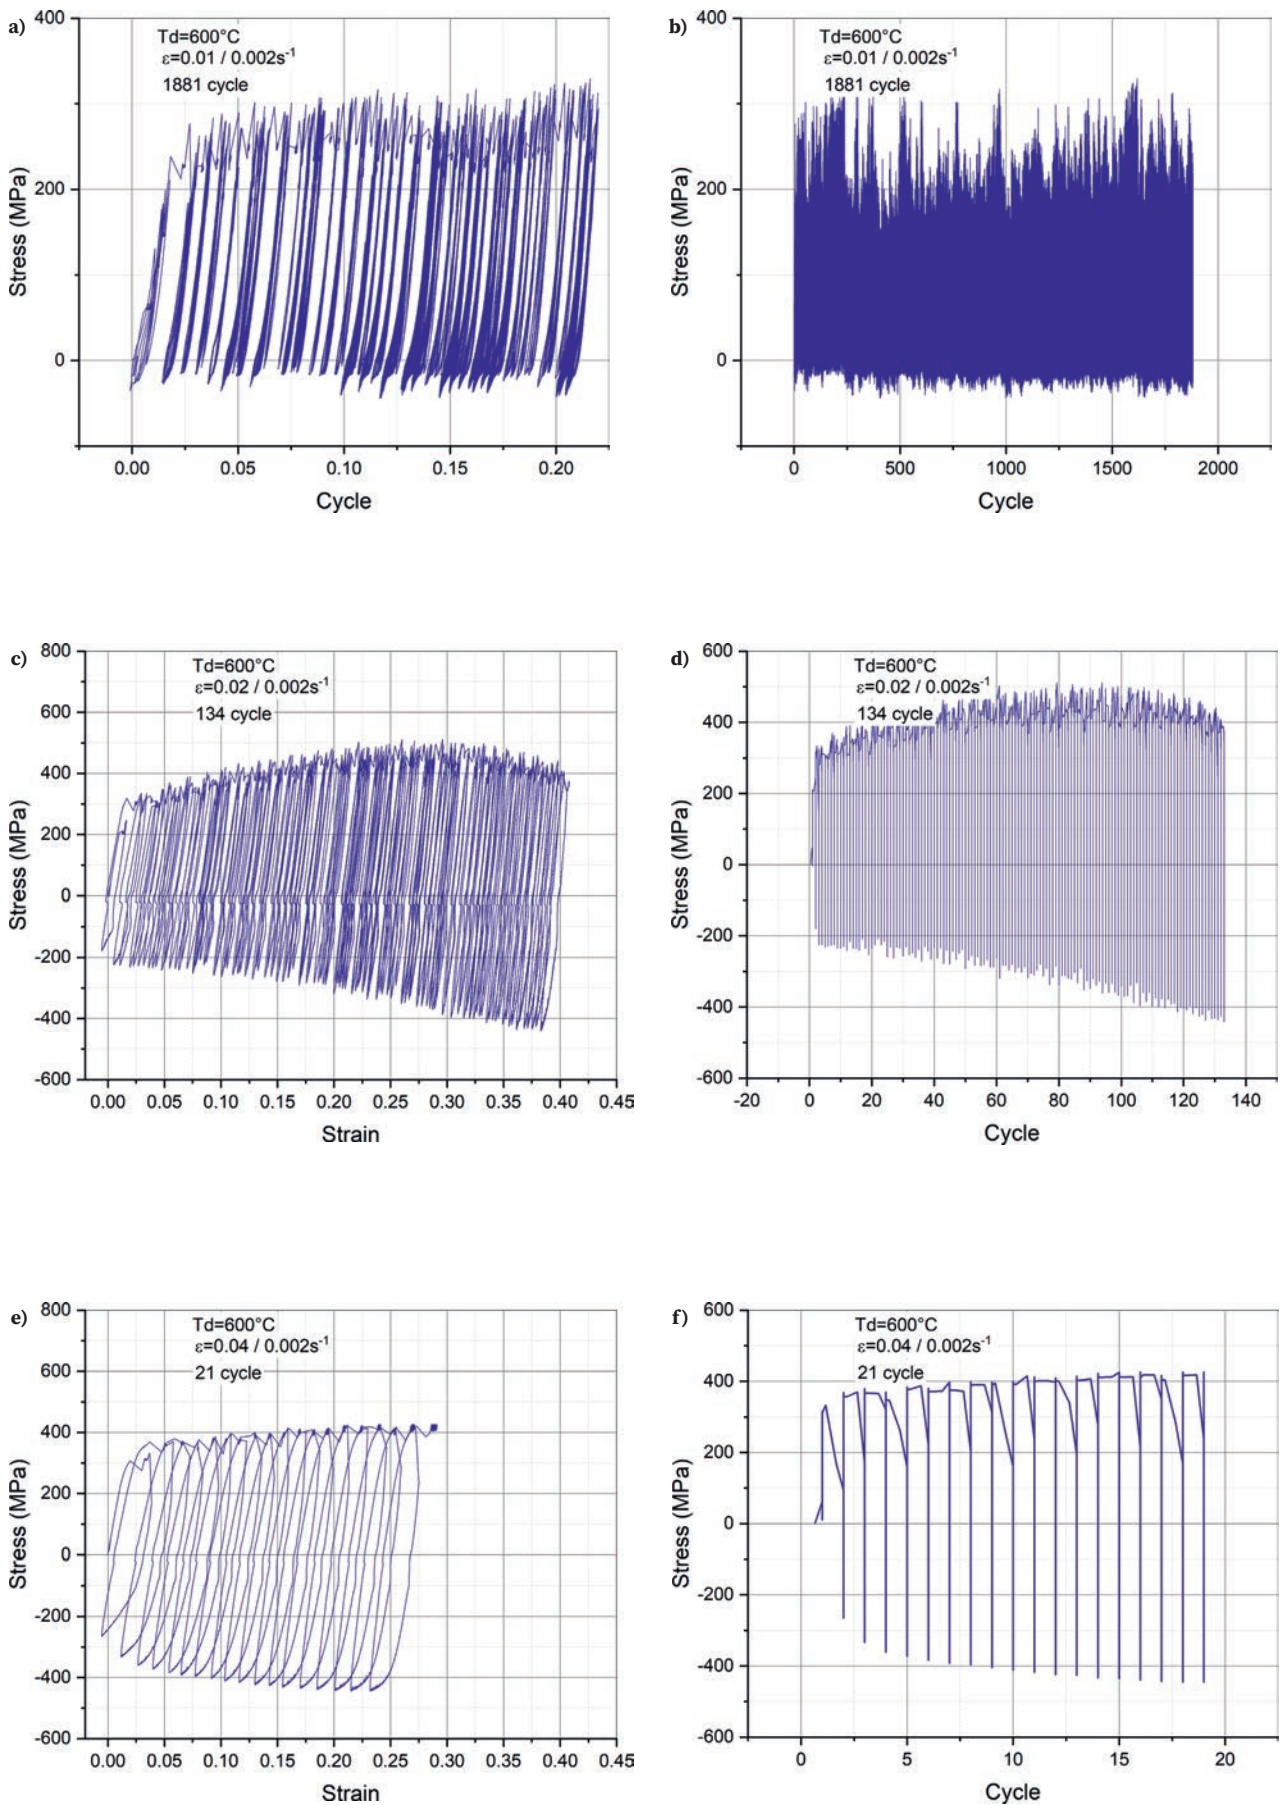
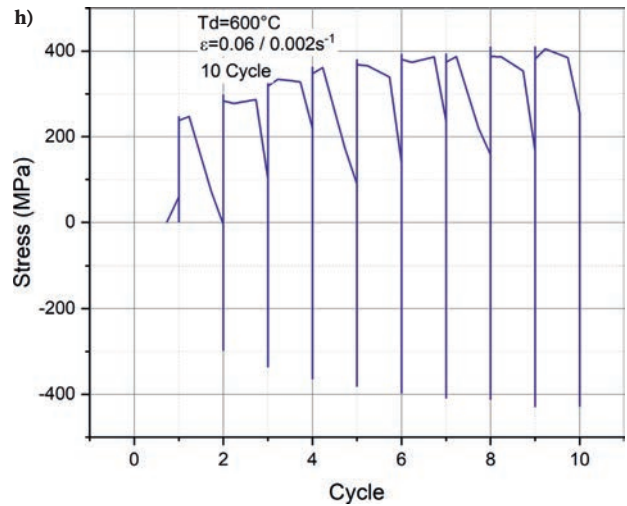
Fig. 8. Results of cyclic fatigue after HT combined with creep process after deformation: a, b) 0.01; c, d) 0.02; e, f) 0.04

Fig. 8 cont. Results of cyclic fatigue after HT combined with creep process after deformation: g, h) 0.06  
 Rys. 8 cd. Wyniki dla cyklicznego zmęczenia w połączeniu z procesem pełzania po odkształceniu po OC: g, h) 0,06

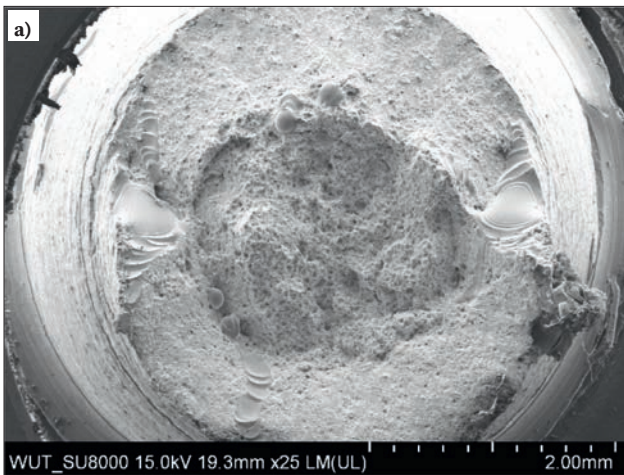
Fig. 9. Fracture surfaces obtained during static tensile test: a, b) pre-HT sample; c, d) testpost-HT sample  
 Rys. 9. Powierzchnia przelomu uzyskana podczas statycznej próby rozciągania: a, b) próbka przed OC; c, d) próbka po OC

Images of the fracture surfaces obtained during the static tensile test are shown in Figure 9. Images of the fracture surfaces obtained during cyclic fatigue combined with

The fracture surfaces obtained during the tensile test and during cyclic fatigue along with the creep process were characterised by the ductile fracture structure in each case. In the case of fracture surfaces obtained in the cyclic fa-
