## The Consolidation Project of Vicente Lampérez after the Demolition of the Archbishopal Palace of Burgos Cathedral

**Keywords:** consolidation, restoration, reintegration, masonry

**Cytowanie / Citation:** Mora Moreno I., Mora Alonso Muñoyerro S. The Restoration of an Easter Egg: The Consolidation Project of Vicente Lampérez after the Demolition of the Archbishopal Palace of Burgos Cathedral. *Wiadomości Konserwatorskie – Journal of Heritage Conservation* 2021, 68S:83–90

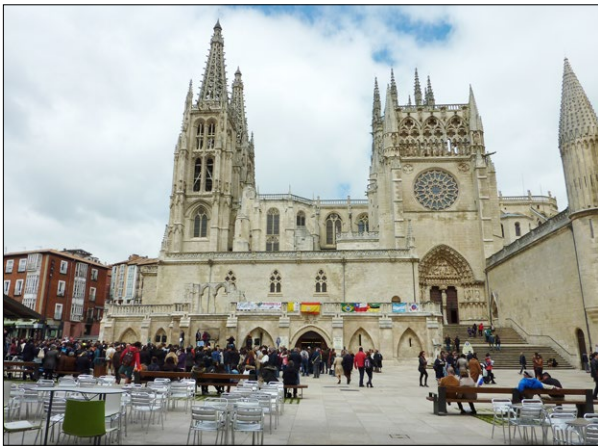
Fig. 1. South elevation of the Cathedral of Burgos from the Plaza Rey San Fernando; photo by I. Mora Moreno.

Burgos Cathedral is a national Historic-Artistic Monument since 1885<sup>1</sup> and was declared a World Heritage Site in 1984 (Fig. 1). Being one of the most important Gothic works in Spain,<sup>2</sup> it has been collecting the different artistic trends throughout the centuries. Ever since Alfonso VI gave away his royal palace in 1075 for the construction of the Romanesque church, the subsequent construction of the cathedral began in 1221 by Bishop Don Mauricio following Gothic patterns. Even being this the predominant style (in two clearly identifiable phases: the classic Gothic style of the thirteenth and fourteenth centuries and a second flamboyant Gothic style starring the Colonia family), also has important Renaissance and Baroque elements.<sup>3</sup> The Burgos Cathedral is the only Spanish cathedral that has the distinction of UNESCO independently, without being linked to a historic city centre or together with other buildings. The Archbishop's Palace might coincide with the former royal palace and was an important part of the cathedral complex, residence of bishops and the kings of Castilla, place of important historical events,

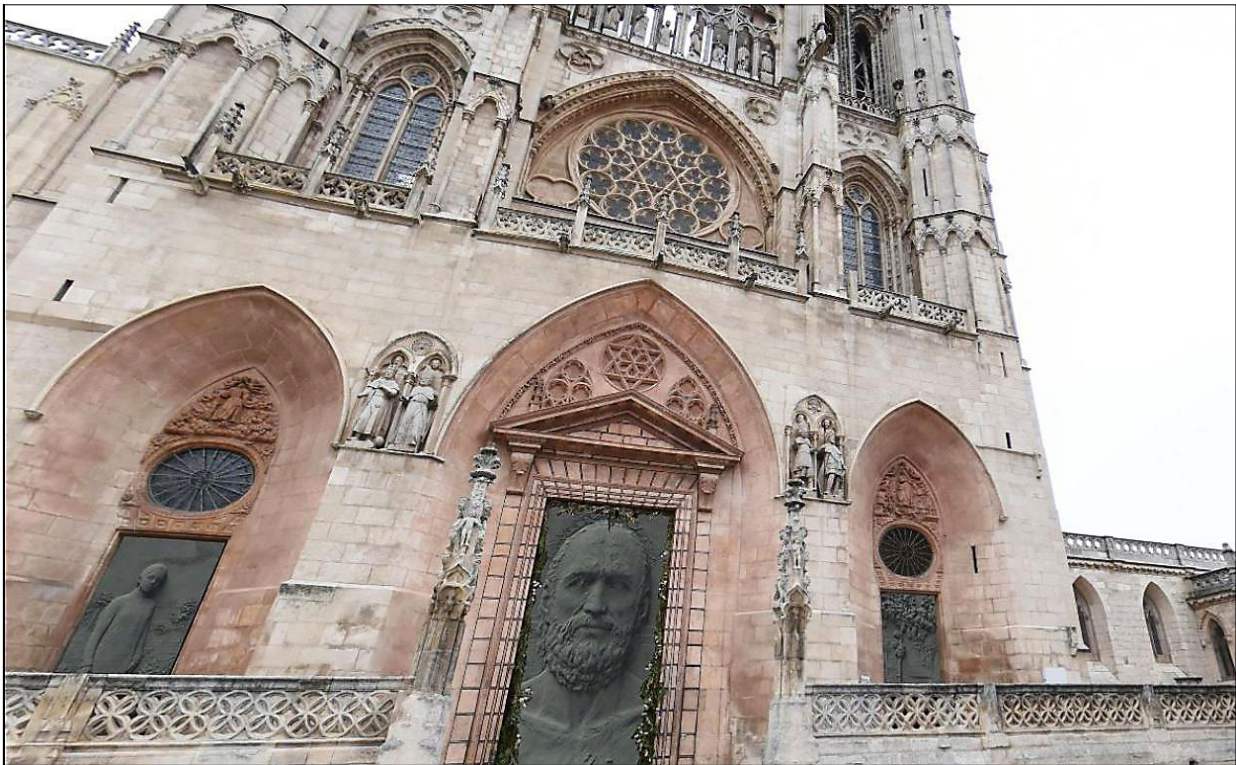
Fig. 4. Sketch of the design of the new doors by Antonio López, 2021; Cabildo de Burgos.  
 Ryc. 4. Szkic projektu nowych drzwi wykonany przez Antonio Lópeza, 2021; Cabildo de Burgos.

The work of Lampérez, although it was always supervised by the Academia de San Fernando,<sup>11</sup> which even rejected some of Lampérez's interventions, was strongly opposed by José María de Palacio y Abarzuza, Conde de las Almenas.<sup>12</sup> These were attacks that had more to do with taste and style than with the criteria of the practice of restoration (although at that time in discussion and unconsolidated) or with technical aspects. Yet again, history would repeat itself a century later with the proposal of the Cabildo de Burgos to replace the current Classical Revival wooden doors on the main facade of the cathedral with a new design proposed by the artist Antonio López (Fig. 4).

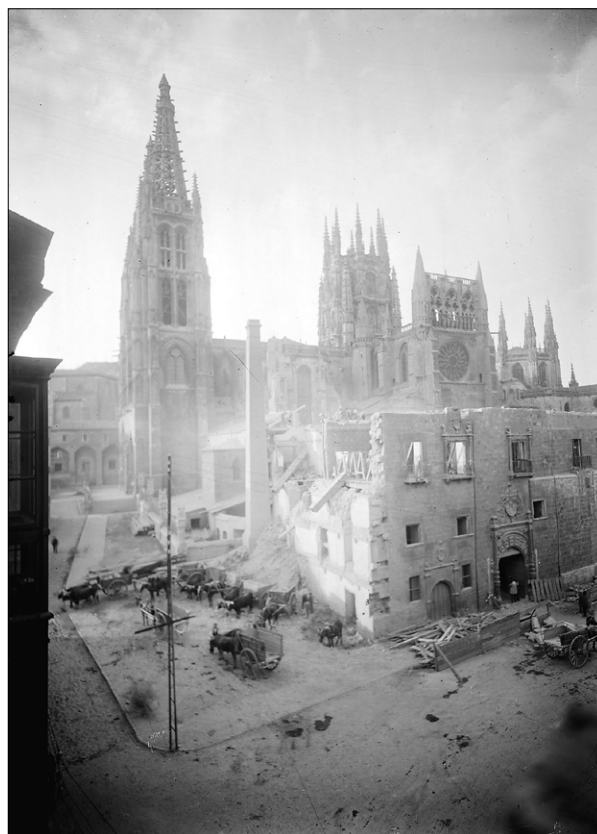
Fig. 5. Exterior view of the Cathedral of Burgos with the Archbishop's Palace in demolition, from Archivo Municipal de Burgos FO-154; photo by Alfonso Vadillo, 1914.

Lampérez established respect for all the remaining parts: for their “archaeological value,” for their “outstanding merit” and for their “historical and cult” meaning (the last one could be equated with use or functional value). The lower parts of the cathedral on the south side, acted as a bracket for the parts of the upper levels, as is the example of the tunnel, which Lampérez now dated to the end of the twelfth century. As it served to contain the land where the chapels settled, the elements to be conserved from a technical, archaeological, and economic point of view (Fig. 5).
