Mass Movements Analysis along a Road Segment (Batushë-Rrasa e Kosharës) in an Alpine Region in Kosovo

The article represents a contribution to the assessment of slope processes, with special emphasis on landslides, rockfalls, and creeps along the road sector Batushë-Rrasa e Kosharës (municipality of Gjakova) in Kosova. The analysis of natural factors, as well as their role in triggering and evolving slope processes, was conducted by observing the processes in the field and, with a multidisciplinary approach, analyzing the natural factors (geology, tectonics, climate, vegetation) as well as the role of humans. By using GIS/RS techniques, the causes and features of processes were identified and presented with various illustrations and maps, assessing the potential risk in the future with the aim of proper management, considering the movement of citizens, and preserving the road infrastructure in a segment with historical and touristic values. The slopes with a 35–40° gradient are more prone to landslides, while the presence of unconsolidated rocks and fractured limestone has accelerated slope destabilization and rock mass movements. Slope stability techniques should be implemented i

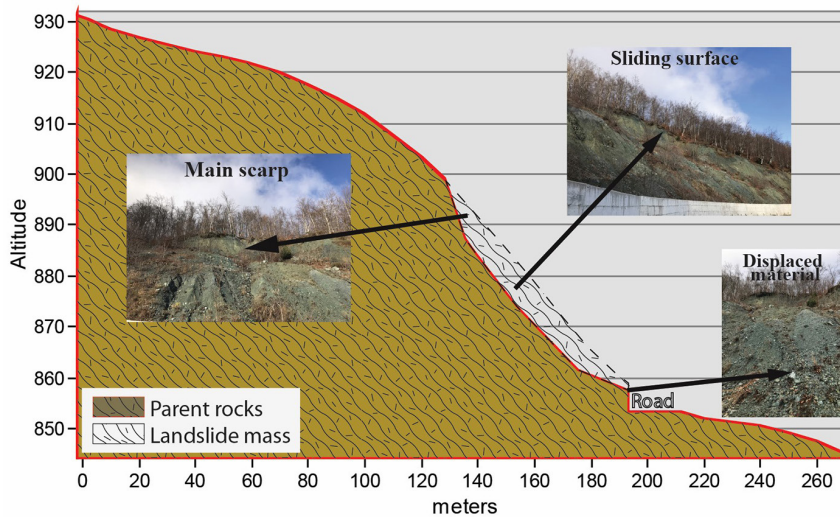
Interpretation by illustration (Fig. 4) shows that on the top (head) of a landslide, where the depletion zone is, slump blocks appear in the form of terraces. The sliding plane of the slope is 30 degrees, with a width of 102 m and a total length of 78 m. After its appearance, it affected infrastructure, causing damage as well as endangering visitors.

Figure 4. Schematic profile of slope processes

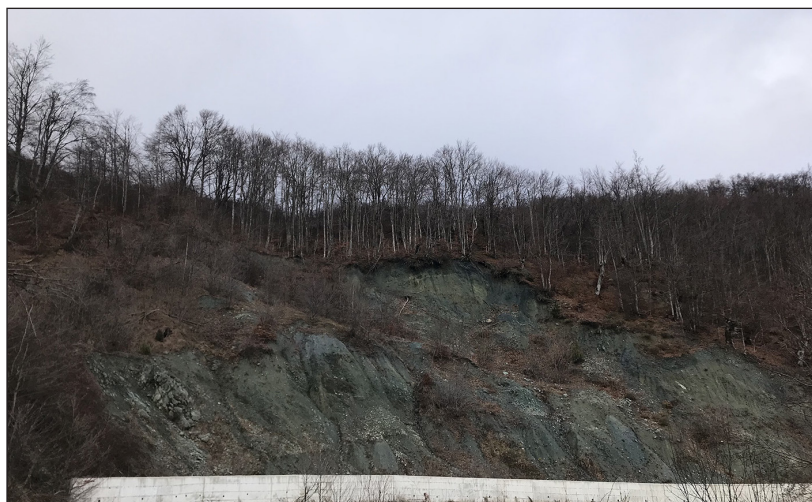
Figure 5. Landslide along the road segment (no. 1 at Fig. 1)

and serve as weakness points of rocks. The first two landslide cases, as well as Case 4, mainly occur in terrains composed of sandstone, phyllite, and conglomerate rocks of the lower and middle Triassic ages, while the third one appears in deluvium, which, in comparison with other rocks, is an unconsolidated rock of slope debris. Study cases in field observation show that unconsolidated rocks and materials are subject to higher rates of erosion. Sandstones are uncemented and fractured, while their porosity allows water to percolate and reduces cohesion. The highest rate of landslides appears on hillslopes between 15–25° and 35–45°, whereas gravity initiation slides are common causes of landslides. Slope destabilization in Study Case 4 is initiated by human activity through the extraction and breaking of rocks, followed by the intersection of tectonic lines,

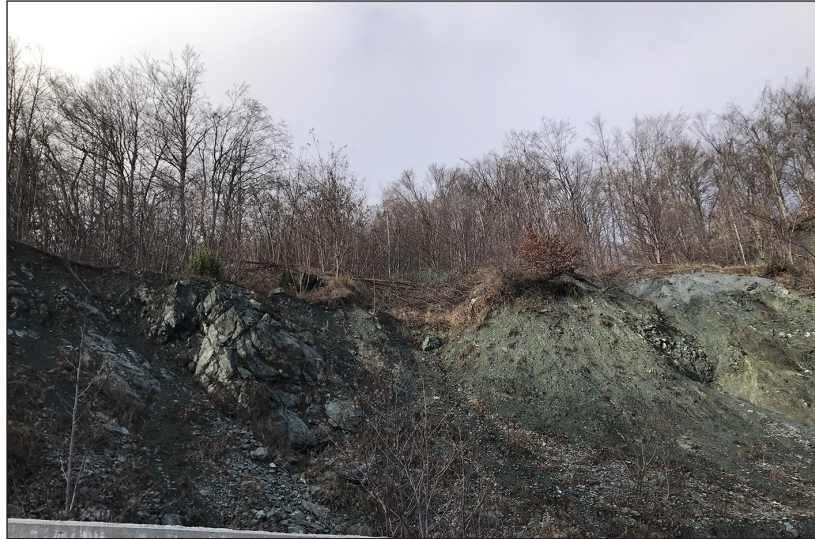
Figure 6. Landslide along road segment (no. 2 at Fig. 1)

During the timespan, the second case followed the first case and caused great damage, which resulted in the road closing for a certain time. The object of the movement was the soil-mantled layer (eluvium), whereas during its slide, it included the uppermost layer until the bedrock. The sliding plane was 30°, with the length from head to road being 55.5 m, while overpassing the

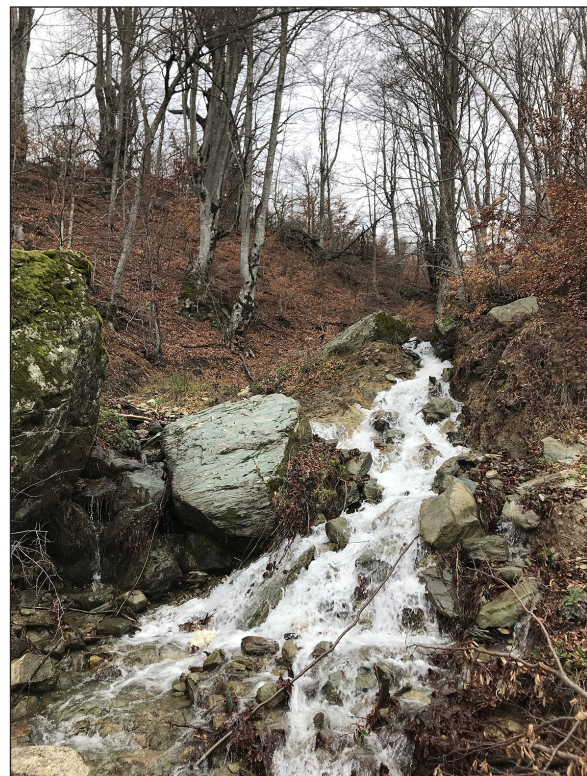
Figure 7. Stream through the area of Koshare

The area of Koshare has underground aquifers with numerous water sources and streams (74), whereas the total amount of water from all sources within the area (measurements performed within 24 hours), is 14.983 m³ or 0.174 m/s⁻¹. During field surveys in January 2023, numerous surface flows were observed, which are as a result of heavy rainfall in this area. While in the observations made in September 2022 there were no such surface water flows. These surface water flows have appeared along the slopes, causing surface erosion and higher intensity of landslides. Such natural activities are concentrated mainly during winter and spring seasons, as well as during the mentioned seasons surface activity with different types of mass movements are densely appearing.

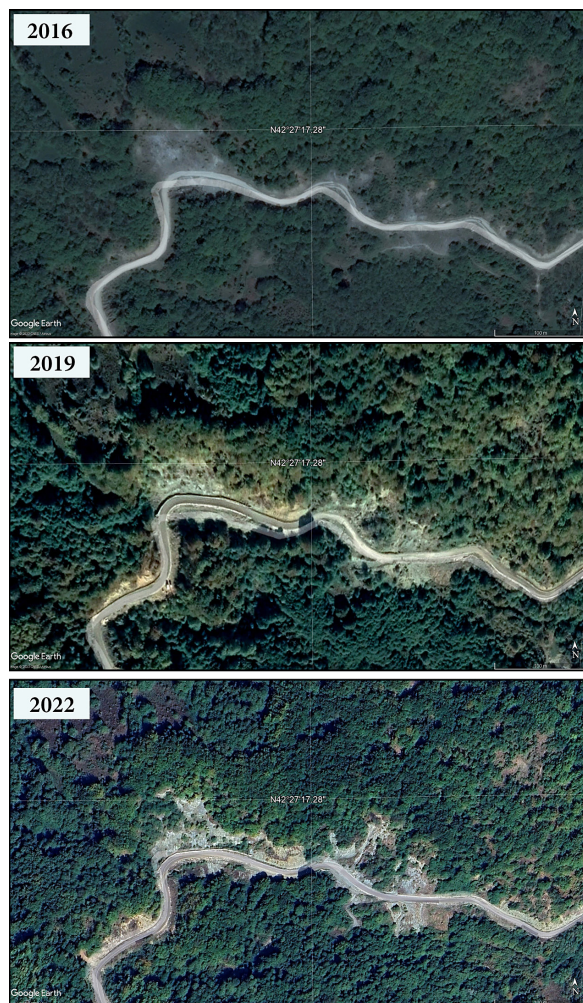
The area of Koshare has been continuously exposed to slope processes throughout the years. From the images provided by Google Earth Pro, it was noted that in 2016, landslides were present but on a very small scale, and the surface erosion process was dominant. Over time, the rate of landslides has increased as a result of weathering and geological settings causing slope instability. From the measurements carried out, it can be seen that the surface of the slides has doubled and caused material damage. The increase in the intensity of

Figure 8. Changes in the hillslopes throughout the years (source: Google Earth Pro)
