## THERMAL ACTIONS ON THE MATERIALS DURING DECK AND PAVEMENT CONSTRUCTION

The article presents the results of the research on thermal actions on the materials occurring in the cross section along the depth of the bridge deck and bituminous pavement during its construction. The impulse to carried out the research was the need to explain the causes of the blistering of bituminous waterproofing membranes and asphalt pavements often observed on the bridge decks. The paper presents the examples of such failures and the analyses of possible mechanisms of the phenomenon. Research indicates a significant influence of all technological processes on the temperature of materials in the cross section as well as daily temperature changes. The probability of initiation of reactions between concrete components with gaseous products has been confirmed in such conditions. The susceptibility of bituminous materials to gas emission and blistering is the subject of a separate study. The research was part of a research project carried out under the contract INNOTECH-K3/IN3/50/229332 /NCBR /14 [13].

*Keywords: blistering, waterproofing membrane, bridge deck, asphalt pavement, thermal action*

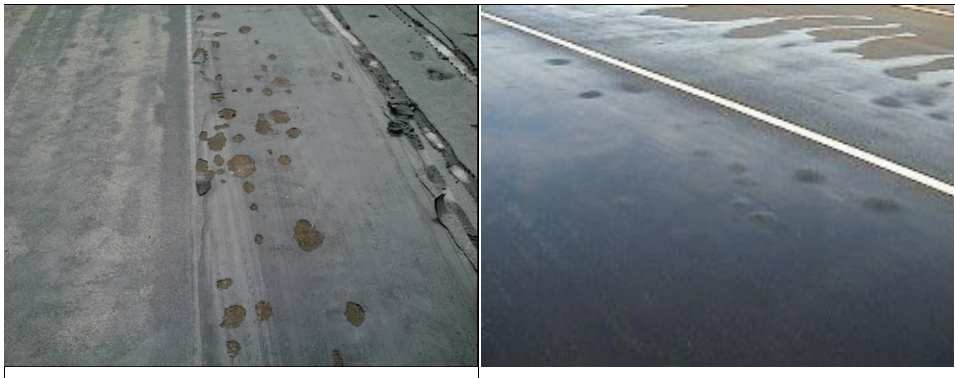
Fig. 1 Blisters containing gas on a) the waterproofing membrane b) the asphalt pavement

The problem concerns blisters containing gas under pressure, which arise on waterproofing bituminous membranes on concrete decks. This phenomenon is often encountered during bridges and viaduct construction, what is well documented by Road and Bridge Research Institute in Poland [1] and in publications [2,3, 16]. Blisters form on the membranes (Fig. 1a) from a few to dozen and few days after application or even after application of asphalt pavement (Fig. 1b). Diameter of blisters varied from a few centimetres even to 1 m. It increases the cost of the investment as well as delay in commissioning. Not often a composition of gases in blister is subjected to chemical analysis. However, at least in a few cases quantitative chromatography analysis detected a huge amount of hydrogen in samples of gases taken from blisters at construction site.

In one case (viaduct in Katowice, over Bracka str.; year 2003) the blisters appeared on the surface of about 3000 m<sup>2</sup> of waterproofing membrane during two weeks after insulation was placed. Some of them reached diameter about 1 m. The analysis carried on by two independent laboratories show similar gas composition [2, 3], what more gas burned with colourless flame characteristic for hydrogen:

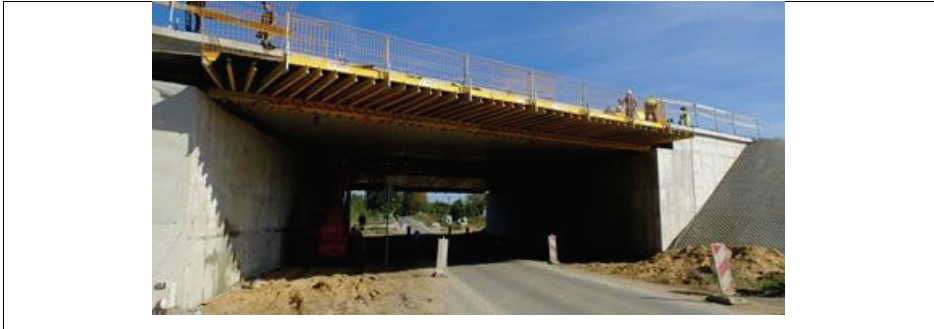
Fig.2 The view of the bridge deck at the A2 carriageway under construction.

A concrete slab of the bridge deck being a part of dual carriageway (A2, near Lodz), was chosen and tested (Fig. 2). It included in one direction, three traffic lanes, an emergency lane and a pavement with total width 17 m. Bridge deck (g = 80 cm, C35/45), abutment and pavement (C30/37) was made of reinforced concrete.

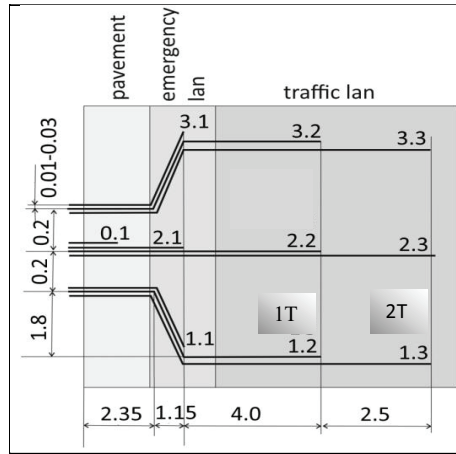
Fig.3 The geometry of the sensors fixed on the deck. From 0.1 to 3.3 the TKP type. 1T and 2T – the T type; six were fixed across the deck cross section: 1 and 2 T-top and beneath them C – in the centre, B – in the bottom. All dimensions in meters

The research plan focused on the measurements of temperature of the materials built into the deck (concrete - waterproofing insulation – mastic asphalt – stone mastic asphalt) and temperature in the formed materials joints. Measurements included (Fig 3) the following materials:

- the concrete in the concrete slab cross section along the depth:
  - the upper part; about 10 cm below the surface of the slab; top points no. 1T and 2T,
  - the middle part; a half depth of the slab; centre points no. 1C and 2C,
  - the lower part; about 5 cm above bottom of the slab; bottom points no. 1B and 2B,
- a surface layer of the slab; 0,5 cm below the surface (10 points from no. 0.1 to 3.3),
- bituminous waterproofing membrane; sheet based material with polyester reinforcement; from the upper side protected by sand layer and from the bottom side a PET foil,
- mastic asphalt (MA), stone mastic asphalt (SMA).

Temperature measurements of the bridge deck across its depth, during concrete casting, hardening and placement of the asphalt pavement layers were carried out using system ConReg 700 with six thermocouples type T (Fig.3, Fig.4). Frequency of sampling varied from 1 per 1 min to 1 per 1h. To measure the high temperature of bituminous materials the registration system was used, which consisted of ten thermoelectric sensors type TKP (range  $-40 \div +1100^{\circ}\text{C}$ ,  $\varphi = 1,5 \text{ mm}$ ) connected to the electronic data acquisition system. Frequency of sampling varied from 1 per 1 s to 1 per 1h. Outer temperature and humidity were registered by Apar AR235. Systems were powered by two VRLA battery (gel cell) and UPS. However, a part of data was lost when the system was powered by electricity supplied for construction site, which was unstable. Moreover a thermal imaging camera Fluke Ti400 with wide-angle lens was used to assess surface temperature changes (range:  $-20 \div +1200^{\circ}\text{C}$ ) over time.

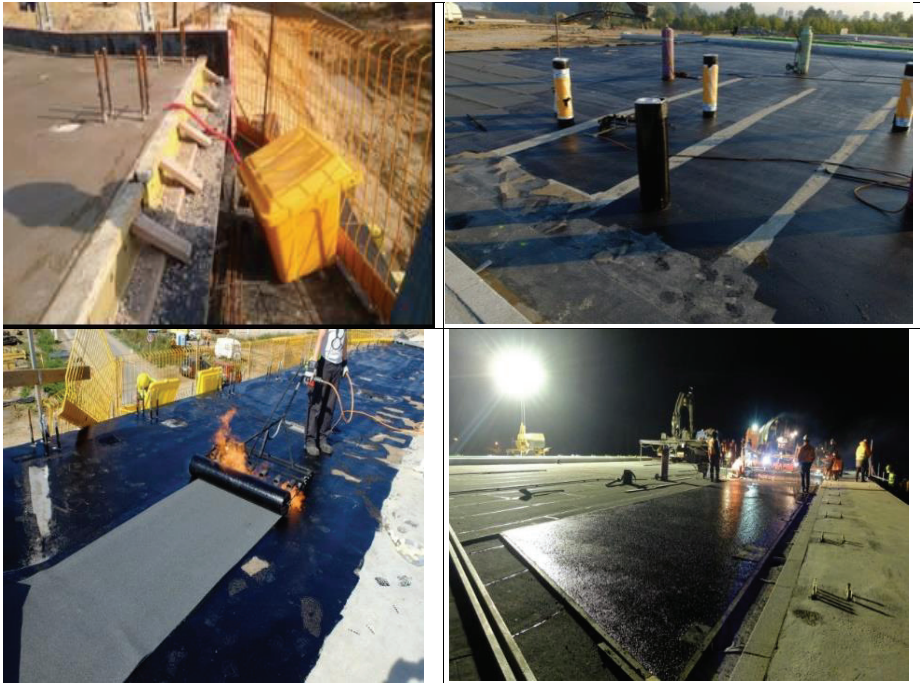
Fig.4 The pavement construction. Sensors fixed inside the deck and put into the box, which contained the data acquisition devices. Visible location of the sensors on the surface; they'rey stripes on a primer black background.

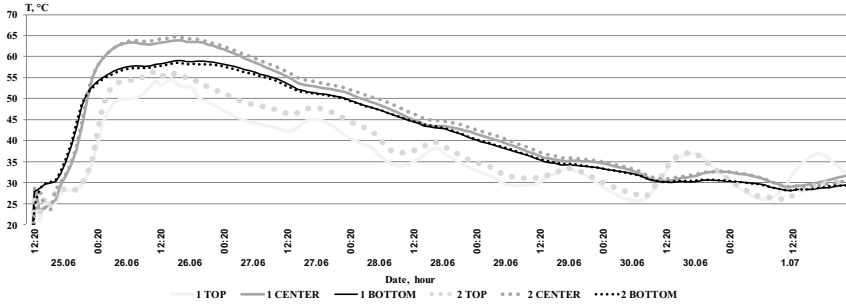
Fig 5 Temperature of concrete measured along the depth of the bridge deck during casting and setting between 25.06 and 1.07 2015. Differences between top, center and bottom of the slab are seen.

Concrete works took place on June 25th (12:20). ConReg registered the temperature along the depth of the concrete slab during the concrete setting (Fig.5), and then for three months (Fig.6); The highest temperature (65 °C) was observed in the middle part of the slab (1Center) and the lowest (55°C) on the top (1Top) during first two days after concrete placing. Then temperature decreased and daily changes (cycles) were observed (Fig.6), when  $T_{out} = +5 \div +41$  °C, when highest temperature in central Poland is +43 °C [14]. The mostly hit part of the concrete slab was its top part with  $T_{max} = 39,6$  °C in July and August and 35,2 °C in September; the lowest temperature reached respectively 14,9, 14,9 and 9,2 °C in that time. Maximum daily changes of the temperature (Tab.2) in the cross section of the deck along the depth ( $\Delta T = 10,8$  °C) occurred between the top of the plate (1T, 2T) and its bottom (1B,

2B). Taking into account the surfacing factor  $k_{sur}=1,5$  for such structure it can be expected that under black insulation membrane the top of the slab can reach the temperature of 60 °C PN-EN 1991-1-5 [14,15].

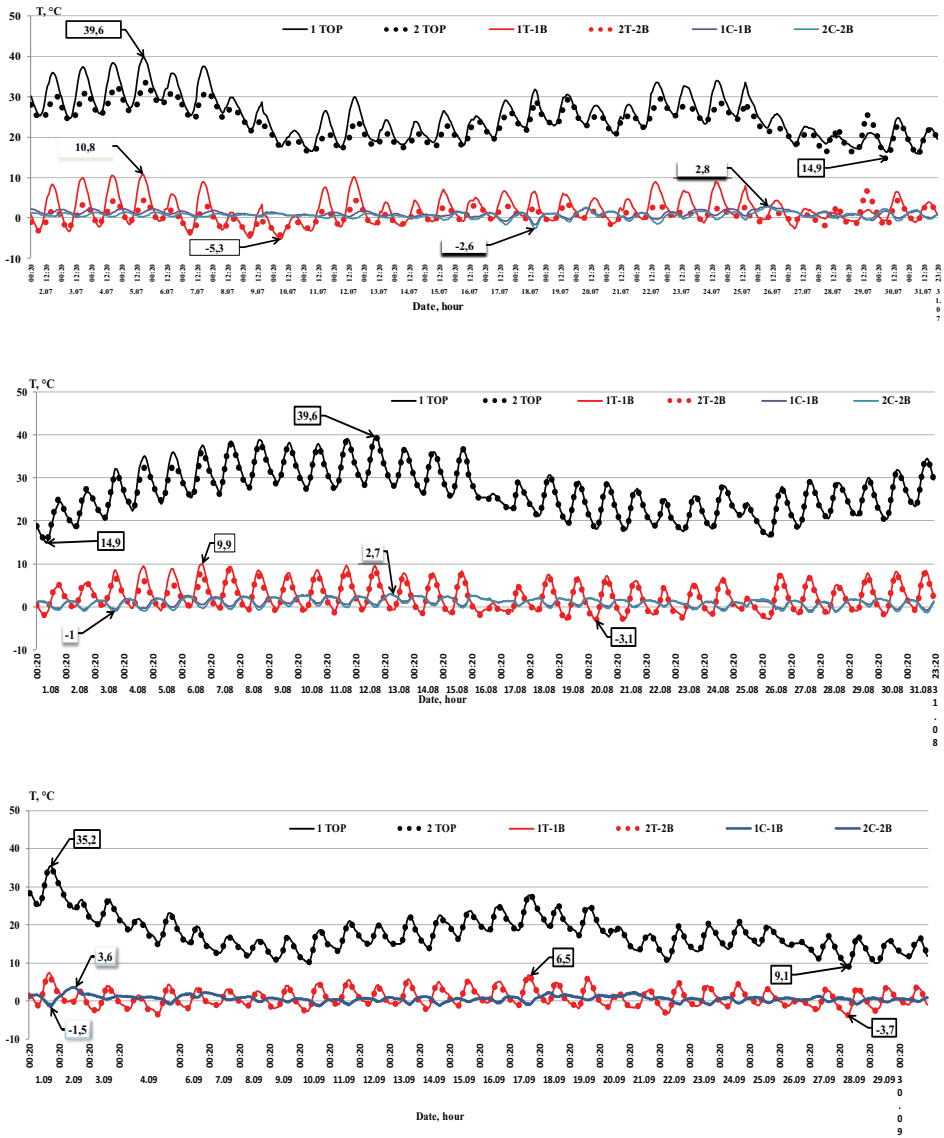
Fig.6 Changes of the temperature along the depth of the deck cross section measured in two points 1TOP and 2 TOP from 02.07 to 31.09 2015. Differences in temperature between the top and the bottom of the deck (1T-1B, 2T-2B) and between center and bottom part (1C-1B, 2C-2B) are also presented. Numbers indicate the highest and the lowest values during each month.

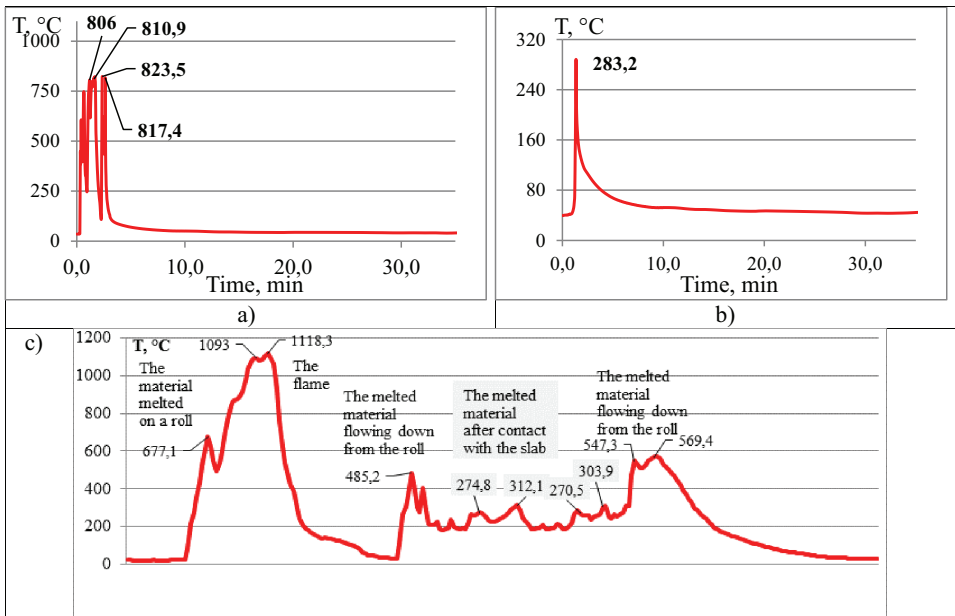
Fig. 7 Temperature of bituminous binder during placement of waterproofing membrane measured a) after flame action on the roll (picks) c) when it flowing down from the roll to the concrete - the sensor placed manually – measurements in seconds (picks), b) when it reached the concrete and was covered by the sheet.

- the highest momentary temperature of the sheet surface, detected just after contact with the torch was in the range 750-823 °C (Fig. 7a).
- the temperature of bituminous binder, which was flowing down from the roll, without contact with the flame was about 500÷600°C (Fig. 7c),
- when the binder reached the slab its temperature decreased to about 270÷312 °C (Fig. 7c, Fig. 7b), then was still kept in the range 160÷340°C, over a dozen seconds, despite a quick cooling of the surface below 100°C (Fig. 8 a, b). 50 °C was reached on the surface in 10 min and  $T > 40$  °C were kept more than 35 min. (Fig 8 a, b). However it was strongly depended on the wind direction (Fig 8 c, d).

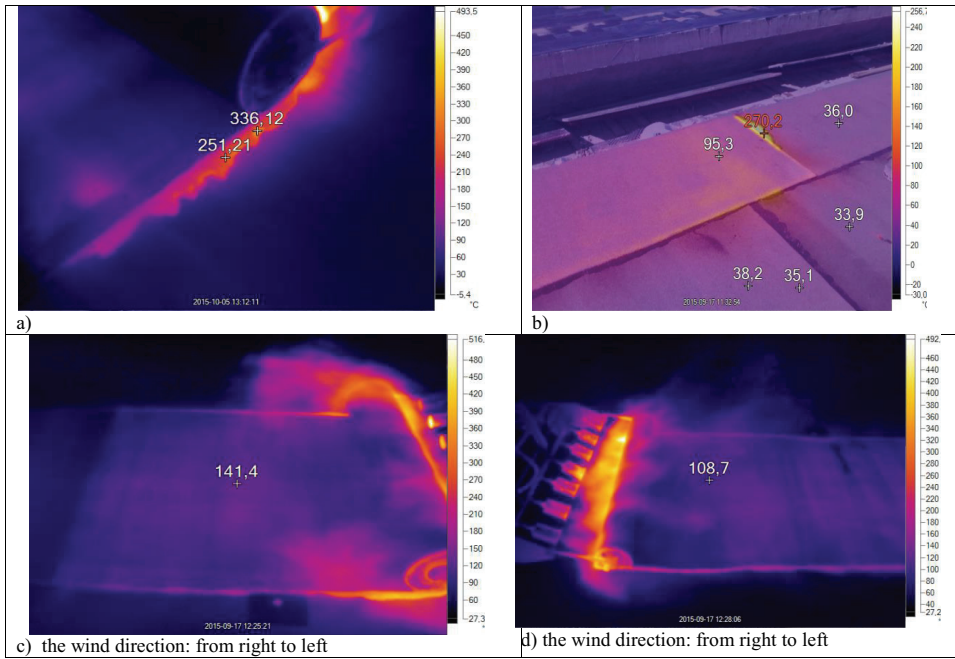
Fig. 8 The insulation membrane placement (17.09'15); IR camera indicates the temperature: a), b) of melted bitumen, which flows out from under the sheet as well as at its surface ( $T_{out} = 25,3$  C); c), d) when sheet is unrolled c) against the wind or d) with the wind direction ( $T_{out} = 29,7$  C).

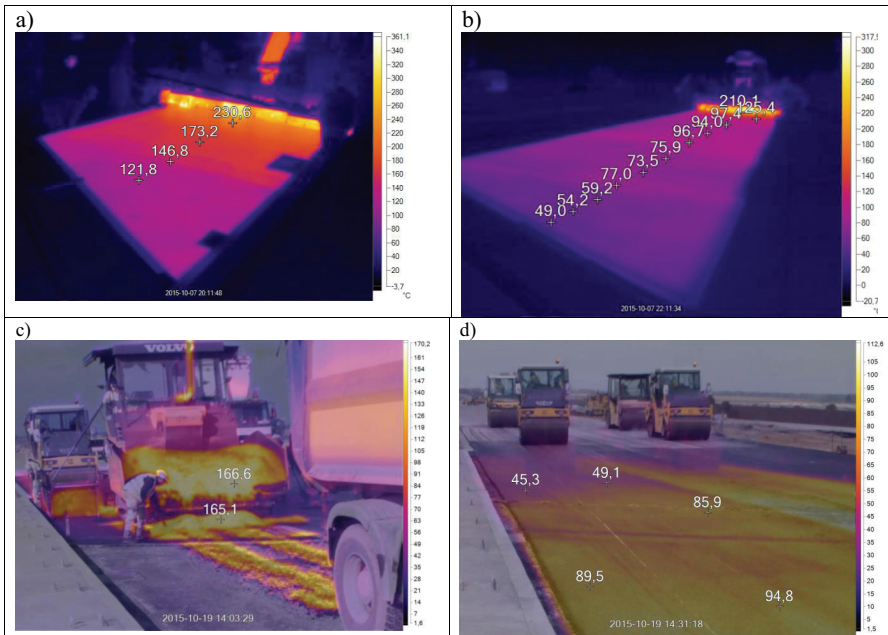
Fig. 9 Placement of a), b) mastic asphalt and c), d) SMA; temperature detected using IR camera

Mastic asphalt having  $T \sim 240$  °C and placed when the  $T_{out} \leq 5$  °C reached  $T = 22$  °C after 2 h (Fig. 9 a, b). The SMA layer was laid on a MA, when during a few hours of construction work the outer temperature changed from 12 °C to 6 °C and then to 20 °C. The SMA having  $T = 170-180$  °C (Fig.9 c, d) after application cooled to 150 -170 °C. Compaction of the mixture done, when the surface temperature was around 50-100 °C. Despite such low outer temperature the process significantly influenced the temperature of concrete slab in the top layer.

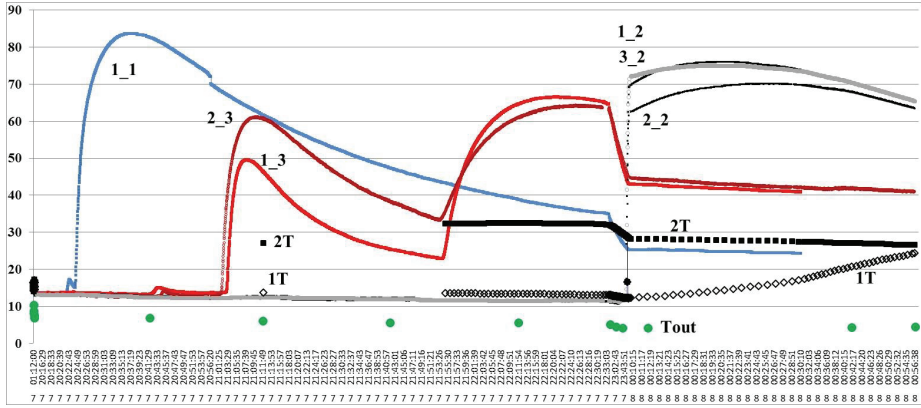
Fig. 10 Changes of the temperature on the slab surface under the waterproofing membrane during the mastic asphalt placement; the numbers indicate the sensors. The increase of temperature in the dipper parts of the slab is also seen; 1T follows points no. 1\_2, 2\_2, 3\_2 and 2T points no. 2\_3, 1\_3). Tout – the ambient temperature; the number of data on the graph has been limited.

It was established (Fig.10, Tab. 2, Tab. 3) that placing of the subsequent layers during the road construction influences the temperature of the slab:

When the MA was placed ( $T_{out} \leq 10\text{ }^{\circ}\text{C}$ ) the sensors no. 1.1, 1\_2, 3\_2, 2\_2 registered the maximum temperature of the slab surface between 83,4 and 70  $^{\circ}\text{C}$ , which lasted from 40 to 220 min above 40  $^{\circ}\text{C}$  (Fig.10). The sensor 1.3 (also 2\_3) recorded two separate consecutive peaks i.e. 49,3  $^{\circ}\text{C}$ , and then 66,4  $^{\circ}\text{C}$ . It is because the MA was placed in two steps. In the same time the top part of the slab cross-section was heated from about 13-15  $^{\circ}\text{C}$  to 32,6  $^{\circ}\text{C}$  and the temperature higher than 30  $^{\circ}\text{C}$  last for 2 - 3 hours (outside the range of the Fig.10) .
