ANALYSIS OF TECHNICAL CONDITION OF LOCAL ROADS DRAINAGE IN THE CZESTOCHOWA REGION

Zbigniew Respondek¹ – *orcid id: 0000-0003-0204-5061*

¹Czestochowa University of Technology, **Poland**

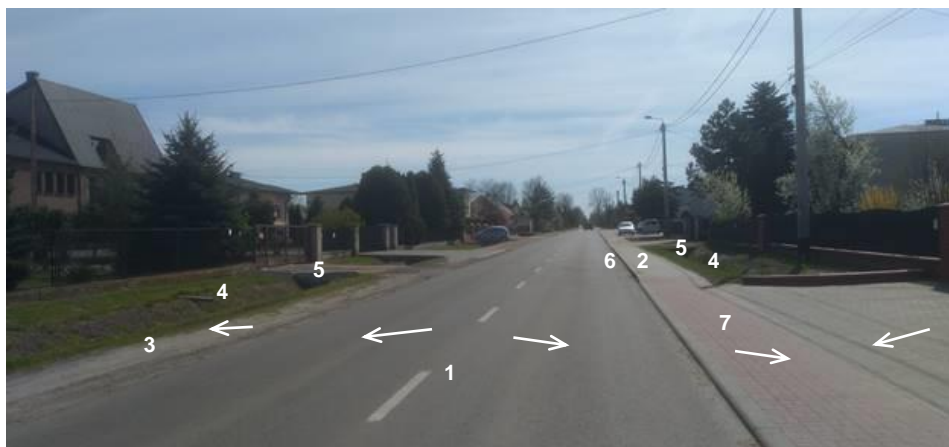
Fig. 1. Elements of drainage in built-up area, arrows indicate the direction of water runoff: 1 – road surface with a „roof-like slope”, 2 – sidewalk, 3 – unpaved roadside, 4 – ditch, 5 – culvert, 6 – near-curb gutter, 7 – exit with lowered curb

further away (Mieszkowski, 2006; Kowacki, 2015; Majer, 2016). An exemplary system of dewatering devices in built-up areas is shown in Fig. 1.

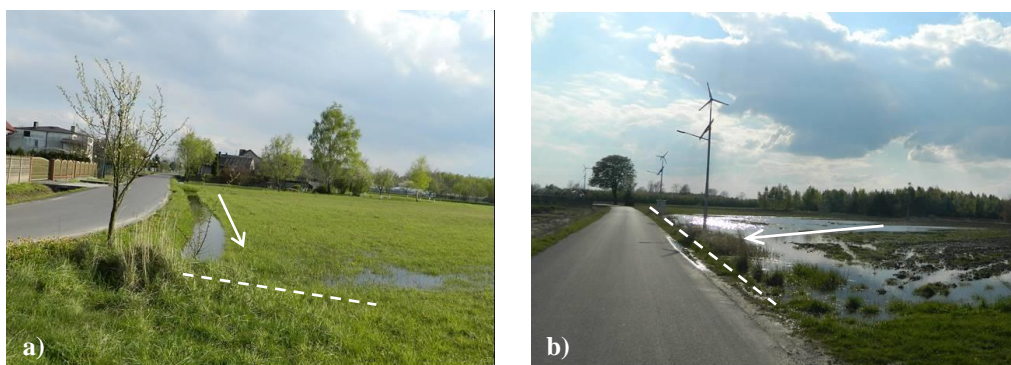
Failure to maintain the drainage continuity results in long water storage in ditches or on surrounding terrain. The material of the road core is washed or rinsed. Exposed to long water effect, the stone foundation corrodes faster, which reduces the durability of the pavement (Fig. 2).

Fig. 2. No continuity of drainage: a) ditch without outlet, b) no culvert prevents water from floating to the other side of the road core

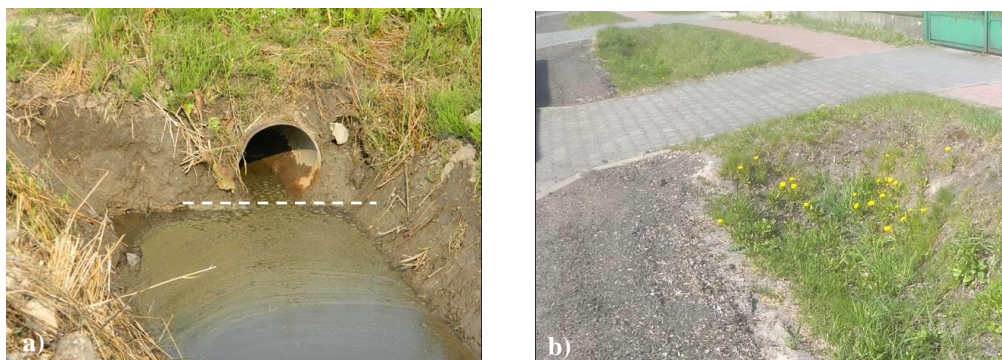
Fig. 3 shows the effects of a faultily performed procedure consisting in the so-called "ditch cosmetics". Deepening the ditches has led to the situation that the bottom of the ditch is below the line of old culverts, which causes the retention of water. It also happens that the culverts are clogged or simply do not exist. Despite the maintenance operations carried out, the technical condition of the drainage was described as bad in such sections.

Fig. 3. Errors in the renovation of ditches: a) low ditch bottom, b) no culverts

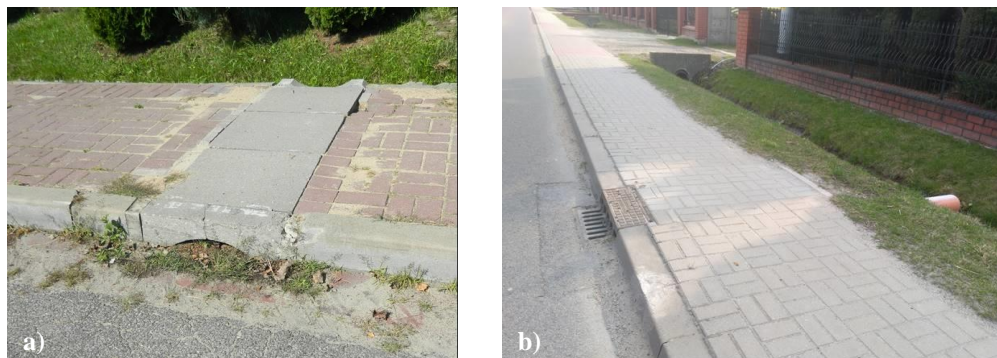
Fig. 4a shows the drainage of water from the near-curb gutter into the ditch by means of a inlet with a lateral conduit located under the surface of the sidewalk. Too small cross-sections of these devices have proven to almost clog them up. After a few years, the error was removed: new inlets with lateral pipes $\phi 150$ mm were installed (Fig. 4b) – it required dismantling parts of the pavement, i.e. incurring unnecessary costs.

Fig. 4. Draining water with a conduit: a) cross-sections are too small, b) after replacement

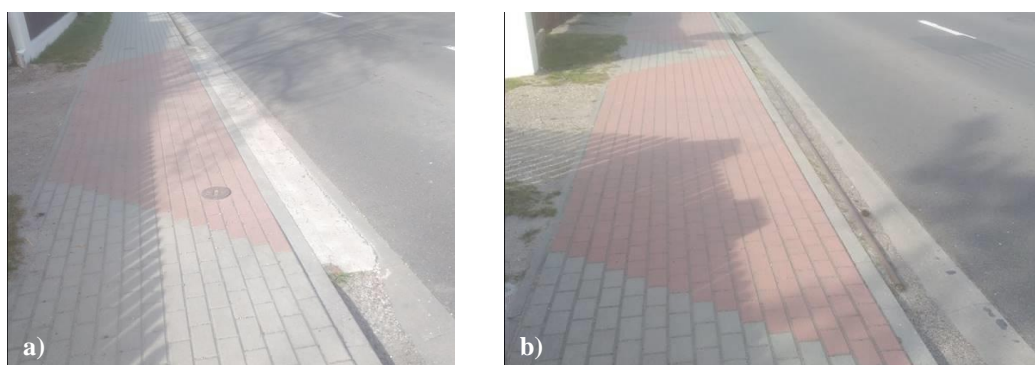
As already mentioned, a sidewalk is usually laid on one side of the road – on the other side lie gutters or unpaved roadside. Near the sidewalk, a high curb and a lowered curb on exits are most often used. This solution has some drawbacks: firstly, the longitudinal equality of the pavement is disturbed, secondly the surface at the curb is silted, which causes puddles to form more often. If a triangular gutter is used instead of a curb, another problem occurs. If the design stage did not include solutions facilitating passing at exits and at the same time not worsening conditions of water runoff, residents "facilitate" passage on their own, often doing it inappropriately (concreting of the gutter, filling with slag, placing wooden, steel or even bricks, Fig. 5). Because of this the gutter is quickly silted up. The technical condition of drainage in this section was described as unsatisfactory.

Fig. 5. "Facilitation of passage" through triangular gutter: a) concreting, b) steel pipes

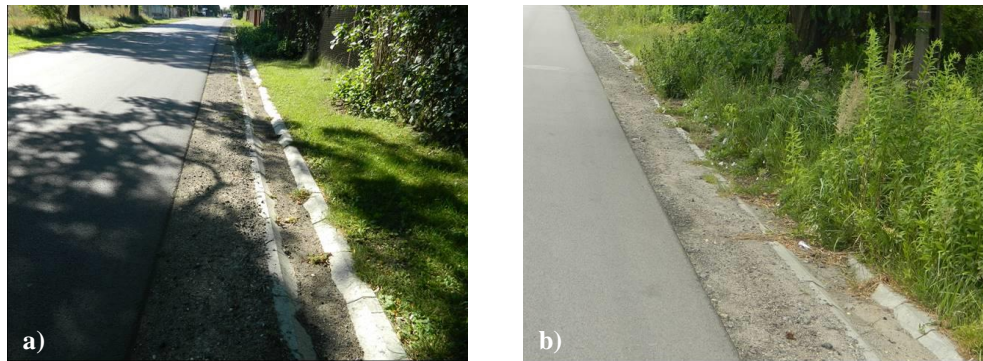
Fig. 6 presents a case of an evidently incorrect connection of drainage devices with each other. The oval gutter was moved away from the roadway, and an unpaved aggregate roadside was laid between the gutter and the roadway. Virtually after the first rainfall, the gutter was contaminated with stone material and after a few years it became practically invisible.

Fig. 6. Incorrect positioning of an oval gutter: a) shortly after construction, b) after two years

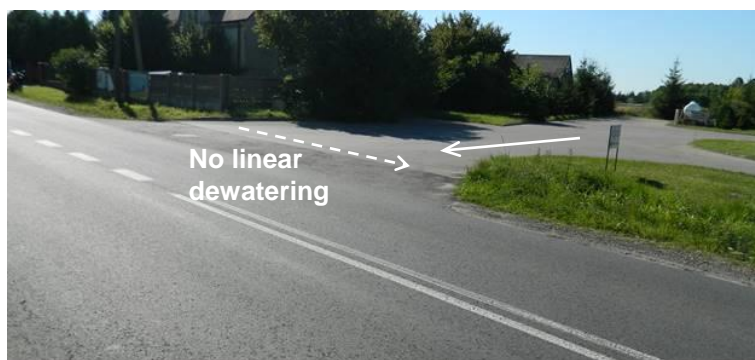
Fig. 8. Possibility of covering the road surface with water from the paved area – the problem would be partially solved by using a box-gutter at the exit

Recently, another factor affecting dewatering has also become apparent. Paving has become common, usually with concrete cubes, not only in areas such as commercial facilities, but also private properties. In case of heavy rain or thaw, the water runs down the paved surfaces almost immediately, which, if not properly taken, can lead to flooding and silting the surface of the roads below (Fig. 8). In this context, it seems

advisable to make more common using collection systems around buildings to collect rainwater for use (Karelová et al., 2013).

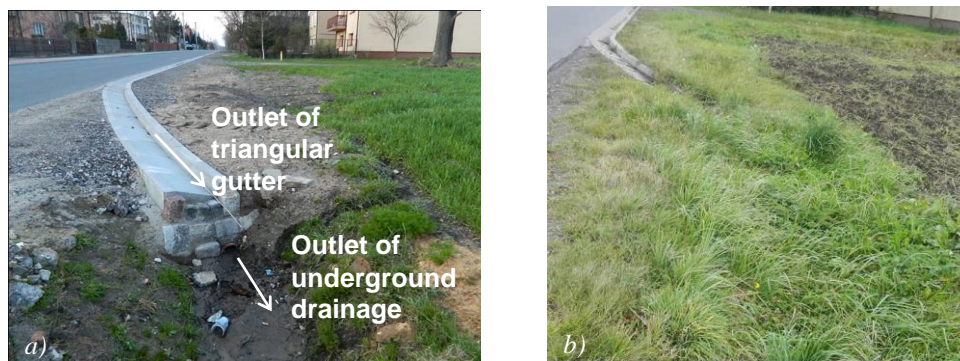
An example of a rapid loss of functionality of uncleaned drainage elements is shown in Fig. 9. It is worth noting the total blockage of the outlet of underground drainage, which makes it ineffective and the sense of designing this device in this area is put into doubt.

Fig. 9. Loss of dewatering functionality due to lack of maintenance: a) drainage elements one year after construction, b) after three years

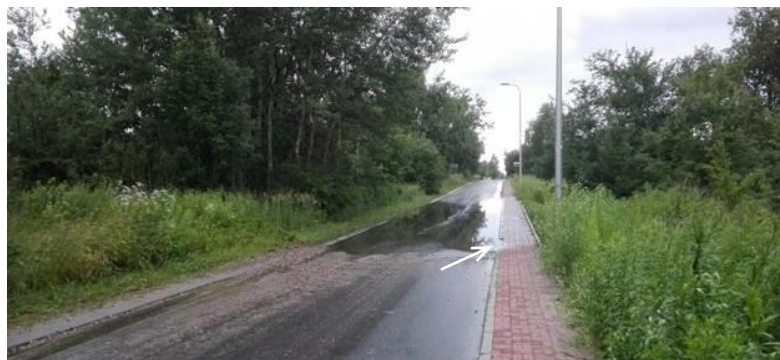
Another example of the loss of dewatering efficiency is shown in Fig. 10. Contamination of underground drainage and lack of drainage ditch leads to deposition of rainwater on the surface located in a lowering of the area.

Fig. 10. Deposition of rainwater in a lowering of the area, clogged drainage inlet

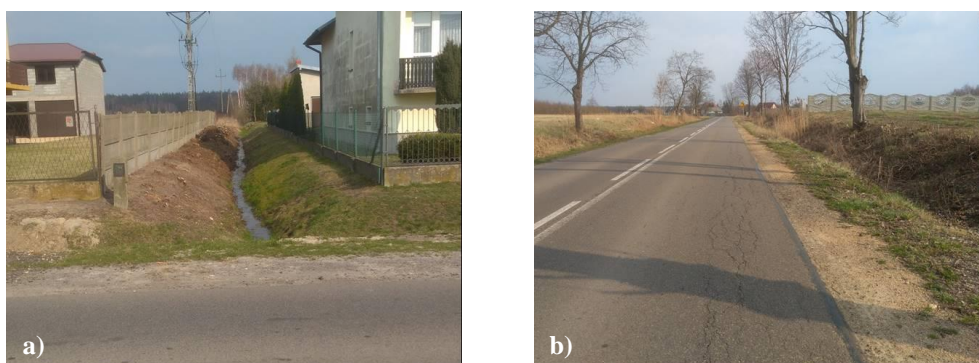
A positive, noticeable effect an increase in the number of treatments involving mowing ditches, cutting off the self-sowing plants in the road nearness, renewing drainage ditches and profiling the swollen roadsides with the use of specialized equipment which could have been observed in recent years (Fig. 11).

Fig. 11. Treatments related to maintenance of drainage: a) cleaned ditch, b) roadside from figure 7a after profiling
