## *Transformations of the form and façade of the Lehndorff palace in Sztynort Duży in the light of architectural research*

### *Introduction*

### *Description of own research*

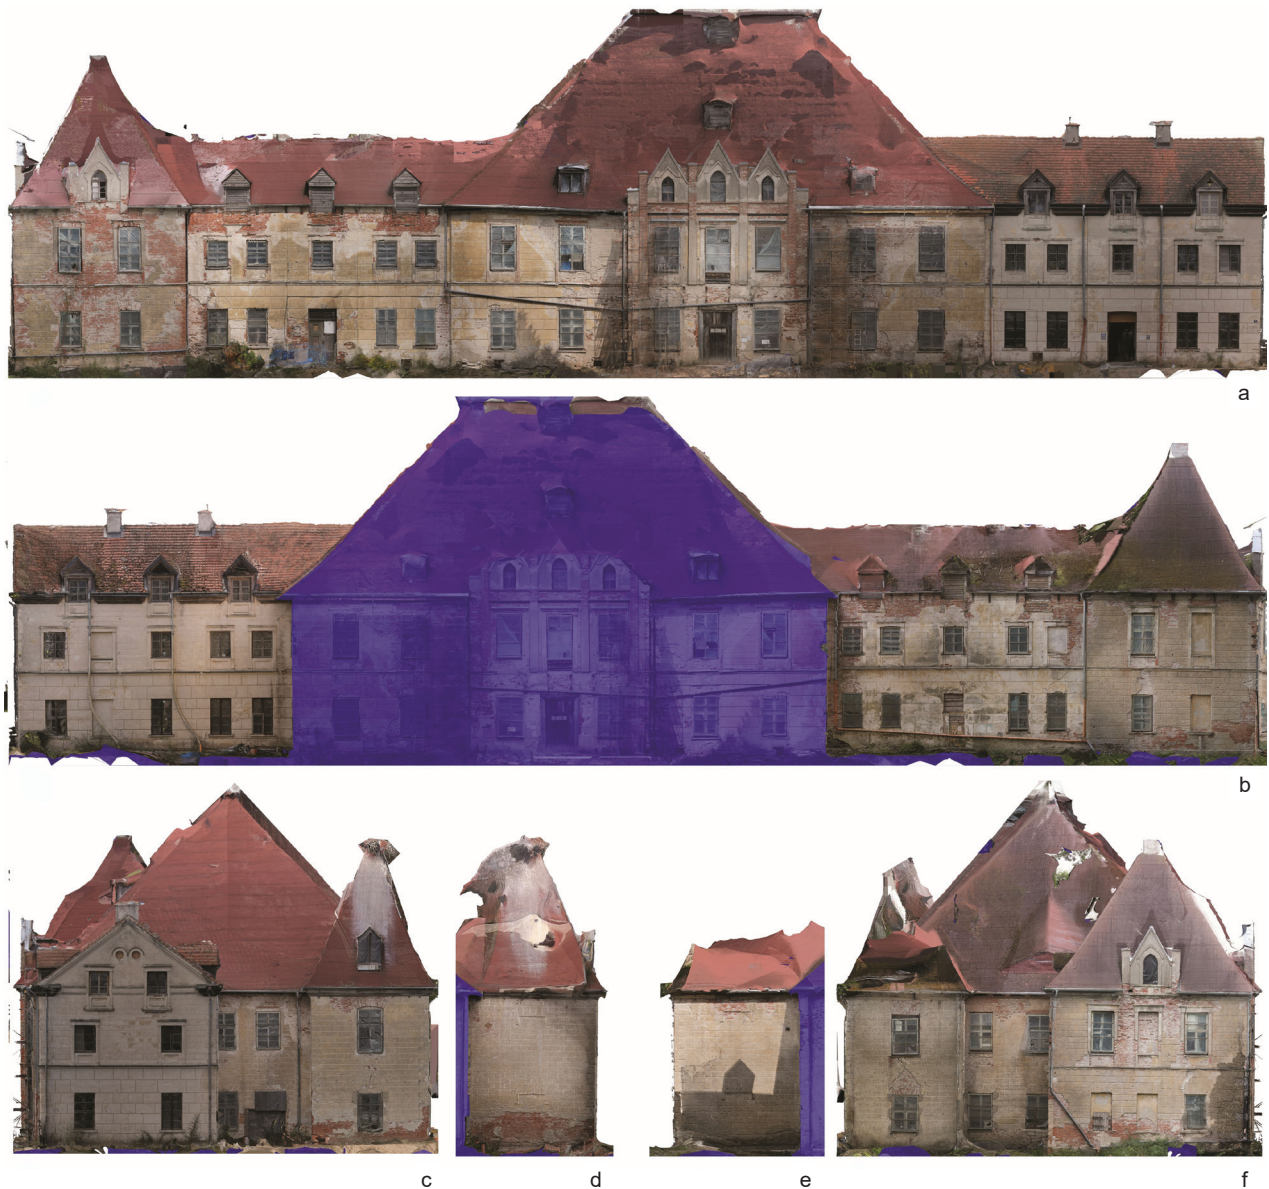
Fig. 1. View of the main façades of the building:

a) façade of the main nave and side wings (western façade), b) rear (eastern) façade of the side wings and kitchen tower, c) southern façade, d) western façade of the southern alcove, e) western façade of the northern alcove, f) northern façade (elaborated by S. Bakalarczyk, 2023)

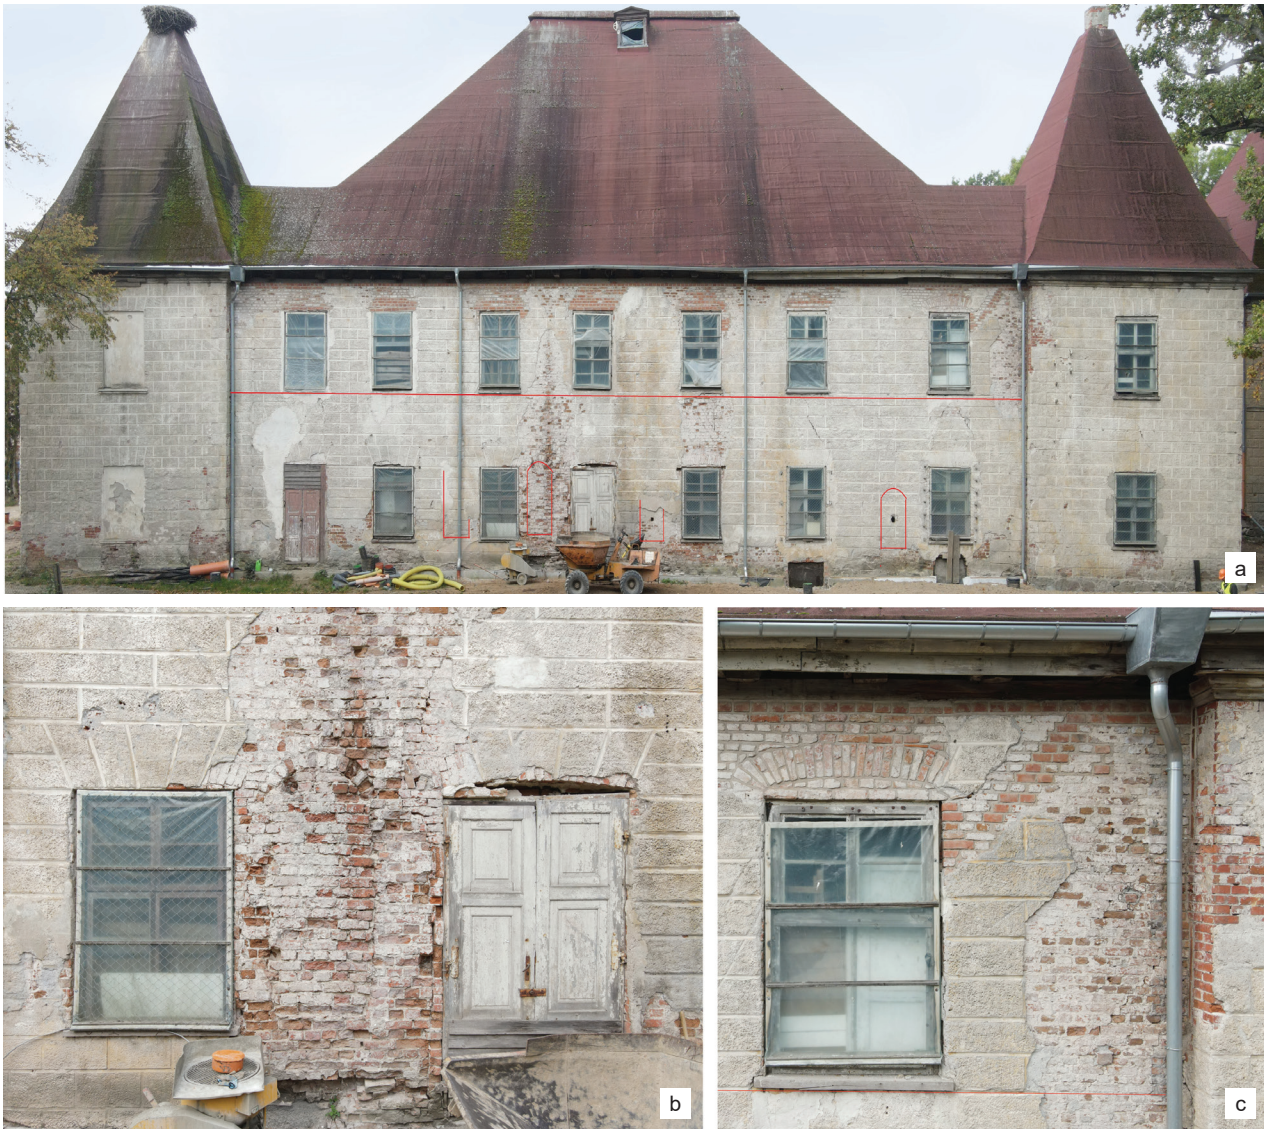
Fig. 2. The rear façade of the nave with the alcoves, which were added in the third stage of the fifth phase:  
 a) the average border of the walls from the first and second phases and the location of the arcaded niches are marked on the view,  
 b) a close-up of the most visible niche by the door to the garden living room  
 (it has chiseled edges below the arch; both the window and the door have rebuilt lintels and glyphs),  
 c) the 1<sup>st</sup> floor window with a clearly legible three-centered arch of the lintel.

Below the window sill, the border of the walls of the first and second phase is visible (photo by S. Bakalarczyk, 2022)

The second phase is related to the Baroque reconstruction of the palace in the years 1689–1695, after its earlier devastation in 1658 [12, p. 29], [13, p. 184]. Archival documents indicate that at that time the roof, ceilings and part of the walls, which were in poor condition, were demolished and the 1<sup>st</sup> floor was rebuilt<sup>14</sup>, giving the main body a shape preserved to this day. A symmetrical arrangement of the façade axes was introduced<sup>15</sup>, an avant-corps was added<sup>16</sup>, using demolition bricks on the ground floor, and all openings were closed with three-centered arches (Fig. 2c).

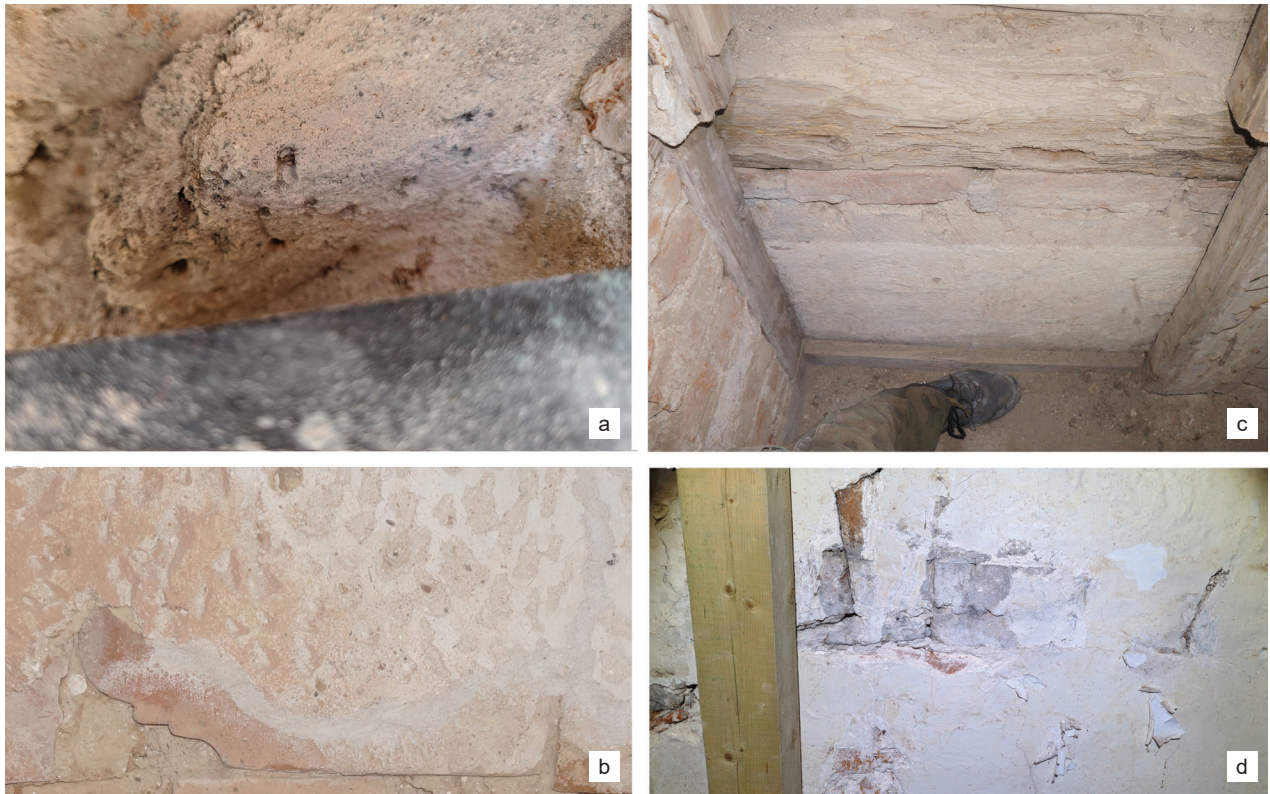
Fig. 3. Relics of the façade finish and roof covering, associated with the second chronological phase:

- a) a fragment of the corner rustication of the nave made of grey plaster coloured in the mass with a needle-punched face,
- b) Baroque beaver tail tile reused as a levelling layer in the eastern room of the front tract,
- c) a well-preserved white background of the western façade in the under-eaves zone, with clear remains of the removed cornice,
- d) the lintel arch of the window on the ground floor of the western façade, lowered and converted into a door to the side wing.

The visible horizontal border of the grey window trim and the white background above indicates that the surrounds did not repeat the shape of the lintel (photo by S. Bakalarczyk, 2023)

a needle-punched texture (Fig. 3). Its presence in this place confirms that in the Baroque phase, the building, at least outside the avant-corps, did not receive either a cordon cornice between the storeys or corner avant-corps/alcoves, visible on archival designs of the palace<sup>19</sup> [19] (Fig. 4).

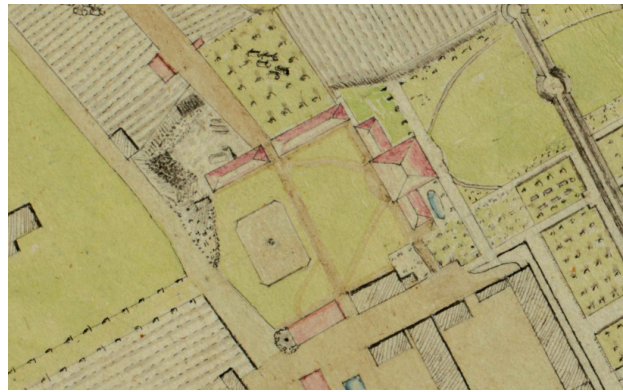
Fig. 5. The palace and its surroundings in 1809. Symmetrical side wings covered with gable roofs, reaching the side walls of the palace (source: [23])

By October 1780, the foundations of the new wing had been made [20, p. 167], and five years later finishing works were still being carried out<sup>27</sup>. The wings are visible for the first time on a plan from 1807, in which, due to the incorrect capture of their proportions, they were interpreted as Baroque alcoves [22]. A more detailed plan from 1809 correctly shows their proportions and indicates that they were covered with identical gable roofs [23] (Fig. 5).

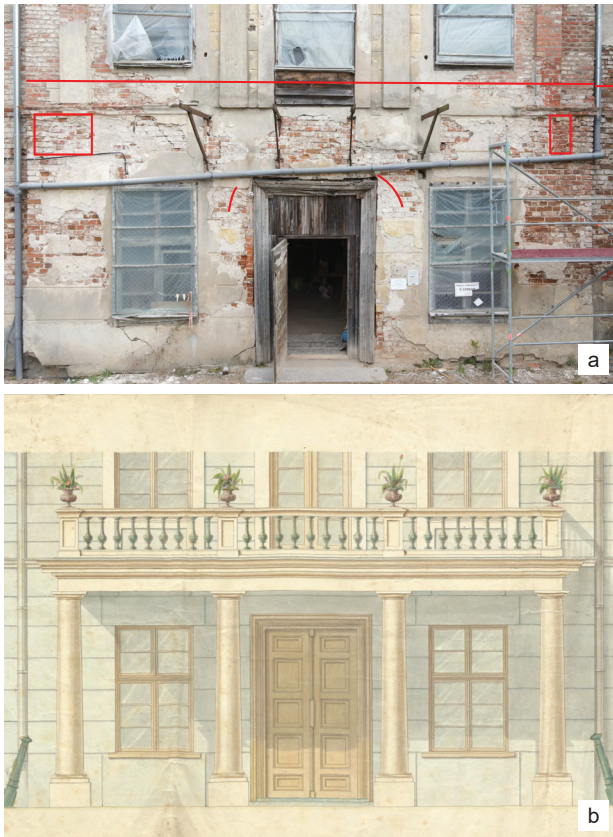
Fig. 6. Front avant-corps with the main entrance and balcony:  
 a) current state with the remains of the three-centered arch, the level of the Baroque superstructure and point rebuilding in the zone of the balcony slab (photo by S. Bakalarczyk, 2023),  
 b) design of the façade with a classicist balcony supported by Tuscan columns (source: [24])

The façade of the front avant-corps from this phase was depicted together with the woodwork preserved to this day in a drawing estimated to date from the mid-19<sup>th</sup> century [24]. Until now, this document was considered to be an unrealised reconstruction project, due to the inclusion of a wide balcony supported by four columns (Fig. 6). The re-bricking discovered above the ground floor corresponds to the points of adding the balcony entablature to the façade.

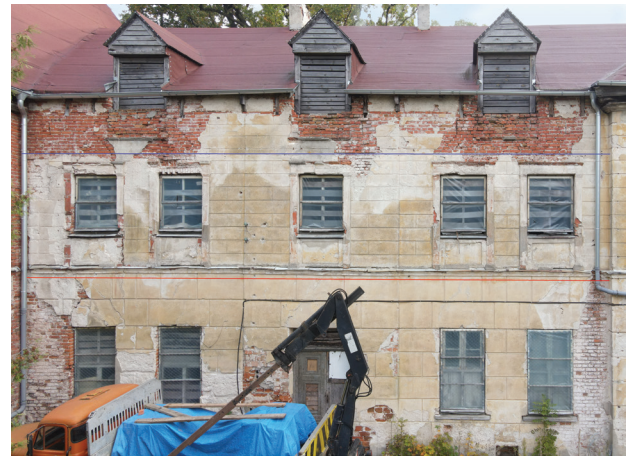
Fig. 7. The western wing has two levels of the superstructure that are clearly visible. Phases three through five.

There is no fourth phase in the eastern wing, the 1<sup>st</sup> floor was erected together with the ground floor in the third phase (photo by S. Bakalarczyk, 2023)

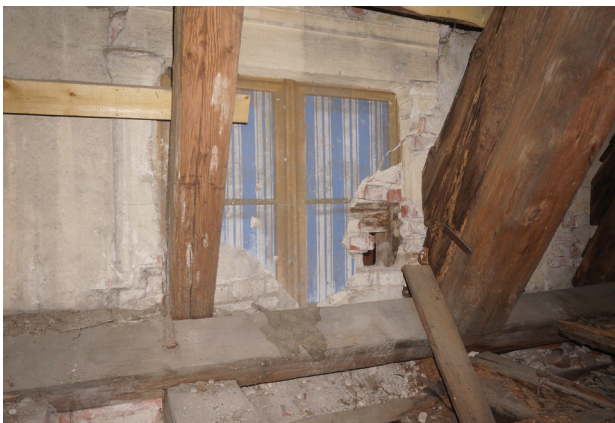
Fig. 8. The gable wall of the western wing, built as part of the first stage of the fifth phase. The brick and skeleton structure of the gable is visible, also repeated in the knee walls (photo by S. Bakalarczyk, 2023)

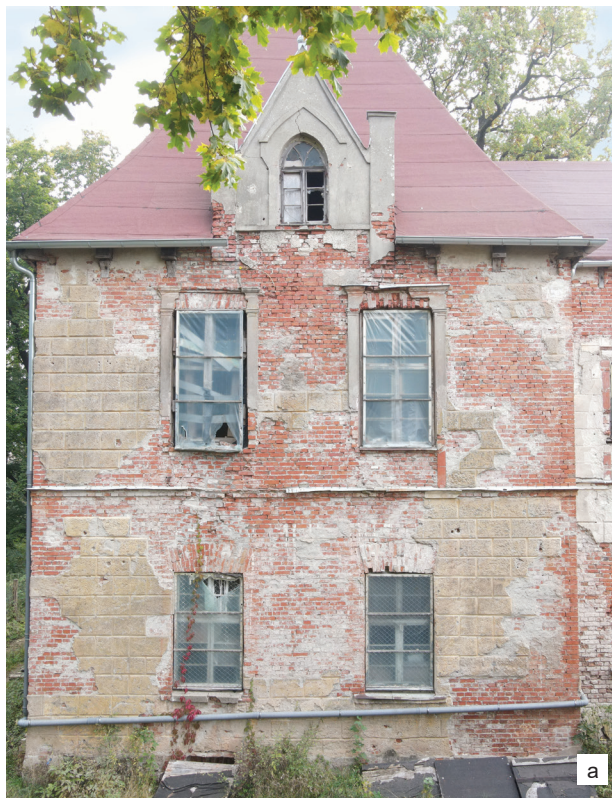
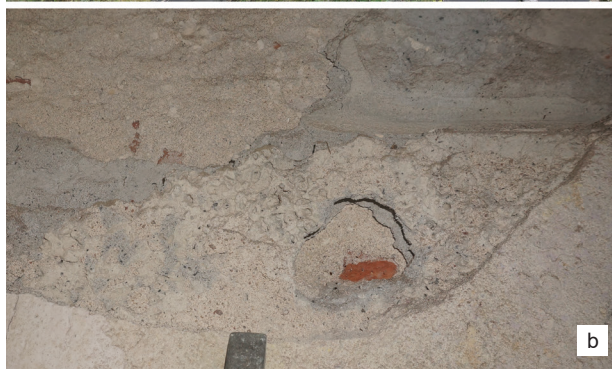
Fig. 9. Solutions characteristic of the fifth phase: a) the façade of the kitchen tower from the second stage of the fifth phase, referring in detail to the façade from the fourth phase (there are no traces in the homogeneous wall suggesting the later addition of neo-Gothic dormers), b) a well-preserved fragment of unpainted plaster with a rustication profile, used on the tower and the side and rear façades of the nave (the alcoves were prepared in the same way using lighter plaster) (photo by S. Bakalarczyk, 2023)

the side and rear façades of the nave – it includes homogeneous rustication with wedges in the zones of window lintels<sup>43</sup>. Well-preserved fragments of rustication, discovered on the eastern and western façades<sup>44</sup>, suggest that in the initial period these façades functioned without paint coatings (Fig. 9).

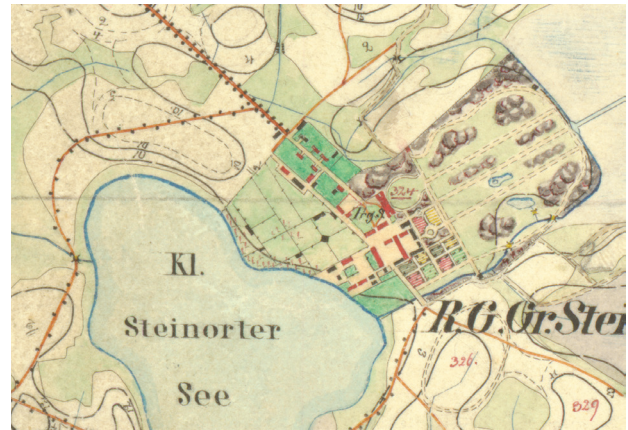
Fig. 10. Plan of the village from 1862.

The palace was depicted with four annexes, which correspond to the side wings and rear alcoves. The scale of the study did not allow for a correct representation of the kitchen tower (source: [30])
