## UNUSUAL REBUILDING METHOD OF HISTORIC ST MARY'S CATHEDRAL IN THE CAPITAL OF WESTERN AUSTRALIA

### Abstract

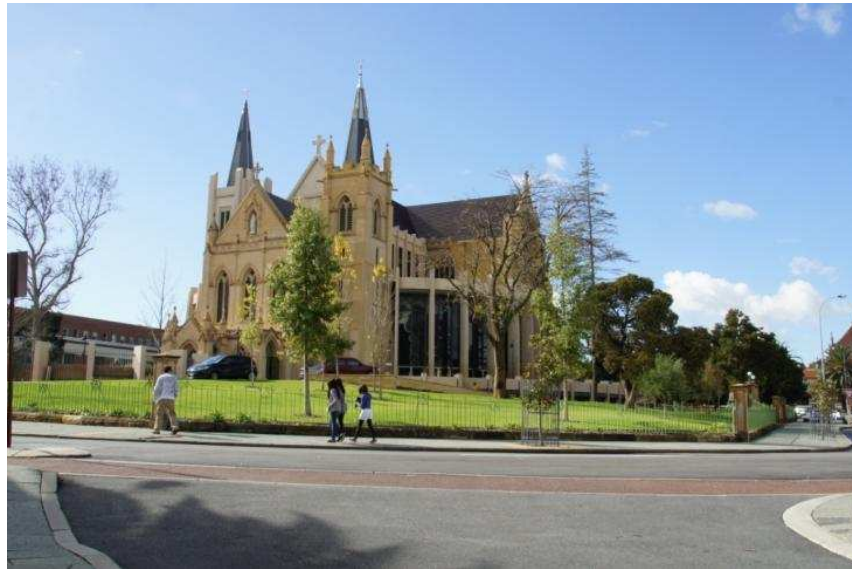
Fig. 1. General view of St Mary's Cathedral in Perth - Western Australia

In the photo placed in Figure 1 one presented a general contemporary view of St Mary's Cathedral in Perth (2014).

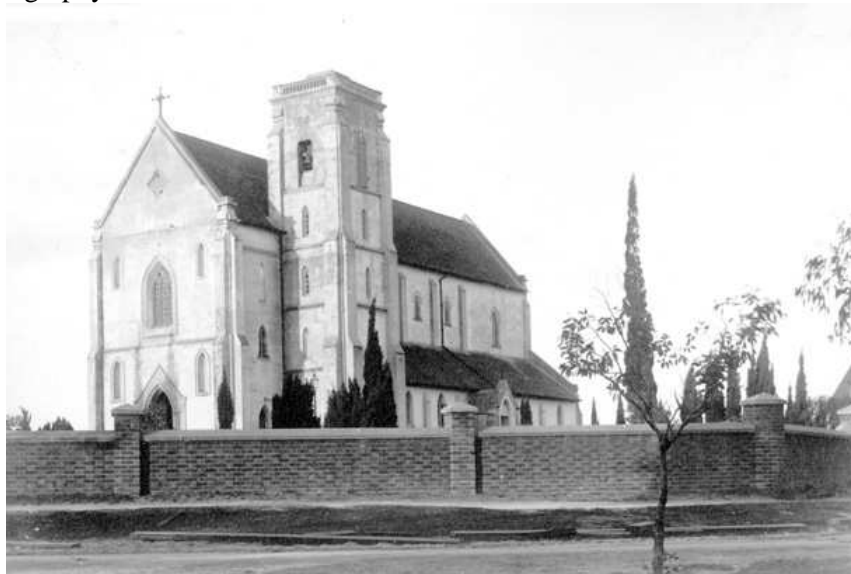
Fig. 2. General view of the sacral building in its original architectural design from 1894.

The main architect responsible for the construction work was Joseph Ascione - originally from Italy. The cathedral was consecrated and opened on 29 January, 1865. Figure 2 shows a view of the sacral building in its original form - photography dates back to 1894.

It was a relatively small building, although at that time it most likely met the needs of residents.

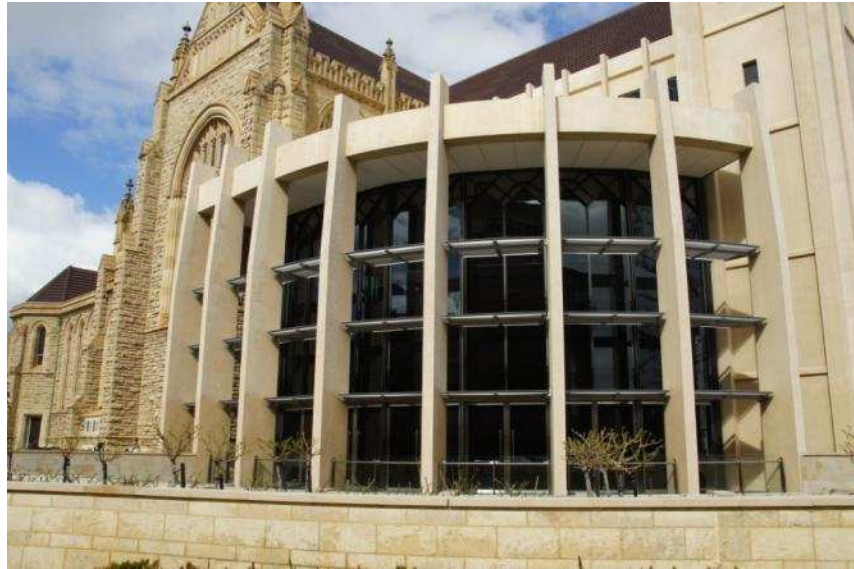
Fig. 3. A general view of one of the attached aisles, aimed at increasing the usable area of the object. Clear way of combining "the new" with "the old" - in the background view of the historic facade of the cathedral

This is achieved by "cutting out the" middle, narrow part of the cathedral with small window openings and constructing at this point double-sided "expand" (i. e. development) of the central part of the cathedral through the construction of two symmetrical aisles of a modern spacious architecture.

An outer load-bearing structure supporting the roof surfaces of the aisles are the pillars of reinforced concrete with a variable section whose architectural form also allows sufficient illumination of the cathedral interior through the use of large panes of glass.

In the photographs, appearing in Figures 3 and 4 was shown the "effect" in the form of the spaciousness of the cathedral building, achieved through the expansion of its middle part (additional usable space in the aisles and intense lighting).

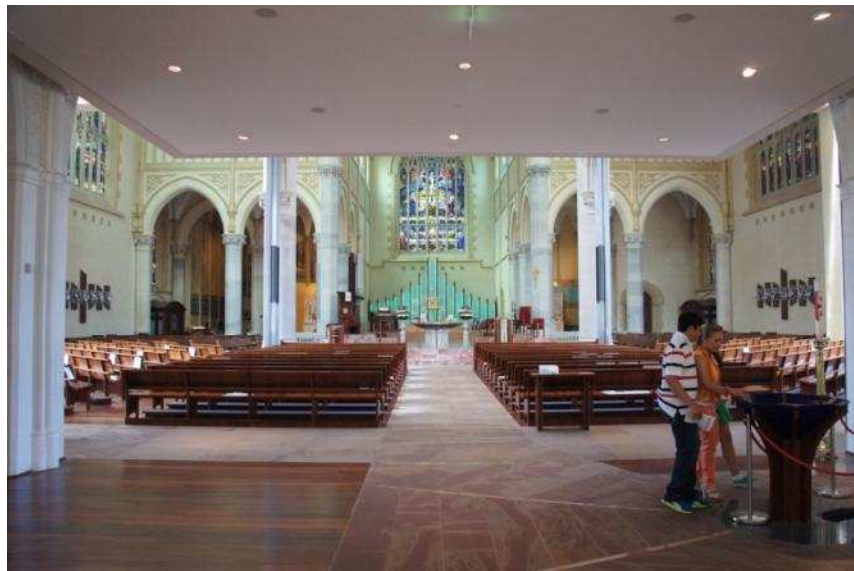
Fig. 4. View of the interior of the cathedral from the entrance. Visible effect of increasing the usable space of the object by mounting double-sided aisles and additional lighting

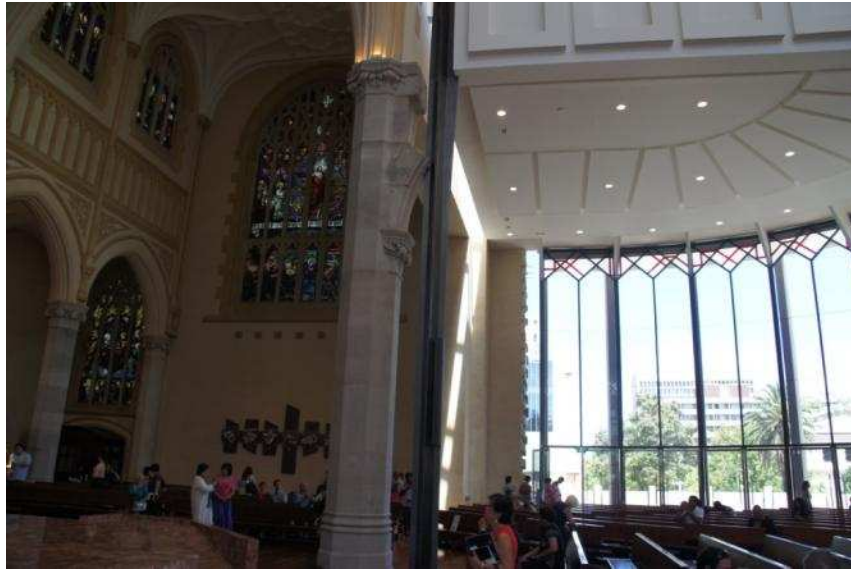
Fig. 5. View of the combining area of the cathedral existing structure with an added aisle. Visible pillar of steel structure next to the historical pillar made of sandstone

The essential inner structure of these aisles accounted steel frame construction made of structurals. Through the use of steel components one obtained "lightness" of the design and construction elements do not restrict architectural values inside a cathedral.

In addition, in the photographs, appearing in Figures 5 and 6 one shown construction details of load-bearing steel structure inside the sanctuary.

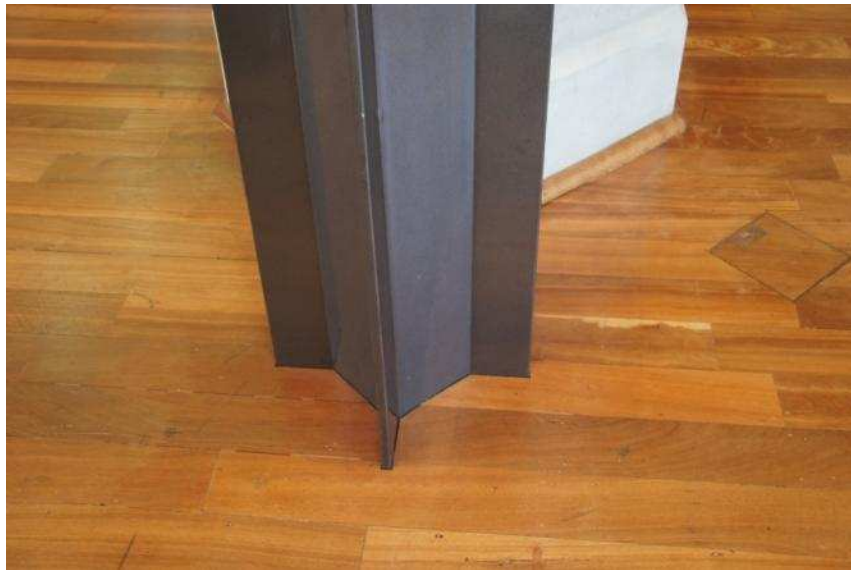
Fig. 6. Zone detail of "penetration" of column base by the design of the floor. Visible special section of the pillar limiting the number of stiffeners (battens and ribs) - in order to eliminate unsightly, in this case, architectural details

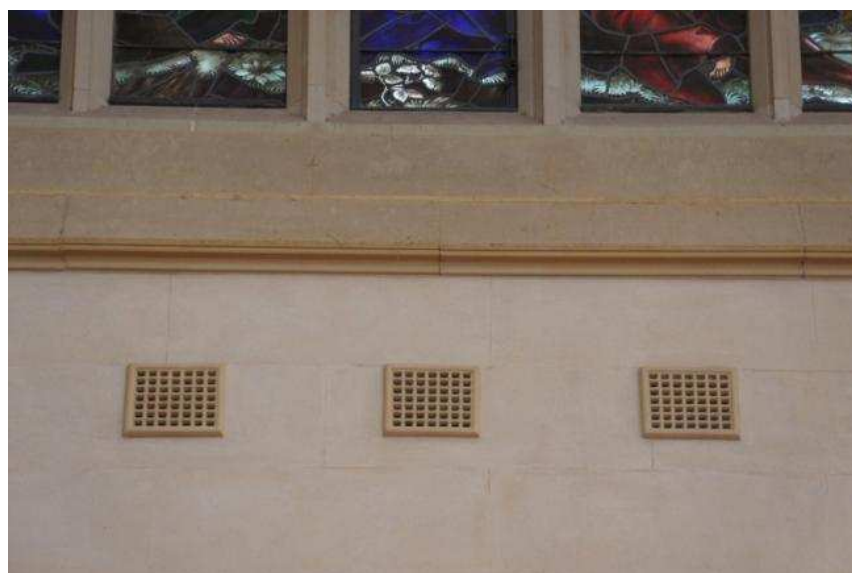
Fig. 8. Detail of the elements of the ventilation system - exhaust grilles. Visible effect of properly chosen elements to the historic character of the cathedral interior

In particular, one performed a complex ventilation and heating systems. The method of distribution of exhaust components was designed in order to not to affect the character of the interior, while maintaining their full capacity. This was achieved by using a specially adapted fitting, both in terms of shape and colour.

In the photographs, listed in figures 7 and 8 one shown an example of the details of used solutions of heating and ventilation systems.

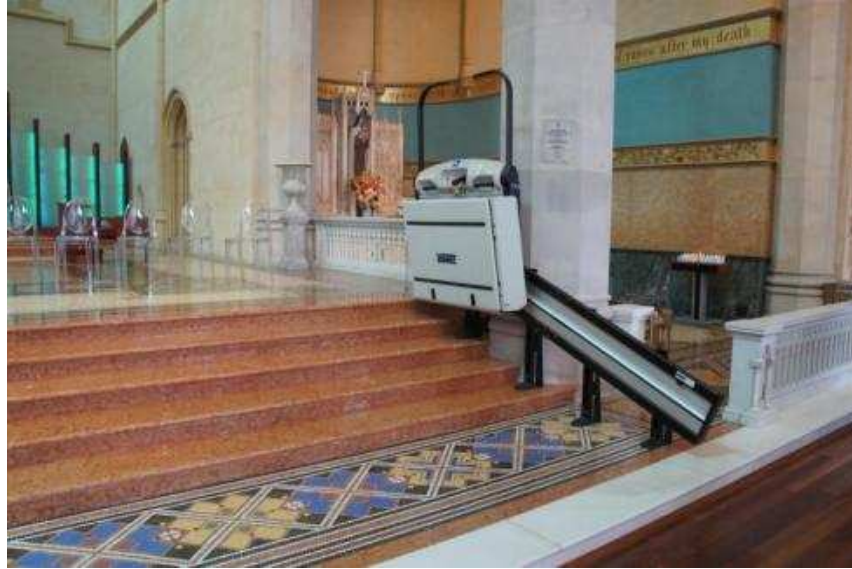
Fig. 10. Example of devices that facilitate the use of sanctuary for disabled and elderly people - ramp that allows overcoming the stairs leading to the altar

An example to facilitate the use of a sanctuary for disabled and elderly people shows the photograph in Figure 10.
