STUDY OF FACTORS DETERMINANT OF SILICEOUS ELECTRICAL PORCELAIN RESISTANCE TO STRUCTURAL DEGRADATION

The subject of this study was investigation of the factors that have a decisive influence on the resistance of siliceous porcelain to degradation processes. There was tested material C 110 type, which is widely used for the production of low-voltage (LV) elements such as insulators and bushings. On the basis of mechanical-acoustic and microscopic research of small-sized samples, which were subjected to compression, there were distinguished successive stages of degradation of the material structure. In the authors' opinion, they have a reference to the ageing process, taking place during many years of work under operating conditions. Thus, it was possible to assess the structural factors that determine the durability and reliability of LV electroinsulating elements. The results were related to electrical aluminous porcelains.

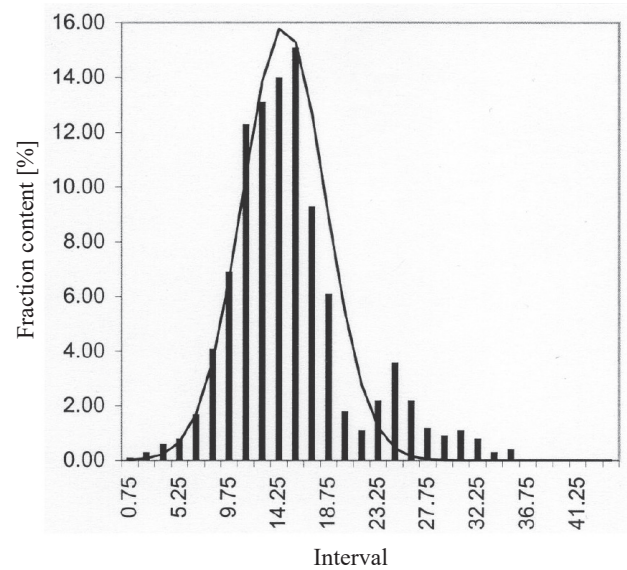
Fig. 1. The size distribution of quartz grains in the tested porcelain. The vertical axis - fraction content in percent, along the horizontal axis - an interval of particle size in microns. The distribution is dominated by two fractions - the size of a dozen or so and 20 - 30 μm . The value of the average is 14.7 μm

The content of quartz was equal to $20 \pm 2\%$. Considering the size of quartz grains – explicitly dominated fraction of dozen or so micrometers, nevertheless a significant part constituted the relics in the range of $20 \div 30$ μm . Figure 1 presents distribution of the quartz grains diameter. Unfavorable phenomenon was the presence of agglomerations of larger quartz grains. Additionally, a significant part of the relics exhibited disadvantageous lamellar morphology. In the structure of majority of electrical porcelains, the quartz phase is mainly responsible for internal stresses and the initiation and development of cracks. This is the basic cause of increasing ageing processes with time passing. Significant part of quartz grains contained cracks and was insufficiently associated with matrix. As a result a substantial part of relics fell out during the preparation of surface of the tested samples.

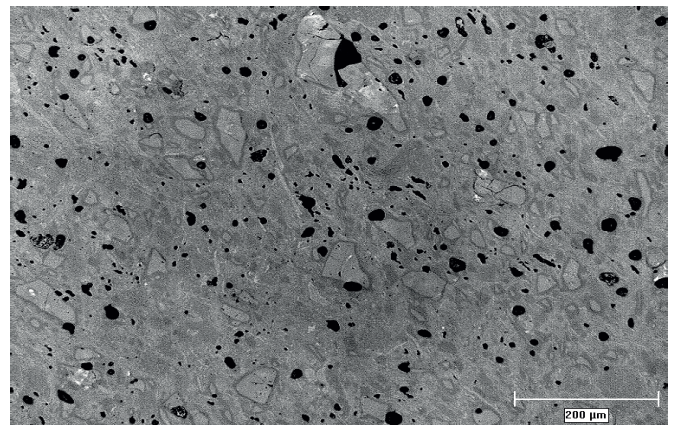
Fig. 2. Image of the microstructure of tested siliceous material, magnification 100x. There are visible brighter quartz relics and darker precipitates of mullite against the background of gray glassy matrix. Black cavities remaining after the crushed out quartz grains occupy about 6% of the surface. Pores are small - a few microns - and cover approximately 0.5%

The content of the glassy matrix was high - as compared to other electrical porcelains, even of the same class. It amounted to $55 \pm 4\%$. A high content of the glassy phase has advantageous influence on the cohesion and bonding of all porcelain phases. The material contained small amount of cullet, originating from grinding media. Electrical siliceous porcelains are characterized by significant diversity, but the structure of the tested material can be regarded as homogeneous and representative. The phase composition was in general typical. In Fig. 2 is presented image of the material microstructure.

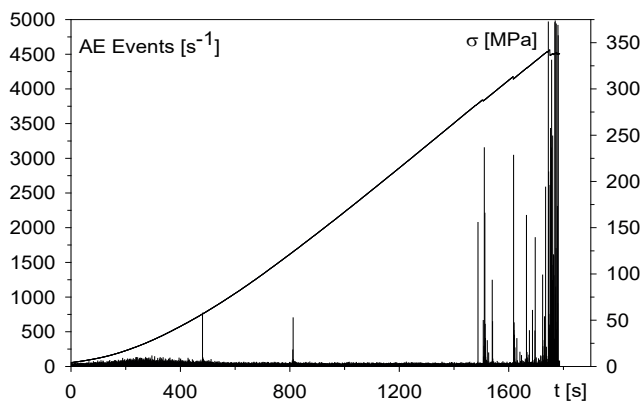
Fig. 3. Mechanoacoustic characteristics of the weakest specimen - compressive strength equal to 342 MPa. Linear scale of AE events

The mechanical-acoustic characteristics of the individual samples demonstrated considerable diversity. Nonetheless, there were recognized characteristic, successive stages of degradation - the preliminary, the subcritical and the last - critical stadium. Figure 3 presents the course of the rate of AE events versus the increase of compressive stress for the weakest sample. Figure 4 represents the rate of events energy of the other specimen.

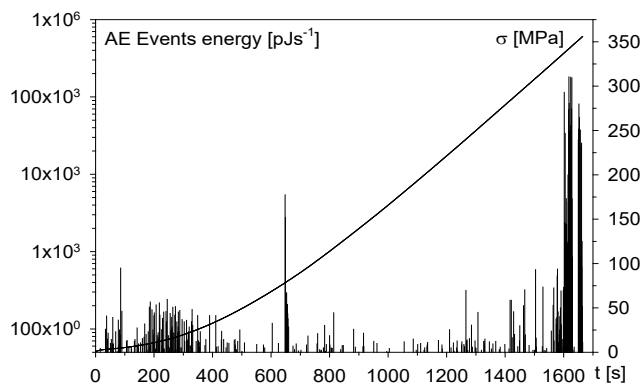
Fig. 4. The rate of events energy in one-second intervals as a function of the stress increase for the sample destroyed at 351 MPa. Logarithmic scale is used for the EA descriptor

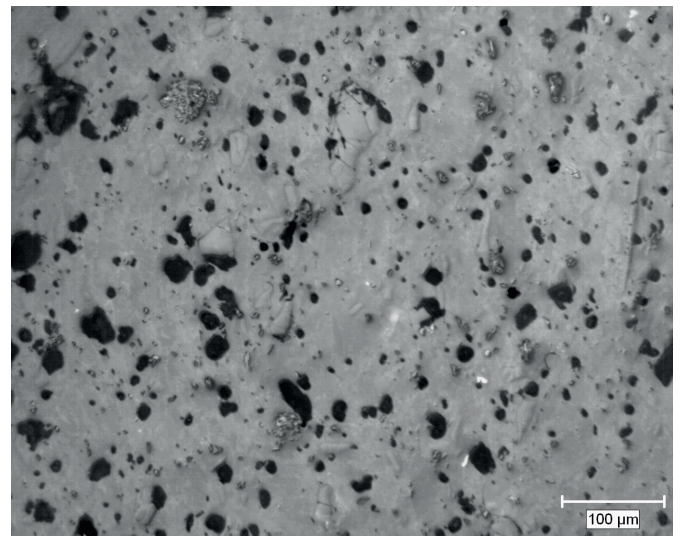
Fig. 5. The structure of siliceous material loaded up to the preliminary stage of degradation, magnification 200x. Numerous damages and crushed out grains of quartz are visible. Dark cavities cover about 10% of the surface

and crushing out of quartz grains was the source of AE signals. This effect referred particularly to the small grains - of the size of several microns. Susceptible to degradation were the grains with a lamellar morphology. The most resistant to failure and separation from the matrix were the grains of a middling size between 20 and 30 μm , distinguished by the regular shape and typical morphology. Besides quartz, there occurred crushing out of almost all particles of cullet. Mullite precipitates were not affected by degradation. They had a coherent structure and were well combined with the glass matrix. Damaged and crushed out elements of the structure covered over 10% of the area of tested surfaces of the stressed samples. In figure 5 is presented material of the sample loaded up to 60 MPa.

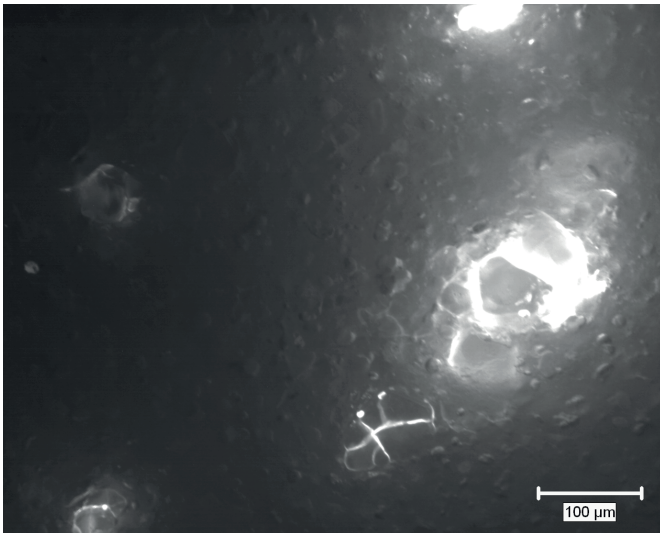
Fig. 6. Microscopic image of the material of the sample loaded up to 387 MPa, in UV light, at a magnification of 200 times. There is visible the area of loose structure - a cluster of large grains of quartz and distinctive grain cracking. Resin with addition of a UV fluorescent was used

Image analysis of the samples loaded up to 285 MPa and 387 MPa showed that further, relatively small degradation - in a wide range of stress - undergoes only the quartz phase. Circumferential and internal cracks are generated and increase in the grains. Thorough examination, using UV light, proved that in the material structure occur centres of cracks. These are the regions of loosened structure - the agglomerations of the larger grains of quartz, which crack with increasing stress and are being separated from the glassy phase. The cracks that can propagate into the matrix are initiated in these regions. These cracks, growing gradually in the matrix, are one of the most important factors in the process of degradation. Their rapid rise takes place during the critical stadium and leads to the sample destruction. Figure 6 presents the area of loose structure - the center of large cracks in the material of the sample, loaded up to 387 MPa.

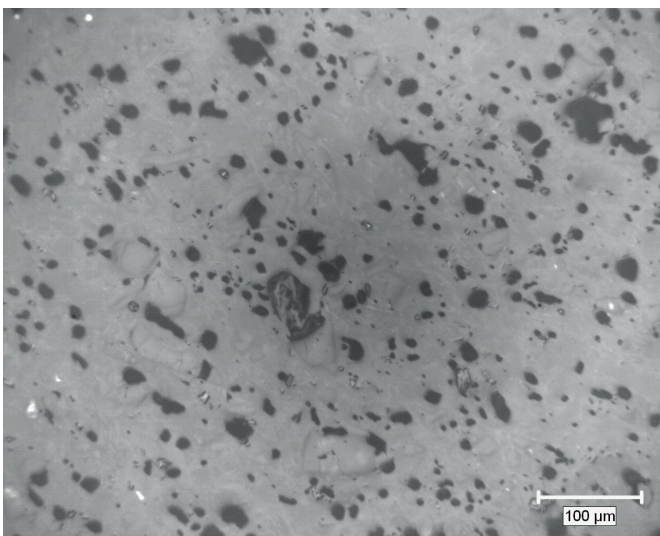
Fig. 7. Microstructure of the sample stressed up to 285 MPa, at a magnification of 200 times. Dark areas representing cracked and crushed out grains of quartz and their fragments as well as cullet fragments comprise above 11%. The mullite phase and the glassy matrix remain unaffected

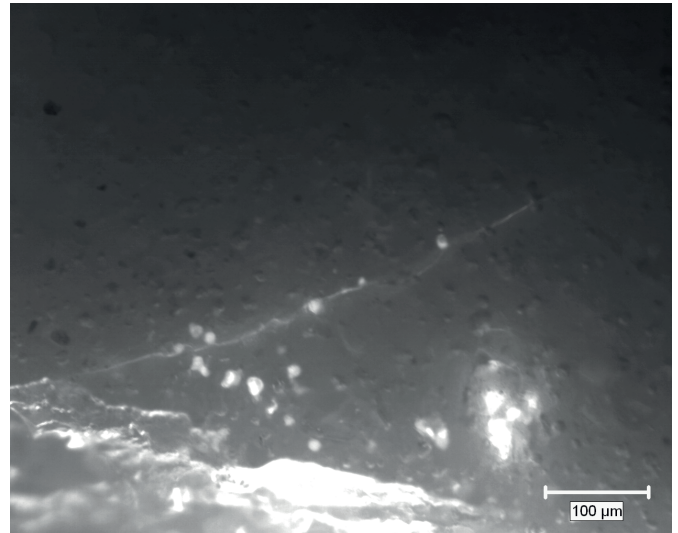
Fig. 8. Microscopic UV light picture of the material of the sample loaded up to 285 MPa, at a magnification of 200 times. The area in the immediate vicinity of the broken off fragment is visible. In addition to cracking, takes notice characteristic area of loose structure at the bottom right of the image. It is clearly visible due to applied resin with added fluorescent agent, visible under UV light

Sometimes, during the subcritical stage, a local fracture and splitting off the corners or even the whole wall of the stressed sample can occur. This effect is followed by strong AE signals, and is visible on the stress increase curves as a characteristic faults (leaps) – Fig. 3. In the vicinity of the broken off portion are then shaped large cracks. However they are typical for the critical stadium of degradation. Figure 8 shows a marginal area of the sample, loaded up to 285 MPa, in the area adjacent to the separated portion of the wall. Visible large cracks are not characteristic effect of the subcritical stage. There is also evident the typical area of loose structure.

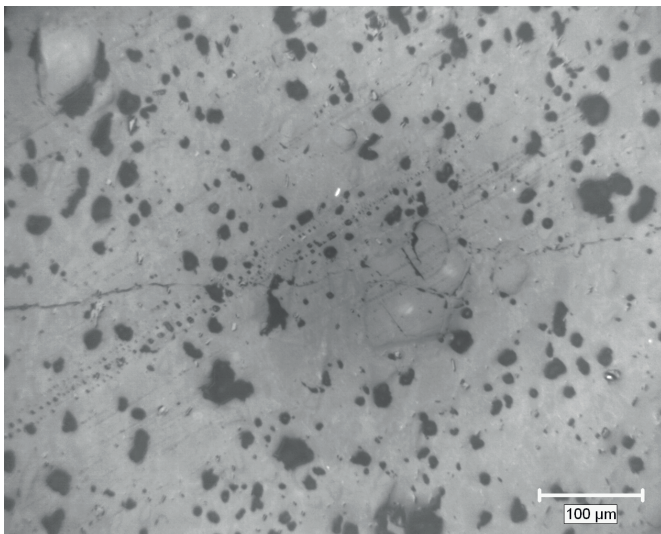
Fig. 9. Heavily fractured microstructure of the strongest sample fraction, at a magnification of 200 times. Separated and crushed out elements of the structure comprise about dozen percent of the surface

In the case of the sample with the highest strength (469 MPa), the agglomerations of the larger grains of quartz, forming a loose structure centers, occurred very rarely. The homogeneity of the material, observed in micro and semi-macro scales, was high. Therefore, the mullite phase distribution was the most advantageous, although very small number of individual crystals of mullite in the glassy matrix – typical for such type materials. This structure showed high resistance to compressive stress, even higher than in the case of the typical strength of aluminous C 120 kind material of the traditional, older type - generally about 400 MPa (in the case of modern material - over 500 MPa) [4]. Figure 9 shows the highly cracked microstructure of the fraction of the strongest sample. Beside the distinctive macro-cracks, plurality of the parallel cracks of the matrix are visible. Characteristic course of the cracking is a reflection of the loading direction.

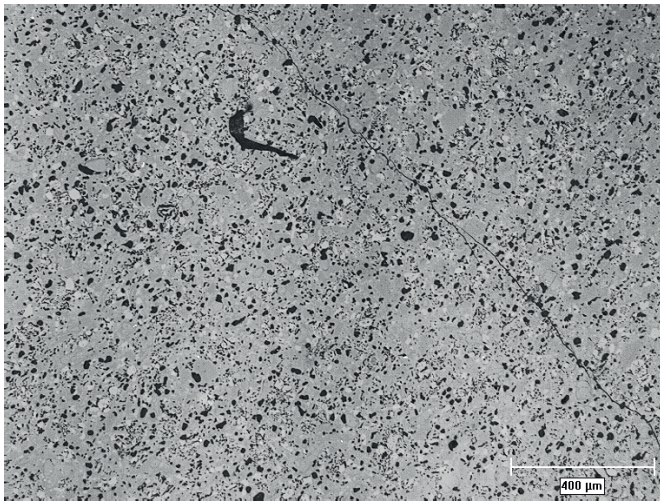
Fig. 10. The image of siliceous porcelain of LV stand-insulator after over 20 years operation period, at a magnification of 50x. Extended crack as well as black slit, elongated in a direction parallel to the axis of the insulator, are visible. There are a lot of micro-cracks within and at the boundaries of the quartz grains. Black areas that remained after crushed out grains of quartz and cullet fragments cover about 10%

Figure 10 presents advanced ageing processes in domestic siliceous material of the LV stand-insulator after over twenty years of exploitation. About 1/3 of initial amount of quartz phase (29 – 32%) were damaged and underwent crushing out during surface preparation. Remaining grains contained microcracks, especially peripheral. Structural integrity were much weakened and there were found elongated, nearly critical cracks propagating throughout all phases of the material and only deviated by precipitates of mullite.

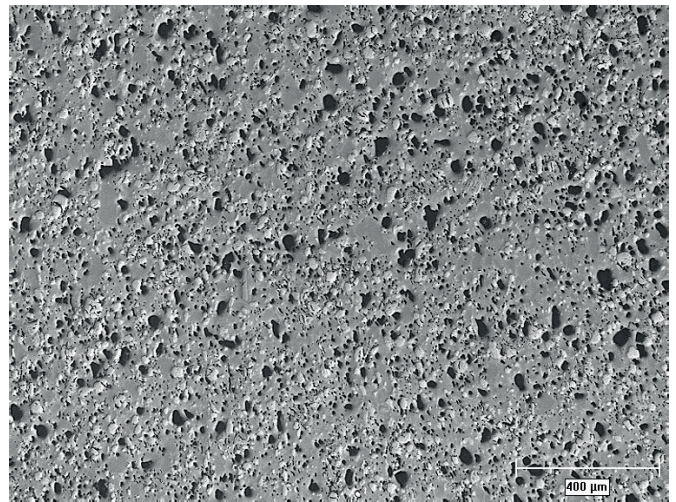
Fig. 11. The image of C 120 type porcelain of HV line insulator after about 30 years operation period, at a magnification of 50x. The effects of the degradation of the structure appropriate to the subcritical stage, with a high degree of advancement. Over 1/3 of the quartz grains (nearly 9%) was separated and crushed out from the structure. In the vicinity of the relics of quartz are present numerous micro-cracks in the glassy matrix

disintegration. In figure 11 is presented typical image of aged aluminous material of domestic line insulator after about 30 years operation period. Advanced degradation processes are visible. They are a consequence of high and diversified amount of the quartz phase in the material structure - initial average content 24%. This phase was the main source of internal stresses, initiation and growth of micro-cracks.
