Pictures from the past. Adapting a historical building of a former armoury into an exhibition and education center for the Museum of Photography in Kraków

The article presents an example of the adaptation of the former armoury building into a museum of photography, in which, despite a relatively large interference in the existing structure, it was possible to retain the character of a monument.

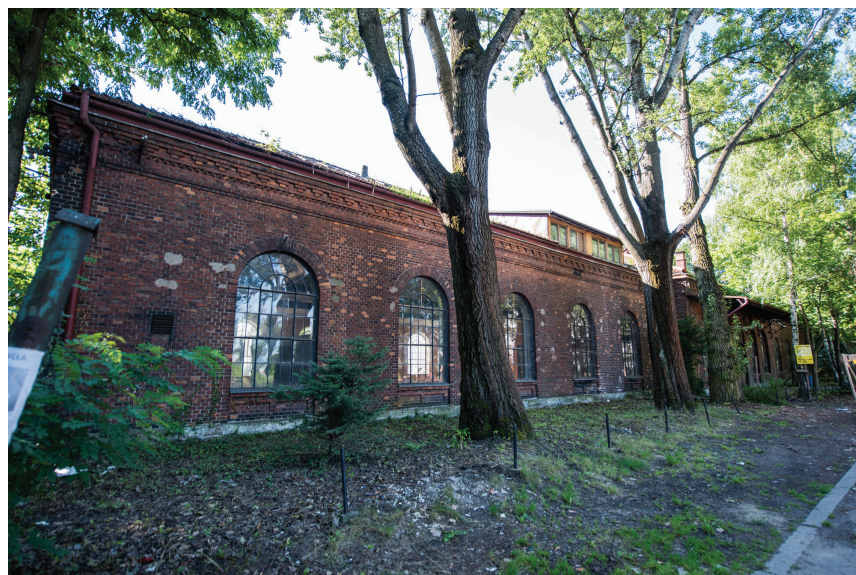
Il. 1. Initial state – exterior (author of photography: Marek Pabich)

it was planned as a single-storey building with a roof void, covered with a hipped roof and without a basement (il.1.). The armoury was built of solid ceramic bricks on a rectangular plan measuring 79.07 x 20.67 metres with a central risalit. The roof had a wooden roof truss system made of purlin and tenaille supported on wooden columns and covered with ceramic tiles. Klein's ceilings were used over the ground floor in the form of segmental brick vaults supported on steel beams and columns (il.2.). Steel mullioned windows have been preserved in the building. The building was listed in the register of historical monu-

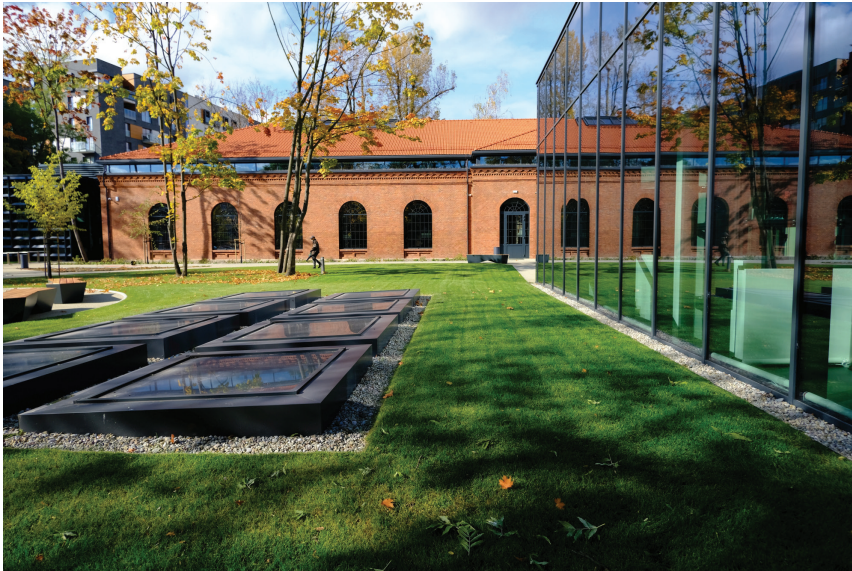
Il. 5. Building after adaptation – skylights integrated into the garden area (author of photography: Zofia Kazimierak-Piotrowska)

The building has also been enlarged by an underground part, which houses conference rooms and a cloakroom. This underground extension made it possible to create an additional usable space without interfering with the structure of the historical building. The only factor which indicates the presence of the basement from the outside are rectangular skylights integrated into the garden area. (il. 5.)

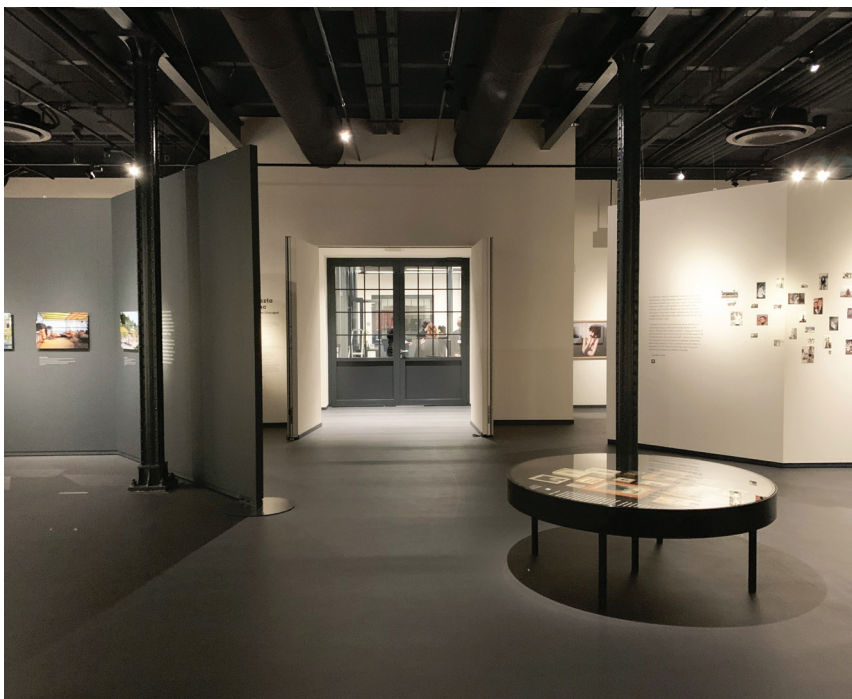
Il. 7. Building after adaptation – interior (author of photography: Marek Pabich)

The existing rooms on the ground floor were adapted mainly for exhibition purposes. The open spaces with a symmetric column grid create optimal conditions for exhibiting pieces of art. Even after the adaptation of the building, the interiors retained their original character. The existing columns have been renovated, whilst the segmental vaults has been left exposed, which allowed historical interiors to directly juxtapose with the exhibited photographs (il. 7.).
