THE IMPULSE CHARACTERISTICS AND ELECTRIC STRENGTH OF VARISTORS PILES DEPEND ON GEOMETRY OF THE ELECTRODES

Electrotechnical Institute Division of Electrotechnology and Materials Science, Wrocław

Abstract. The paper describes the results of the impulse characteristics and electric strength measurements of the pile of varistors with modified side surface. Basing on the impulse voltage tests on the surge arresters it was found that one of the reasons of the failures of these devices may be the surface discharge at the varistor - insulating housing phase boundary, through the gas between them. Flashover voltage of power protecting systems can be increased by applying of semi - conducting covers which will carry away the generated surface charge and uniform the distribution of electric field on material surface. Comparing two types of electrodes configuration on varistors, it was found that systems without gap between electrode and side surface of varistor exhibited higher values of withstanding voltage whether their side surfaces were covered or not covered with insulating or semiconducting layer.

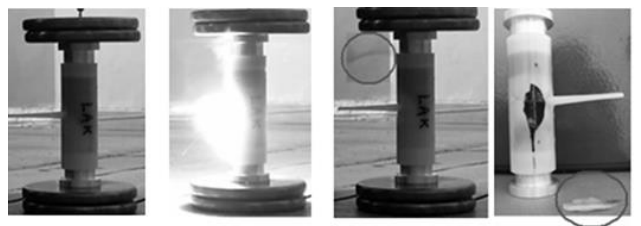
As a result of the air gap formation during the further testing the surface discharges may occur at the phase boundaries (Fig. 3).

Fig. 3. Surface discharge on the surge arrester and damage of the polyamide housing [6]

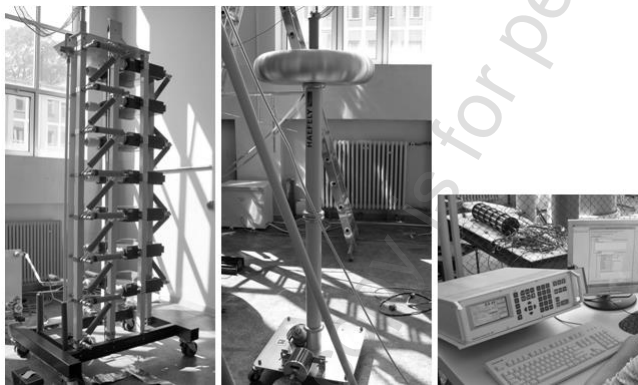
The high voltage tests were carried out using the HAEFELY 700 kV, 35 kJ generator and the measuring system is shown in Fig. 5. Normalized impulses 1.2/50 μ s were applied across the varistor electrodes. Flashover voltages were recorded by the control – recording system of the generator.

Fig. 5. HAEFELY generator and measurement system

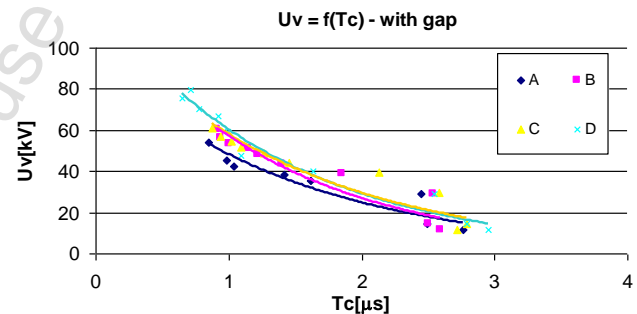
The impulse characteristics were determined and are showed in Fig. 7 and 8. On the basis of this characteristics one can determinate which electrode configuration and materials create more or less uniform system.

Fig. 7. Impulse characteristics for the waveforms with gap between electrode and side surface of varistor. A – sample with semiconducting layer $10^{14} - 10^{15} \Omega$, B – sample without cover, C – sample with semiconducting layer $10^{11} \Omega$, D – sample with semiconducting double layer $10^{11} \Omega$

Impulse characteristics confirm that the varistors pile without gap between electrodes and side surface of the varistor is characterized by higher electric strength made a system with much more uniform electric field distribution.
