EFFECT OF WIRE MATERIAL PROPERTIES ON WIRE ROPE USE

The objective of the paper is to present the results of material tests on steel rope strands operated in the design systems of the basic machines used in surface mining. The presentation is focused on the ropes used in bucket wheel excavators (BWEs). These are the basic machines in surface mines and their proper operation is highly important in ensuring continuity of mining. The authors present the results of material tests on the basis of which the conclusions were drawn about the quality of the production of steel wires that affect the rope use process.

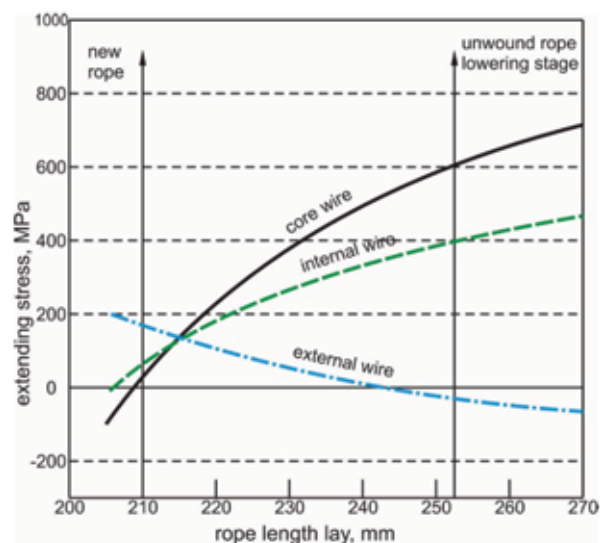
Fig. 3. Expanding stresses in rope wires dependent on change in rope lead

The cyclic change in the lay length has, therefore, a significant impact on the formation of local fatigue failures. The change in the lay length in a given branch is dynamic and results from the scope of operation of the pulley system. This lay length leads to local damage in the sections with the greatest change in the lay length [5]. In consequence of the mechanism that adds variable shear stresses, this factor has a significant impact on fatigue durability due to the change of lateral rigidity. The extension of the lay length causes the gaps between the strands to decrease and the rope rigidity increases. Such a change in rigidity increases the values of stresses from bending. The shortening of the rope lay length causes the destruction of the rope core and the increase of stresses from tensile forces in the rope wires as shown in Figure 3.

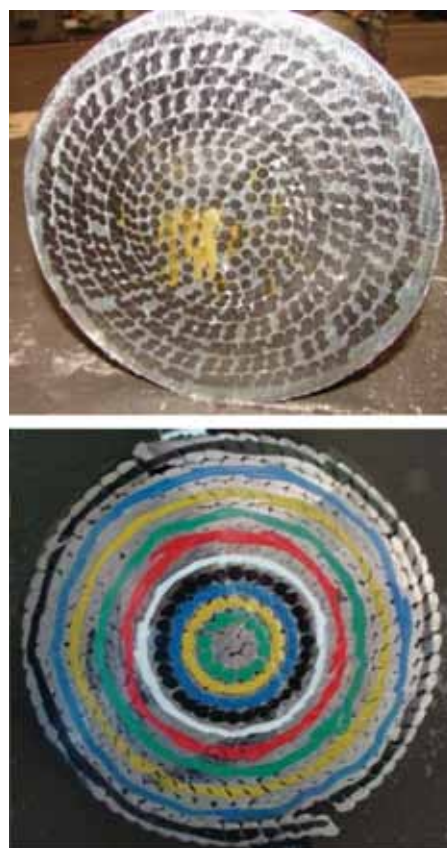
Fig. 6. The stay rope cross sections: after cutting off the thimble (left) and with the marked layers of wires to be included in the testing (right) [9]

The provided sections were prepared for strength and metallographic tests. It is interesting to note that, during these works, the rope design was found to be different from the entries in the documentation of the machine from which they were removed. The stay ropes used in the bucket wheel excavator featured different diameters of round wires, different heights and widths of shaped wires, as well as one layer of wires less than specified in the documentation. These structural parameters have a fundamental impact on the transverse rigidity of the rope and its flexibility. In this case, these parameters were changed to a substantial extent, which could have affected the premature rope replacement. During the preparation of the samples for the testing, each layer of wires was labelled as shown in Figure 6. It was also found that there was excessive elastic energy, as apparent from the “broom effect” shown in Figure 7.

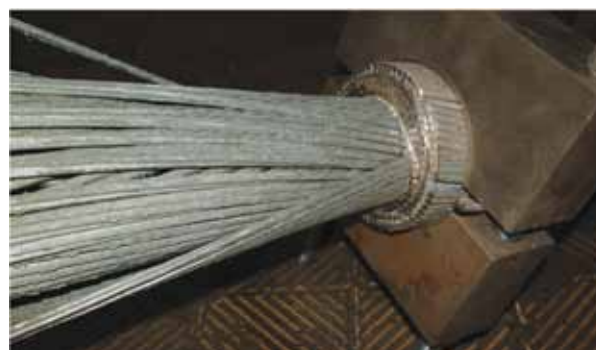
Fig. 7. The “broom effect” after cutting off the layers of the wires [9]

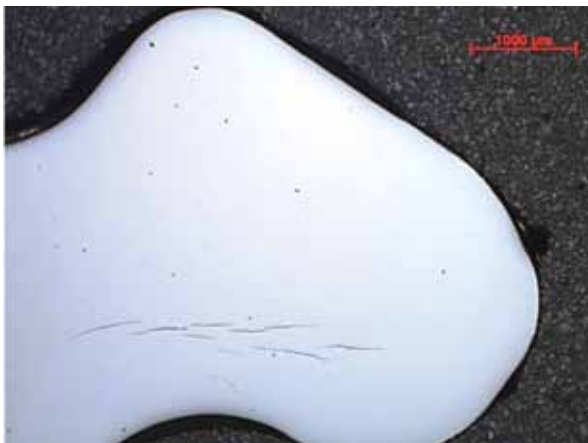
In Section 6, numerous cracks and tears were observed in each layer examined. Fig. 8 presents the microstructure of the breakthrough for a torn sample from Section 6 in the layer of shape wires. The observed fractures were partial in the wires with a circular cross-section and similar in shape to the letter Z (Z wires).

Fig. 8. Crosswise cross-section of the shape wire with visible micro cracks [11]
