ADAM KANCIRUK\*

**INVESTIGATING THE IMPACT OF TEMPERATURE CHANGES, MATERIAL AGING,  
AND SERVICE LOAD ON THE STRAIN OF A REINFORCED CONCRETE CONSTRUCTION****BADANIE WPLYWU ZMIAN TEMPERATURY, STARZENIA MATERIAŁU I OBCIĄŻEŃ  
EKSPLOATACYJNYCH NA ODKSZTAŁCENIA KONSTRUKCJI ŻELBETOWEJ**

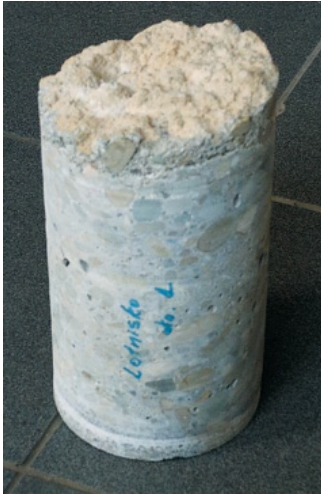
Fig. 1. A sample of the hangar slab

The hangar is a hall whose dimensions are  $84 \times 42.5$  m. It is surrounded by maintenance rooms on three sides. Thus, it can simultaneously store two aircraft of the size of Airbus A320, or Boeing 737. The airport management decided to modernize the hangar so that passenger aircraft (mostly of the type specified above) could be serviced there. The hangar slab was designed with the assumption that it would support fighter planes whose take-off weight does not exceed 9,100 kg (MiG-19). The weight of an Airbus A320-type aircraft (without passengers, cargo, and fuel) is 42,400 kg (*A320...*), so it exceeds the aforementioned limit several times. Five samples of the slab were collected so that its strength could be determined (at least approximately). The diameter of this cylindrical samples was  $122 \div 125$  mm. Figure 1 shows a photograph of one of the samples.

The collected samples were not homogenous. They contained the upper, hardened layer of the slab (visible in the lower part of the photograph). They also differed with respect to their height, which meant that the thickness of the slab was not the same in every spot. For the purpose of the research, three samples were chosen, after prior preparations. Their size corresponded to the requirements of the norm (PN-EN 12390-1, 2002). Then, the strength of the samples was tested in accordance with the norm (PN-EN 12390-3, 2002). The tests were carried out by means of the Instron 8500 test machine, used for testing brittle materials. The determined values of the three samples' strength under uni-axial compression ( $R_c$ ) were: 79, 29, and 30 MPa. Varied slab thickness, significant differences in concrete strength, and, above all, the damages to the slab resulting from the wheel load (Fig. 2) – these were the reasons for which it was decided that the hangar slab would be replaced, at least partially.

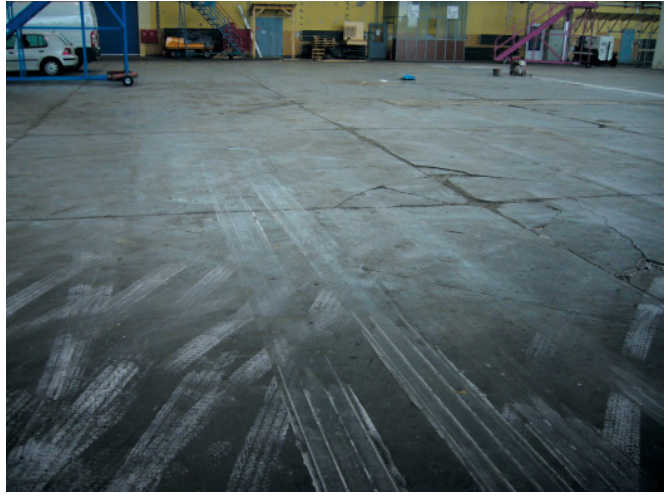
Fig. 2. The hangar slab with visible damages

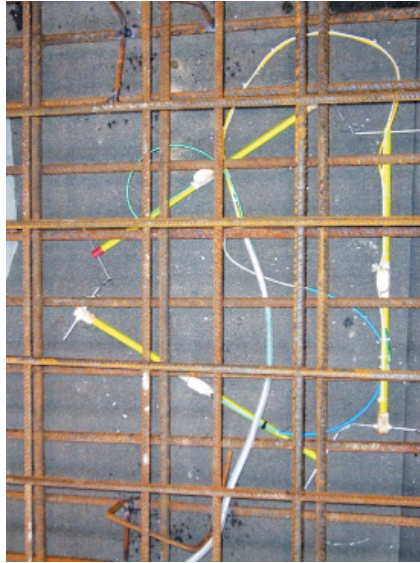
Fig. 4. A rosette installed in the area of the load of the wheels of the main left leg

For the purpose of the measurements, 9 vibrating wire strain gauges (Kanciruk, 2012, p. 61) were used, as well as 3 thermistors for measuring the temperature of the reinforced concrete, and 2 electronic meters – data loggers (Kanciruk, 2012, p. 91). The electronic meters were also equipped with thermistors for measuring the temperature of the air inside the hangar. Vibrating wire strain gauges were arranged in the shape of three equilateral rosettes. Each of the rosettes was inserted into the slab, 4–6 cm above its bottom surface (adjoining the separating layer), in the spots for which the maximum load was predicted – i.e. under the wheels of the landing gear of the serviced Airbus A320 aircraft (Fig. 4).

colorful pieces of cloth which were put on the wires (Fig. 4). Accordingly, on the graph below, the curves representing the measurement data obtained by means of these strain gauges have adequate colors. Figure 6 presents the values of the strain calculated on the basis of the readings displayed by particular strain gauges of the left rosette.

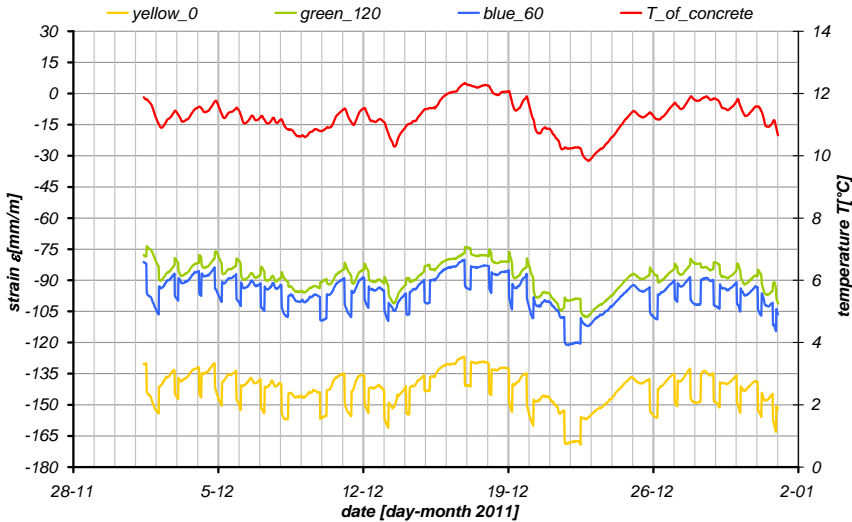
Fig. 6. The left rosette. The values of the strain calculated on the basis of the readings of particular strain gauges (the „yellow”, „green”, and „blue” one); the temperature of the bottom layer of the slab (concrete temperature). December 2011

As illustrated by the graph, all the strain gauges react to changes in the temperature of the concrete, and to service load. Every time an aircraft is moved into or out of the hangar, the strain of the slab changes suddenly. With a special software, these strain values can be established and, on their basis, the values of the main strains and their directions can be determined. Figure 7 presents the calculated values of the main strains for each situation when an aircraft was stationed in the hangar in December 2011.

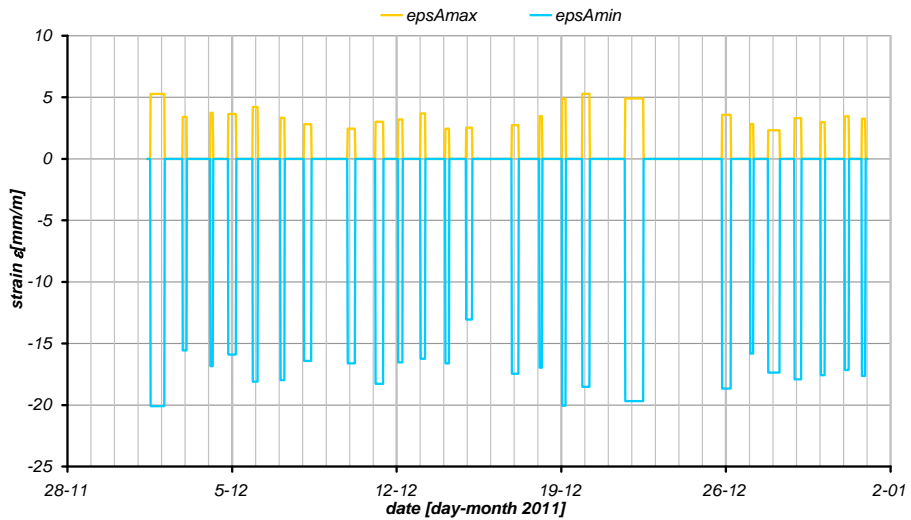
Fig. 7. The left rosette. The values of the main strains: the maximum (*epsAmax*) and the minimum (*epsAmin*) ones, caused by the aircraft load to the main slab. December 2011

The compressive strains  $\varepsilon$ , measured with the rosettes located in the vicinity of the spot where the load from the wheels of the main legs is exerted, reached the values of ca. 20  $\mu\text{m}/\text{m}$  (Figs 5 and 7). In order to evaluate the tensile strains occurring in the spot of the wheel load, a computer simulation was performed (Kanciruk, 2012, p. 183). From the results of the simulation, one can infer that the value of these strains is even 12 times greater (module-wise) than the measured compressive strains, and exceeds 240  $\mu\text{m}/\text{m}$ . The tensile tests performed on the concrete samples (Kanciruk, 2009, p. 126) indicate that the modulus of elasticity  $E$  of the concrete of the same class as the concrete used to build the hangar slabs is ca. 30 GPa, and its strength  $R_r$  slightly exceeds the value of 3 MPa. Thus, the maximum tensile strains of the concrete in the spot with no access for observation:

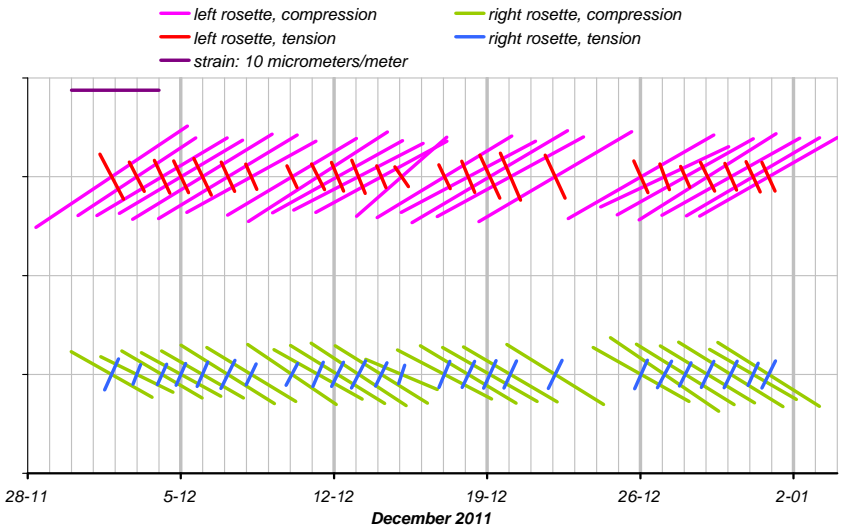
Fig. 10. The main strains of the constituent slabs making up the main slab, in the spots where the rosettes were located, for each case of stationing an aircraft in the hangar in December 2011

After adding the time axis to Figure 9, and removing the aircraft outline, the lines representing the slab edges, and the gate, we obtain a simple timing diagram depicting the values and directions of main strains, calculated on the basis of the readings of strain gauges in both rosettes (Fig. 10). The diagram takes account of all the cases of stationing an aircraft in the hangar in December 2011. The spots where the pairs of segments cross correspond (time-wise) to the midtimes of the periods of aircraft stationing in the hangar.

Just like in Figure 10, the diagrams were created for each consecutive month of the observation process, from June 2011 to April 2014. Measurements of the slab strains are still being performed.

The graph in Figure 10 represents the strains of the slabs at the time when these strains reached the maximum values, module-wise. Figure 11 shows the values of the strains for all the cases of stationing aircraft in the hangar. It can be seen that, during the first six months of exploiting the hangar, the values of the strains tended to rise module-wise. Subsequently, they tended to decrease, which would ultimately result in a state of stability. Surely, there may be several factors that explain why the values of the strains change, and why they reach stability. One of them is the fact that the foundation of the slab subsides. However, particular attention should be paid to another potential reason, i.e. the fact that an airport apron, whose area is 11 ha and thickness is 30 cm, was built in the vicinity of the hangar. The weight of the airport apron has probably caused groundwater to migrate, which resulted in an increase in humidity and bearing capacity of the ground underneath the hangar. This seems to be confirmed by the increased flooding of the so-called manholes in the hangar, as well as by slight upthrusts of the slab along the gate.

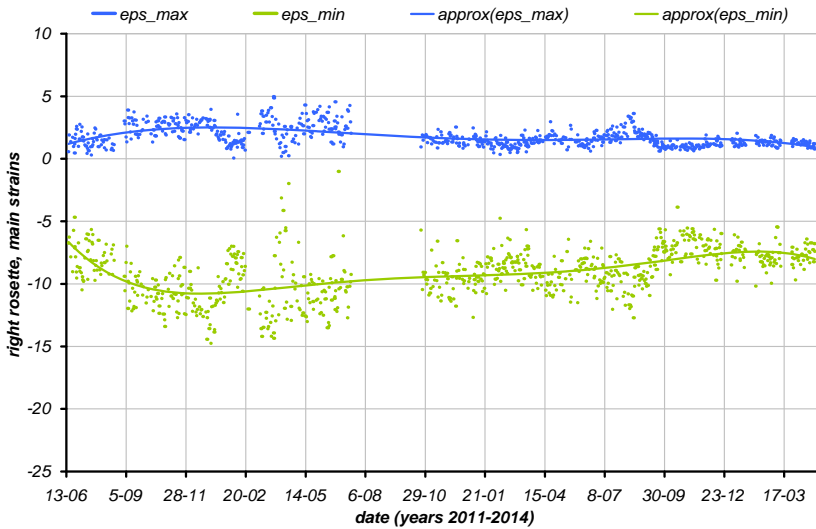
Fig. 12. The right rosette; a tendency towards change revealed by the values of the maximum (*eps. max*) and minimum (*eps. min.*) strains, for all the cases of stationing aircraft in the hangar
