A HISTORIC RUIN – INTERVENTIONS AND THEIR CONDITIONS

MOLSKI Piotr ¹

ABSTRACT: The effective protection of historical ruins, just as of other monuments, depends on their contemporary use. Adaptation of ruins to utilitarian standards requires preventive and preservative conservation, but also architectural interventions necessary for new functions. The principles of dealing with ruins were included in the Charter of Historical Ruins adopted by Polish National Committee ICOMOS in 2012.

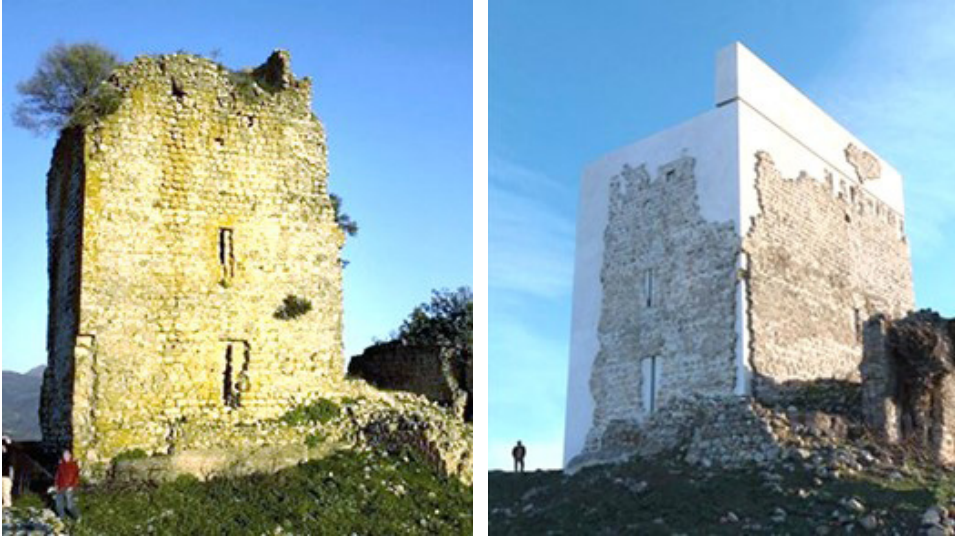
Fig.1 Castillo Matrera, ruins of the tower before and after the transformation;
source: <https://www.medieval.eu/matrera-castle-vilharigues-tower/> - DOA 20.10.2020

The transformations were aimed at stopping the progressive destruction of the ruins by consolidating them while restoring and authenticating some of the tower original (Fig. 1).

The completed fragments of the tower were covered with lime plaster referring (according to the author of the project) to the authentic details found on the spot. The consolidation additions are clearly distinguished from the historic fabric and structure, dominating over their remains - mainly due to the contrasting colors. The regular form has changed the previous exposure of the ruin in the landscape. In further view openings authentic fragments of the tower lost their legibility, and the existing ruin of the castle is perceived as a fragment preserved in its entirety, regular in form. The effects of consolidation are not always determined by their scale in relation to the authentic fabric.

The regularity of the form and material characteristics created as a result of consolidation may dominate the historical destruction, even to a small extent. The framework of minimal interference was exceeded and was subordinated to making the tower's shape and form more legible. The additions with contrasting white plaster meet the condition of distinguishability from the authentic tissue, although the composition and color coherence of the whole raise doubts. The aesthetics of the rear exposition of the ruin leaves much to be desired. The consolidation transformations, in principle, are irreversible. Reduction of the contrast between the new restorations and the authentic tissue is possible due to the long-term aging process of the material used for the consolidation.

Type of intervention: consolidation of fragmentary preserved walls to ensure the stability of the ruin through restoration - without introducing a functional programme.

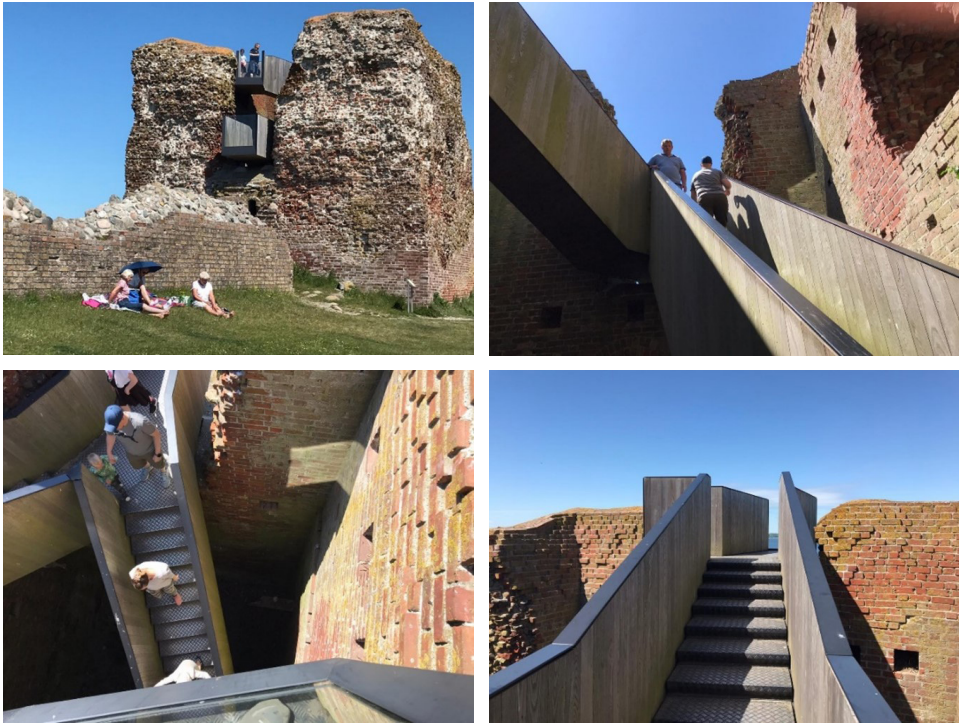
Fig. 2 Kalo Castle – a ruin with an addition; photo by the author

The aim of the intervention was to make the ruin safely accessible for tourists, providing exposure of the interior of the ruin and external viewing openings, including the well-defined outline of the outer castle walls (Fig.2).

Stairs leading to different viewing levels were introduced into the interior of the ruin, based on a steel frame with structural supports at four points. Their design does not dominate the ruin. The wood and steel stairs have contemporary, ahistoric features that clearly distinguish them from the historic fabric and structure. Located inside the ruin, the structure does not interfere with the external perception of the ruin.

In further exposures, the view bridges are not legible, thus ensuring that the existing exposure in the landscape is fully preserved. The structural independence of the addition fully respects the principle of minimum interference and reversibility of transformation.

Type of interference: architectural additions in the form of small architectural items allowing safe exposure of the interior of the ruin and use as a viewpoint.

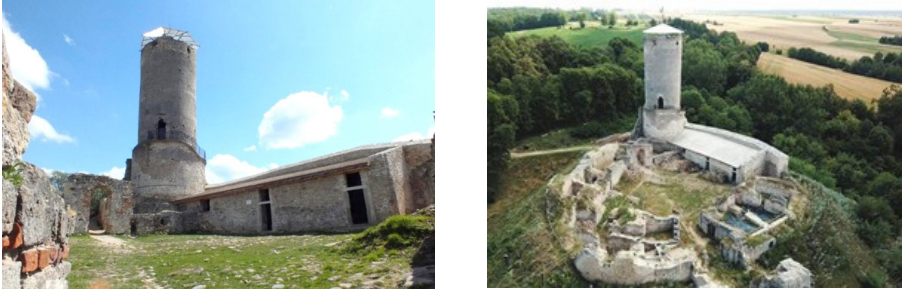
Fig. 3. Ilza, additions to the castle ruins; source: 3a.- <http://www.ilza.turystyka.pl/zamek-w-ilzy/> 3b.- <https://plus.echodnia.eu/radomskie/tajemnice-naszyc-zamkow-ilza-wideo-zdjecia/ar/13341797>, DOA: 20.10.2020

The interventions were aimed at ensuring the structural stability of the tower, safe access for tourists to the scenic exposition from its top storey and providing the ruin with a usable cubature (Fig. 3).

Inside the tower, reinforced concrete ceilings were made to strengthen and at the same time stiffen the structure, as well as additional bracing elements in the form of peripheral reinforced concrete towers. An external spiral staircase was added as well as a contemporary roofing on the top floor of the tower, protecting its crown from rainfall. The usable cubature was added to the reconstructed wall in the courtyard.

The additions did not dominate the authentic fabric, although the form of the roofing of the tower's crown is questionable. The added pavilion, using a building material reminiscent of the authentic one, differs from its historic surroundings in that it is not in a state of disrepair. The ahistoricity of the pavilion is evident in the form of its mass and the features of its canopy visible from the top of the tower. The pavilion, hidden behind the wall, does not affect the external, existing exposure of the ruin. The landscape exposure was preserved with a slight disturbance of the regularity of the reconstructed fragment of the wall. The solutions that stabilize the construction of the tower according to their purpose are not reversible.

Type of interference: consolidation of the ruin by structural reinforcement of the vaults, ceilings and walls associated with the provision of rooms; addition of a small volume object and small architectural elements allowing the use of the ruin.

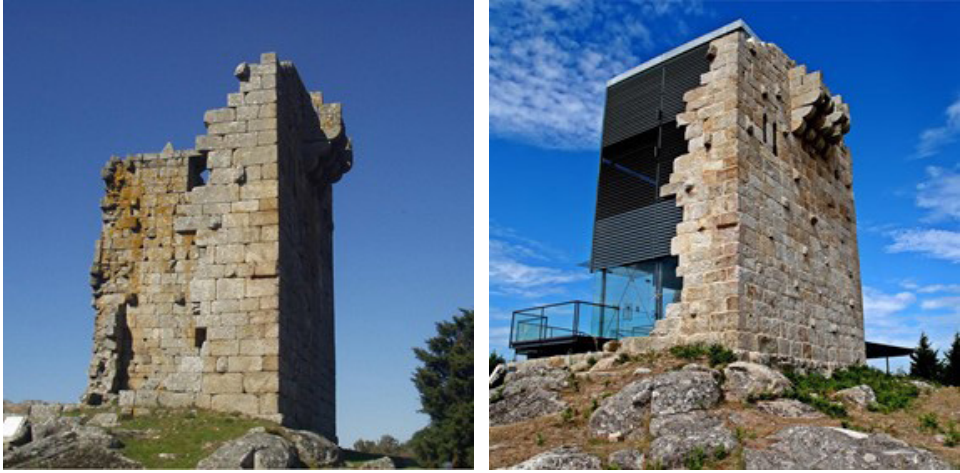
Fig. 4 Torre de Vilhariques, tower ruin before and after transformation, source: <https://www.medieval.eu/matrera-castle-vilharigues-tower/>

The aim of the intervention was the structural stabilization of the preserved fragments of the tower and the introduction of useful cultural and exhibition functions into the ruin (Fig.4).

An ahistoric metal and glass construction with a division into three storeys was inserted into the original interior of the tower with partially preserved walls. Despite the scale of the addition, the balance between the new structure and the historic fabric was maintained. The materials used in the restoration clearly distinguish it from the historic fabric and structure. The main, previous landscape exposure of the ruin from the side of the city did not change.

The juxtaposition of the contemporary architectural detail of the restoration with the stone relics of the tower ensures the legibility of the ruin in its close exposure from the side of the unpreserved fragments. Despite the transformations, the significance of the ruin in the landscape has been maintained. It can be assumed that the interference in the historic fabric is minimal, and the transformations made are reversible.

Type of interference: ahistoric, cubic architectural addition to the ruin with the introduction of a utility program into the ruin.

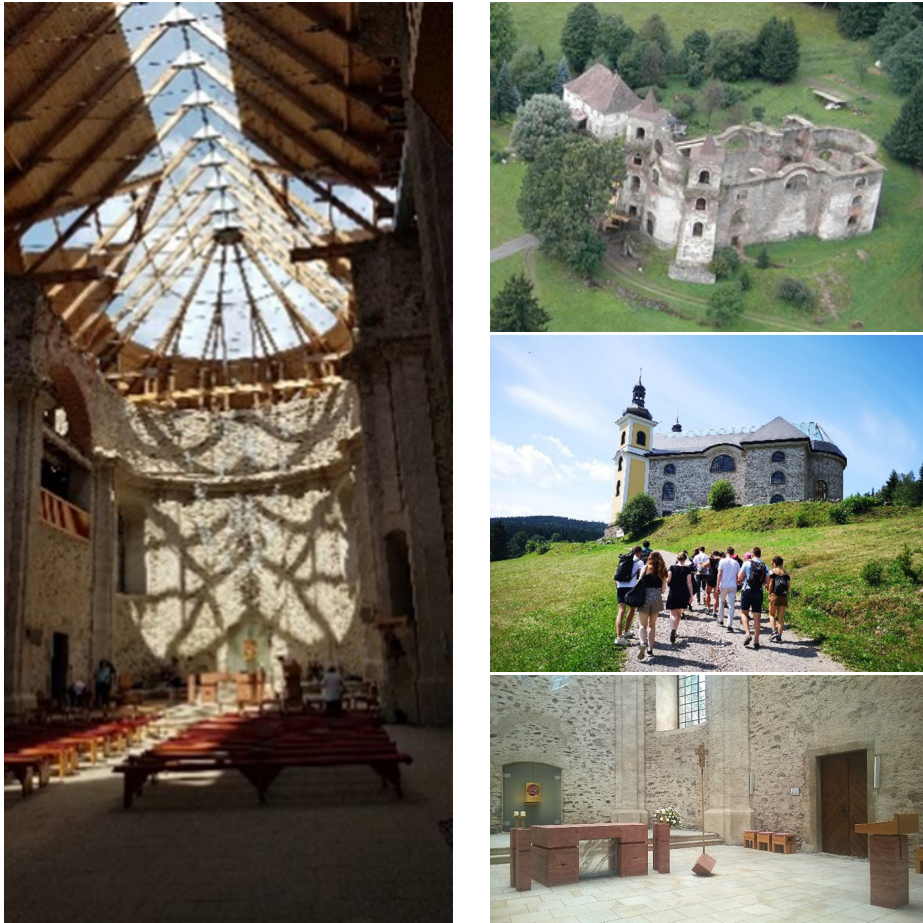
Fig. 5 Church of the Assumption of the Blessed Virgin Mary, Neratov; source: 5a neratov.cz; 5 b-d photo by the author

The aim of the works was to secure and stabilize the ruin with simultaneous restoration of its historical function and extension of its cultural functions (Fig. 5). The ruin was cleaned, conserved, and covered with a glulam construction with a cross-shaped glass roofing section to protect the authentic fabric from weathering and to allow year-round use of the interior. The new roof addition does not dominate, but at most is in balance with the preserved perimeter walls of the church. The unambiguously contemporary design of the roof and its glazing emphasises the authenticity of the church walls in the interior, reinforcing their exposure with natural light that changes throughout the day.

The new, minimalist interior design emphasizes its added value to the historic ruin. Covering the ruin with a roof was equivalent to recreating the original body of the church in the landscape. The location of the church on a hill means that the external views are dominated by the walls of the ruin, while the new roofing is almost invisible. The exterior faces of the walls have been restored, which is a significant departure from the principles set forth in the Charter. This has caused the ruin to lose its genetic characteristics and cease to be perceived in the landscape, as opposed to the interior, as a historical destruction.

The transformation of the spatial structure of the ruin can hardly be defined as minimal interference. This condition is fulfilled by the approach to the interior of the ruin - the conservation of the inner face of the walls, the protection of the crown of the walls and its adaptation to the fixing of the roof structure. Reversibility of transformations is possible, but not justified.

Type of intervention: restoration in place of the unpreserved cubic fragment of the building to authenticate its original mass and restore its original functional potential.

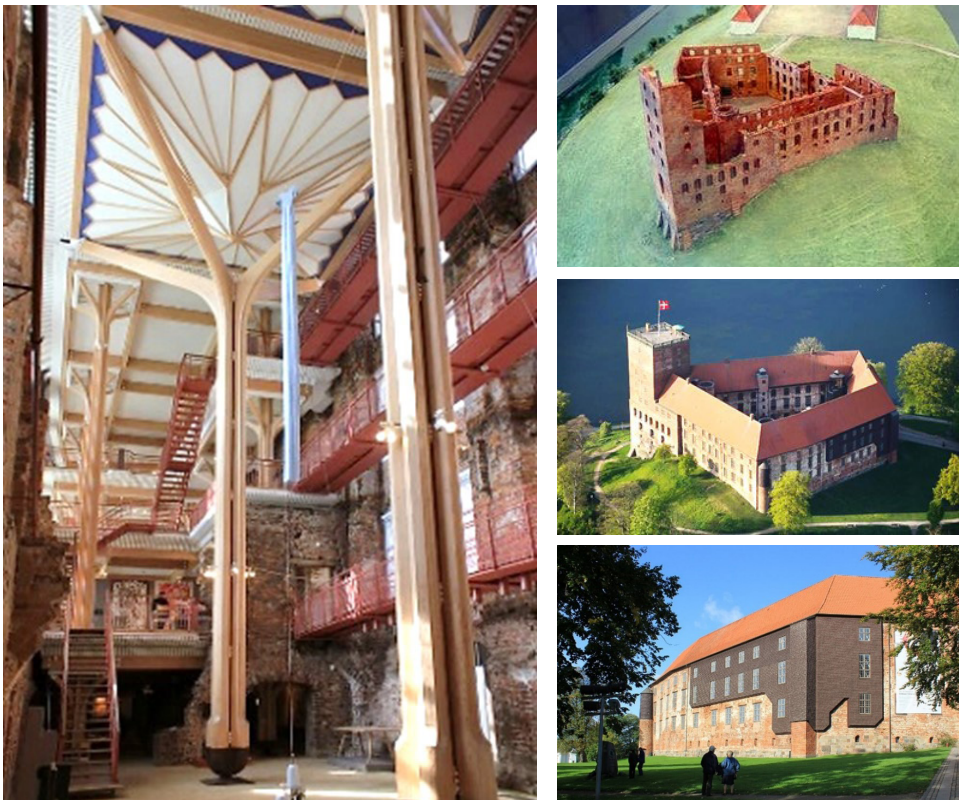
Fig. 6 Koldinghus – castle ruins after restoring its original shape and form; source: <https://www.ubc.net/content/koldinghus>; <https://pl.qaz.wiki/wiki/Koldinghus>; DOA: 20.10.2020

The aim of the works carried out was to secure and stabilise the ruin with simultaneous adaptation for cultural and exhibition functions together with reconstruction of the castle (Fig.6).

The ruin was cleaned and conserved while preserving the authenticity of the ruins. In places of unpreserved fragments of the building, additions were made to recreate the original shape of the castle and to restore the elements of the interior to their original functional potential. On the new foundations inside the ruin, pillars made of glued laminated timber were erected to support the roof, mezzanines and suspended footbridges. Non-preserved fragments of walls were supplemented with light wooden walls suspended on the roof structure with external cladding of oak shingles and contemporary brick. The additions to the body of the castle - the defects in the

walls and the unpreserved roof - did not dominate the authentic fabric. There might be doubts about the architectural form of the pillar structure, which with its aggressiveness dominates in the interiors, while the preserved walls form the background for the bold architectural creation. The distinctness of the preserved original remains has been fully maintained. The additions made are clearly distinguishable from the historic fabric and structure. A significant effect of the transformation is the reconstruction of the castle's mass in the landscape with the legibility of its authentic remains. Thus, the object lost the features of a historical ruin exposed in the landscape - which is a significant departure from the Charter's provision. However, this does not change the fact that its documentary significance has been maintained.

The independence of the construction of the additions in relation to the surviving fragments of the castle meets the condition of minimal interference in the structure of the monument, and its theoretical - in this case - reversibility.

Type of interference: introduction of contemporary additions in the places of the unpreserved fragments of the building in order to authenticate its original form and restore its utility potential.
