Historical Architectural Detail in the Landscape of the 21st Century on the Example of the Train Building Development of Opole Silesia

Marek Konopka

The Faculty of Architecture of Wrocław University of Technology

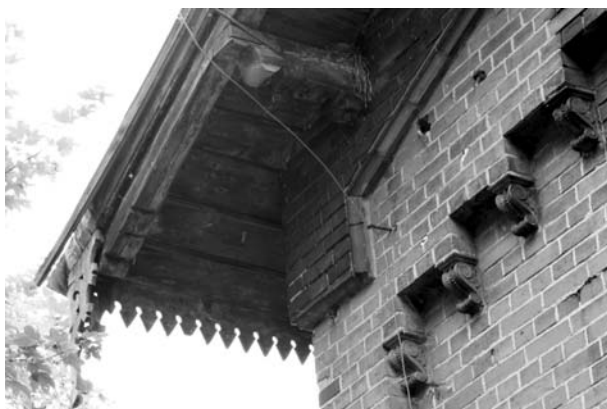
Fig. 1. Decorative carpenter's detail of the rafter framing visible on ends of the rafter and the purlin; by their decorativeness, carpenter's decorations of eaves as well as cast-iron consoles sustaining the overhang of the gable balance strict brick walls of the station in Otmuchów (Pic. by author, 2009).

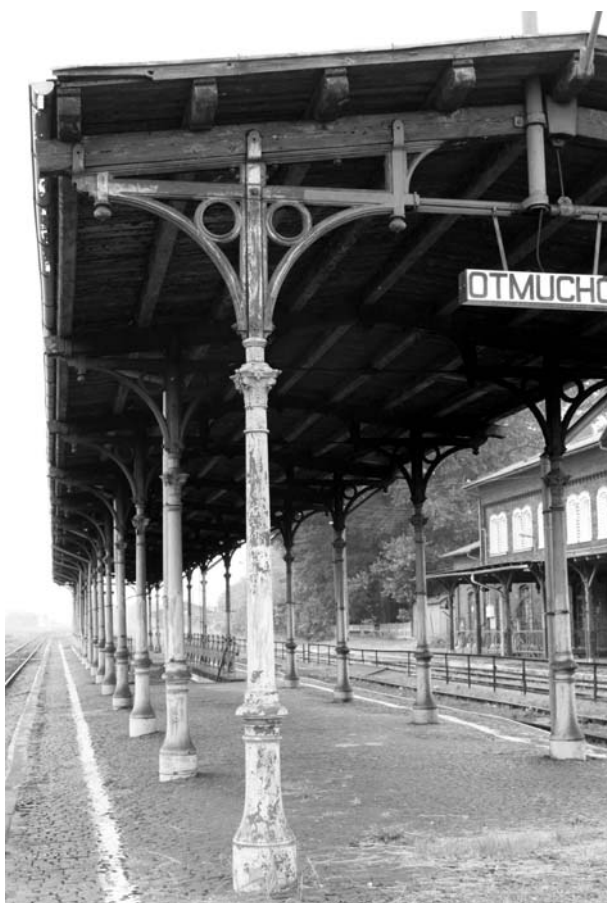
Fig. 2. A shed of the island platform in the station in Otmuchów. Cast-iron decorative poles carry steel trusses on which the wooden rafter framing was based. Clearly one can see the classical tripartite division of the pole modelled on the Corinthian order (Pic. by author, 2009).

number of decorative elements. This was often a metal detail — cast-iron or steel. It is mainly visible in the form of moulding poles (classical tripartite division) and of

trusses of the rafter framing. However, these sheds were usually made later than the main station buildings, and what follows, in their style they often reminded of Secessionist models.

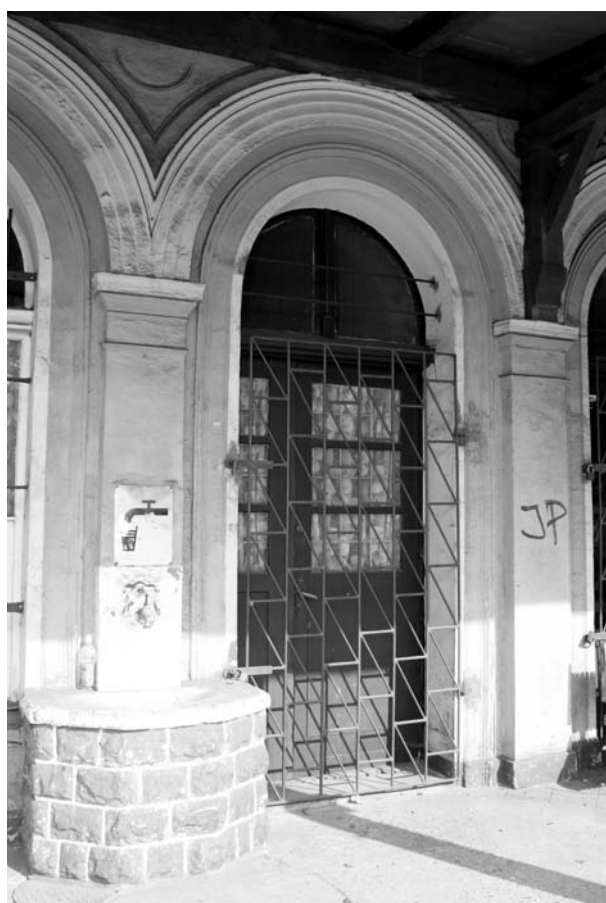
Fig. 3. Fragment of classical finishing of the wall of the station in Gogolin. Simple classical pilasters and arches are modelled on the Doric order. The rafter framing of the shed and the tap were added later (Pic. by author, 2009).

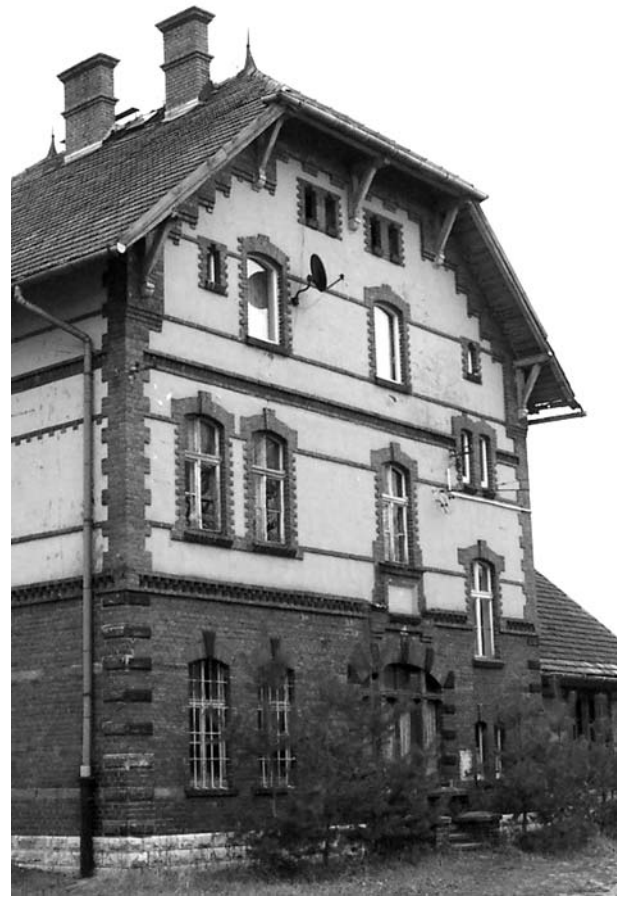
Fig. 4. Elevation of the station in Długomiłowice. An eclectic form with regional elements. Next to brick cornices there are stone finishings of corners, frames, stone bases and keystones of arches. The majority of the elevation is covered by plaster. The rafter framing refers to the Sudeten construction. The main entrance leads through a wide and glazed door opening (Pic. by author, 2006).

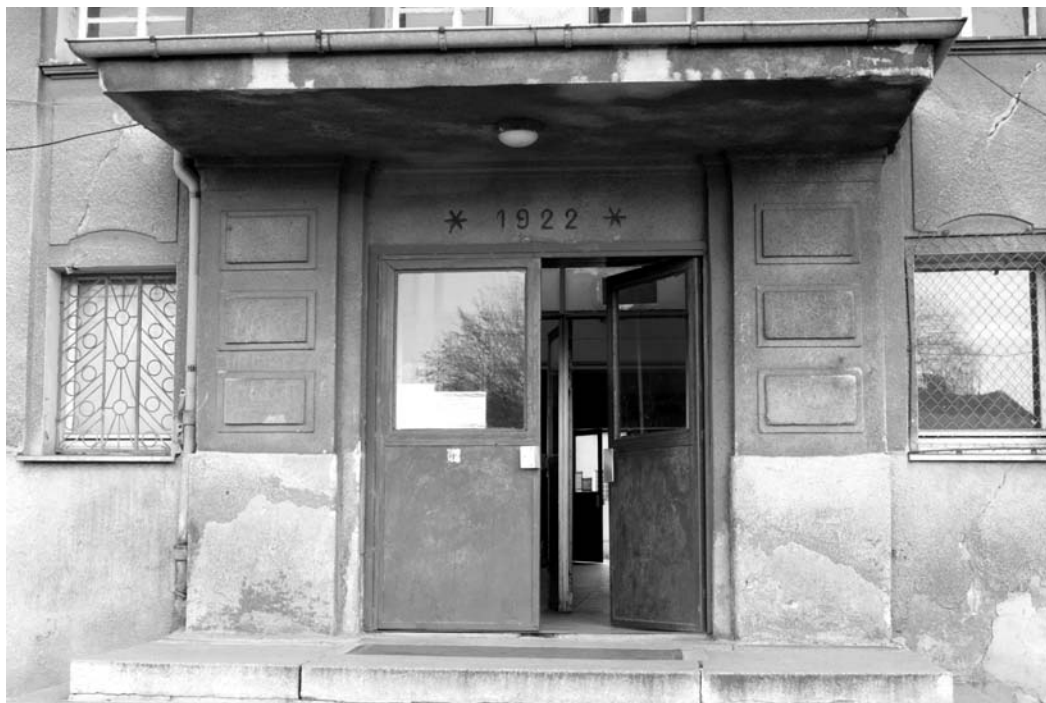
Fig. 5. Modernist door portal of the station in Olesno. Its modest geometrical detail remains in the shade of the monumental mass of the building. A characteristic extensive peak protects the wide access to the main room of the station. The door carpentry dates back to end of the 20th century (Pic. by author, 2009).

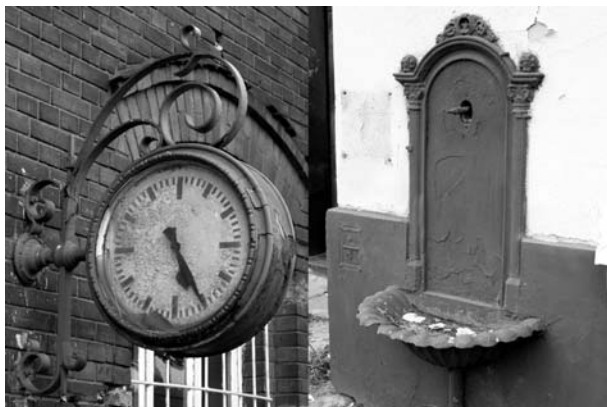
Fig. 6. On the left: clock in the station in Paczków. In the steel structure dating back to the turn of the 19th and the 20th century a mechanism from the end of the 20th century was enclosed. On the right: decorative cast-iron tap in the Szymiszów station. Unused and not-conserved yields to further destruction (Pic. by author, 2009).

commonly accompanied the architectural detail. These were primarily clocks, taps, benches, balustrades, boards and information devices. A few historical examples can be seen even today; however, these elements were most susceptible to changes resulting from the technological progress (clocks, information elements) and from public changes (taps, benches). In the 21st century it is actually possible to shape clocks in any form and to use their many technical solutions, whereas taps have become unnecessary, because all hygienic or dietary activities are mostly performed outside of the range of the station.

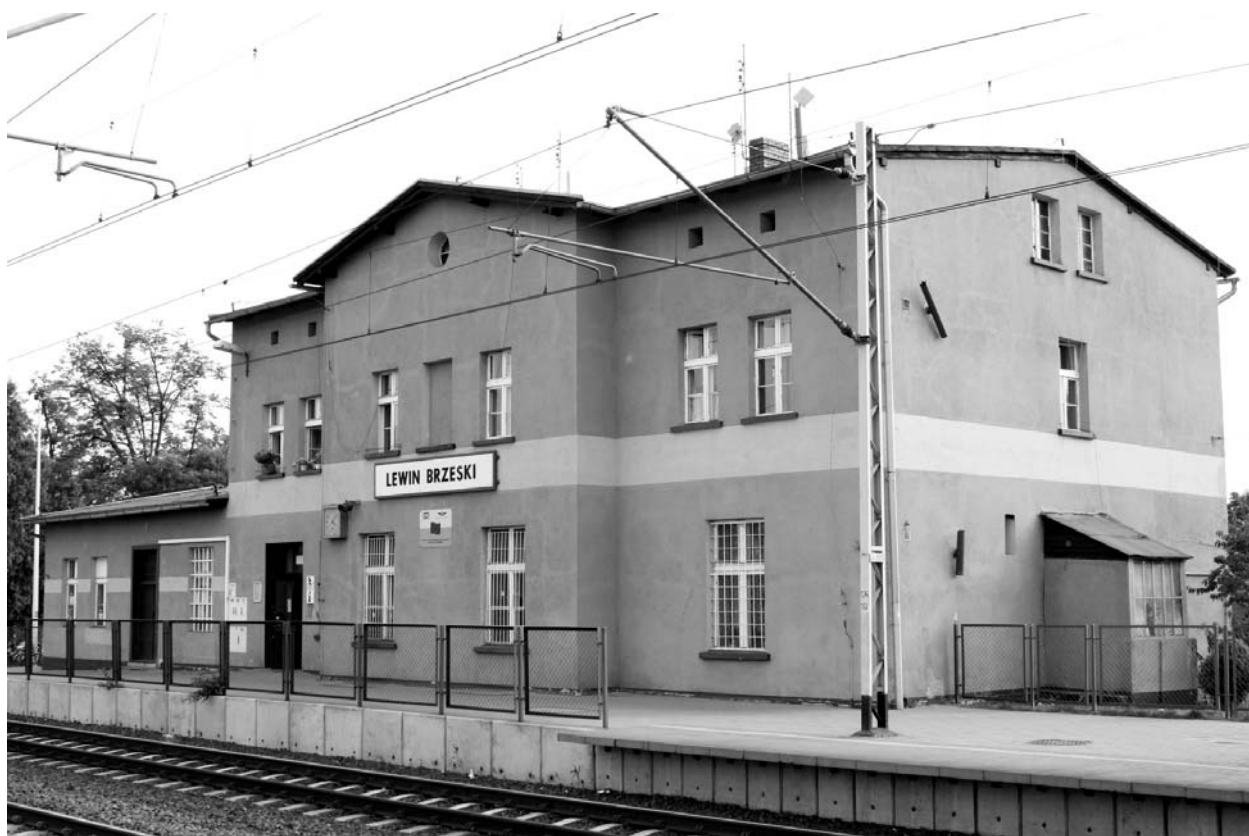
Fig. 7. Building of the station in Lewin Brzeski. During the modernization conducted in 2007 walls were covered with an even layer of polystyrene foam, due to which all details of the elevation were covered depriving the entire building of any stylistic values. Additionally, it was painted in the expressive orange colour (Pic. by author, 2009).

is not respected. Walls are covered with a thick layer of polystyrene foam, ceilings with simple suspended ceiling coffers, and the whole gains new bright colours. The outstanding and functional detail is killed without thinking, and nothing comes into existence in its place. Next to rebuilt buildings new ones appear: prefabricate steel-glass sheds resembling roofs of bus stops, wire seats and monumental concrete ramps with indistinct tubular balustrades. Their shape is merely a connection of technique and usefulness.

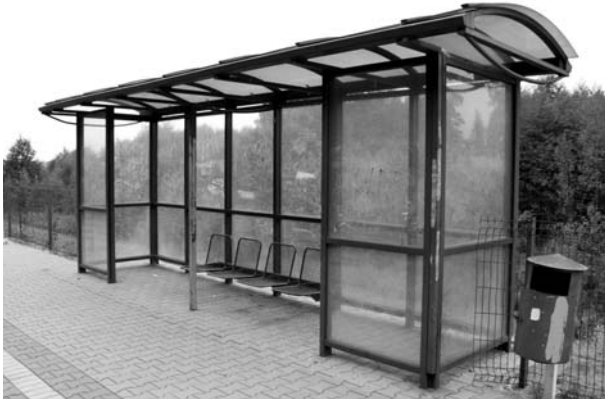
Fig. 8. Modern platform shed in the Przecza station. Made in 2007, after two years of use demonstrated strong wear and tear and damage. The fragile steel construction presents faint aesthetic values. The wire fence and seats are a complete denial of the former majestic style of the train building development (Pic. by author, 2009).
