# FAILURE'S IDENTIFICATION OF TURBOCHARGERS OF INTERNAL COMBUSTION ENGINES BY MEANS OF MULTI-FUNCTIONAL TEST STAND

*Poznan University of Technology*

*Division of Internal Combustion Engines*

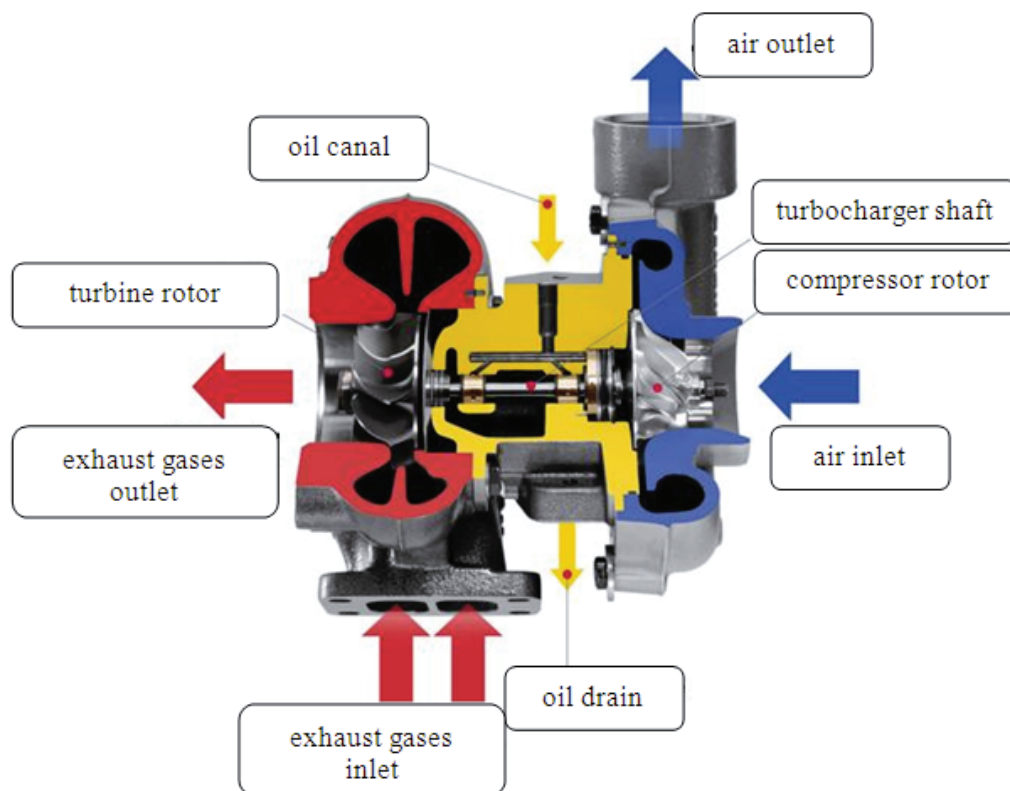
Fig. 1. Cross section and principle of operation of turbochargers

Supercharging the internal combustion engine is delivery of fresh charge of increased density into the cylinder, which enables supplying it with more fuel without altering the air-fuel ratio  $\lambda$ . The aim of the process is to maximize the unit power and efficiency of the engine but also to reduce unitary emission of toxic exhaust components. Turbocharging belongs to the category of compressor supercharging with a flow compressor. The main component is a turbocharger – fluid-flow machine in which the turbine and compressor rotors are mounted on a common shaft (Fig. 1).

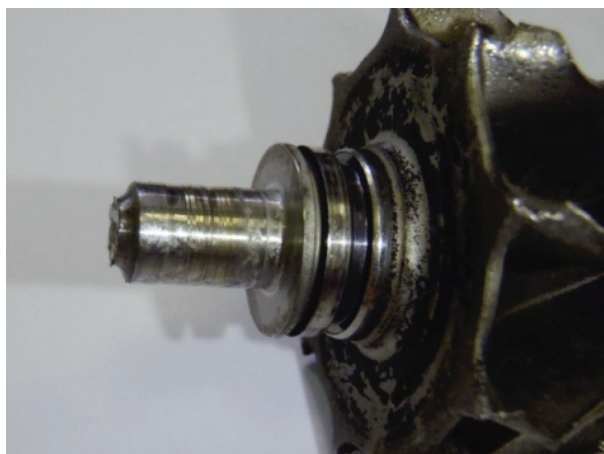
Fig. 2. View of broken rotor’s shaft necks with deep scrapes

Causes of damage to turbochargers done by oil of poor quality should be sought for in engine oil primarily of poor quality – not complying with the manufacturer’s recommendations. In addition, the oil filter may be inadequate, being of incorrect parameters or choked by soil. The most common cause in this type of failure is however, a result of a lack of periodical or distance-determined oil change according to the manufacturer’s recommendation. Turbocharger damage caused by oil of poor quality results in, among others, deterioration of the operating conditions of the axial and radial bearings, as a result of the diminishing of the diameter of oil holes. It can cause local overheating of the components and growth of the contact temperature, which can result in rapid damage of the turbocharger revealed by, among others, deep scrapes on the rotor’s shaft necks (Fig. 2) and bearing surfaces (Fig. 3), alteration of parameters of the outer contact layers (Fig. 4), decalibration of the holes for bearings in the inner housing or the ring seals becoming stuck in their grooves (Fig. 5).

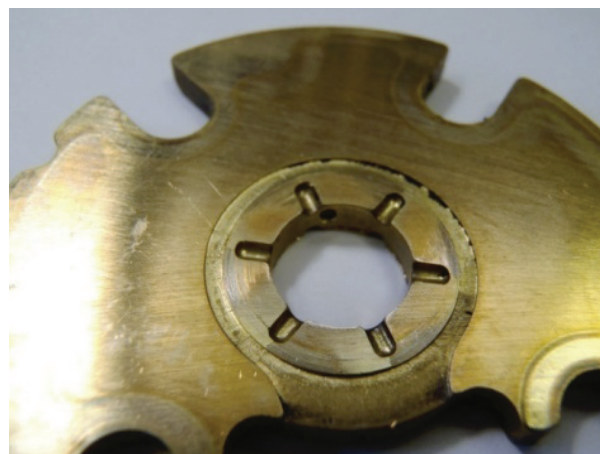
Fig. 3. View of scraped surface of bearing

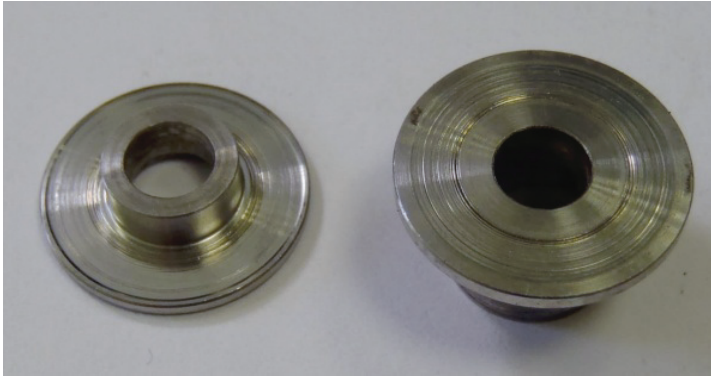
*Fig. 4. View of changes in parameters of the outer contact layers*

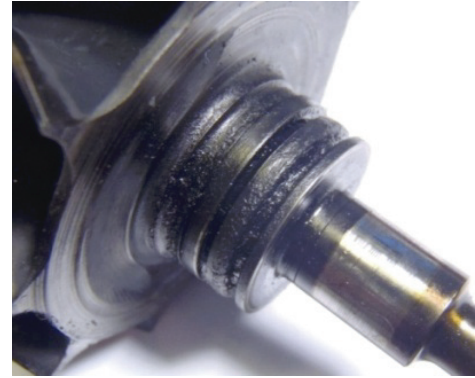
*Fig. 5. View of rotor's shaft with ring seals becoming stuck in their grooves*

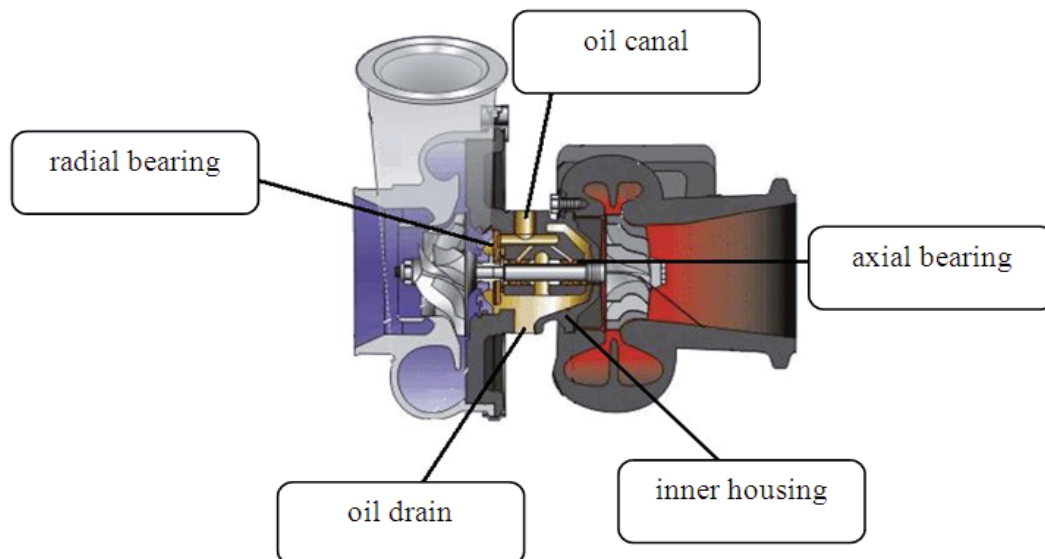
*Fig. 6. Cross section of turbocharger with visible inner housing and oil canal*

Consequences of improper oil parameters have been described above. Another failure type, also related to oil, is one caused by the change in its operating parameters, for instance pressure drop or a momentary lack of oil. Mechanical parameters are thus of importance – oil should be delivered to the turbocharger in adequate amount and at proper pressure. It is also important that the oil outflows sufficiently quickly out of the friction zone and the inner housing (Fig. 6).

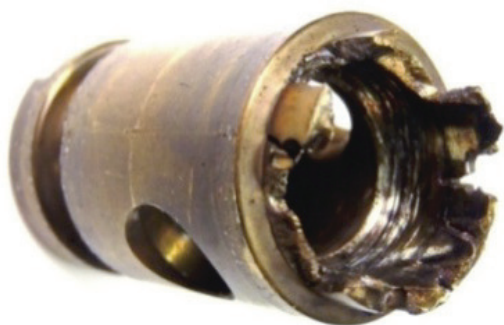
Fig. 7. View of damaged bearing

- damage of the outer layers of bearings and rotors' shaft neck (Fig. 7),
- alteration of physical properties of the material the shaft and bearings are made of (Fig. 8),
- the bearing sleeves becoming stuck in the inner housing holes (Fig. 9),
- thermolysis of the oil components (coking) – leading to carbon depositing in oil holes of the inner housing, causing them to choke (Fig. 10).

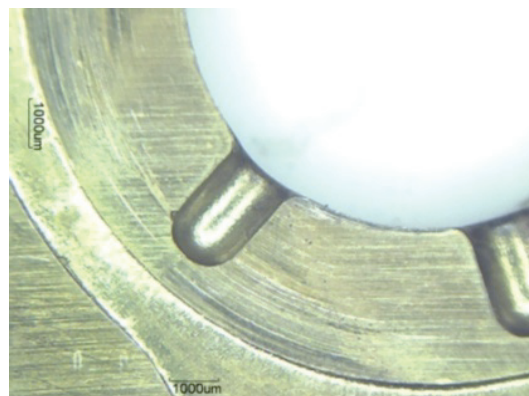
Fig. 8. View of alteration of bearing material

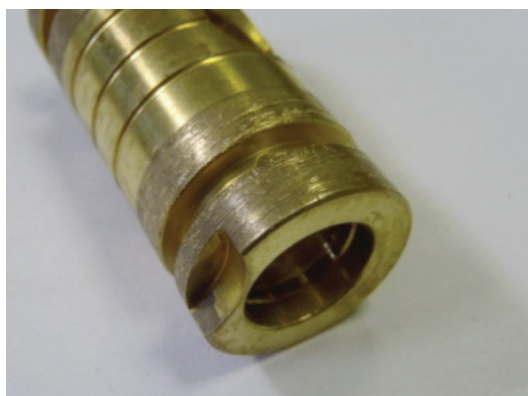
Fig. 9. View of faded bearing (dry friction)

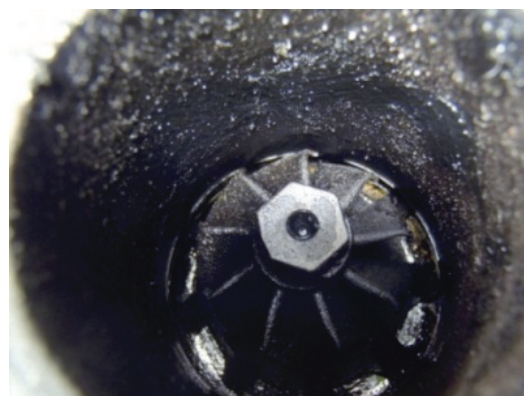
Fig. 10. View of turbine rotor with carbon depositing

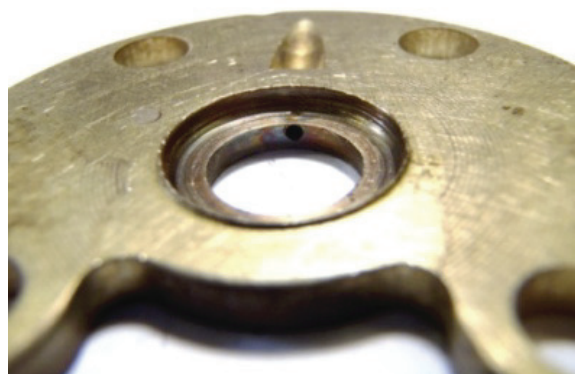
Fig. 11. View of bearing with hot tracks

Another type of failure identified is that caused by overheating. It has in principle two causes: too high exhaust temperature and sudden stoppage of the engine preceded by driving with considerable load and rotational speed [3]. Hot exhaust strongly heats the turbocharger's components – particularly cast iron housing of the turbine and the inner housing (Fig. 11).

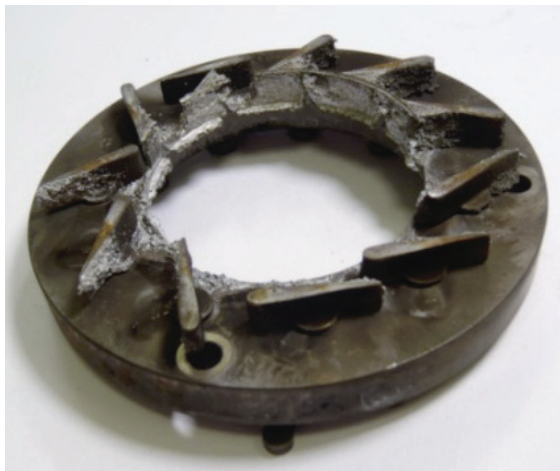
*Fig. 12. View of exhaust steering wheel with contaminations on surface*

The last common type of failure is that caused by foreign matter. This type of failure is a result of foreign matter working its way to the in- or outflow system (Fig. 12).

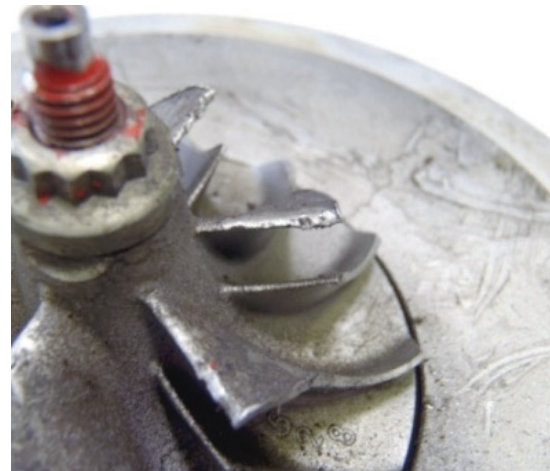
*Fig. 13. View of compression rotor with tracks caused by small body*

The failure is of an erosion type and depends on the size of the body reaching the rotors blades. Even the smallest body carried with the exhaust or air flow reaching the rotor strongly impacts the blades as a result of the high energy of the gas flow (Fig. 13).

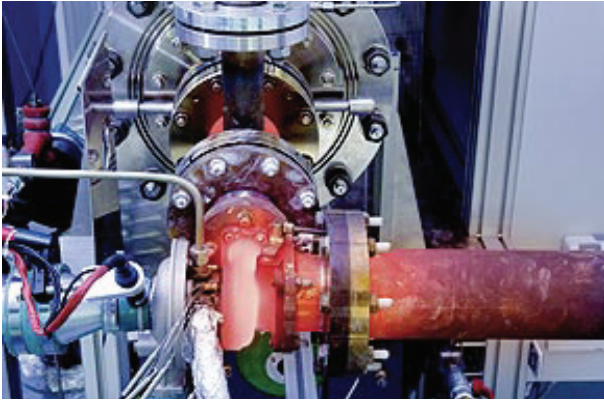
Fig. 14. View of devices which allows for turbochargers testing

On the basis of identification of described failures a conception of device which allows for turbochargers diagnostics have been elaborated. For the research of wear and destruction processes of turbochargers, and so their diagnostics, a test stand is needed which will enable to simulate the component's operating conditions, i.e. accelerating the turbocharger's rotor to a given speed, ensuring constant lubricant parameters and setting the desired parameters of the charging air. The companies specializing in design and examination of the manufactured turbochargers use devices enabling them to create flow characteristics of the turbine and compressor and which can be also adapted for research of destructive processes. Such devices use either compressed air from a tank, or hot combustion gases from an exhaust generator as power feed. The basic disadvantage of such solutions is the big volume of the air tank, being a result of a difference in energy states of air and exhaust. The exhaust, which in real conditions propels the turbocharger's rotor, has considerable energy, which derives mostly from its speed (around 500 m/s) and temperature (up to 1000°C). Moreover, the exhaust stream generated by the engine amounts to 0.1-50 m<sup>3</sup>/min, depending on the engine size and rotational speed. In practice such solutions are often abandoned and the rotor is driven by exhaust in the so-called hot gas test [4] (Fig. 14).

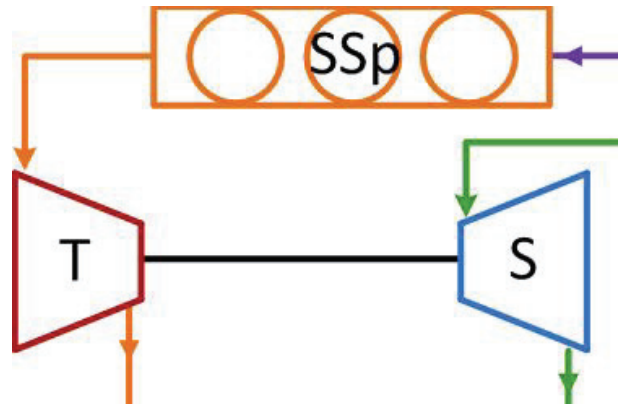
Fig. 15. Schematic diagram of turbochargers test stand

Based on the presented information, in the first phase a solution has been chosen, in which the turbocharger shall be propelled by an exhaust stream (Fig. 15). The research version of the stand uses a normally aspirated combustion engine being the exhaust generator. Spark-ignition engine coupled with a water brake, which receives the power, has been used for the purpose – such a device is in possession of engine test house of the Combustion Engines Laboratory of the Poznań University of Technology (Fig. 16).

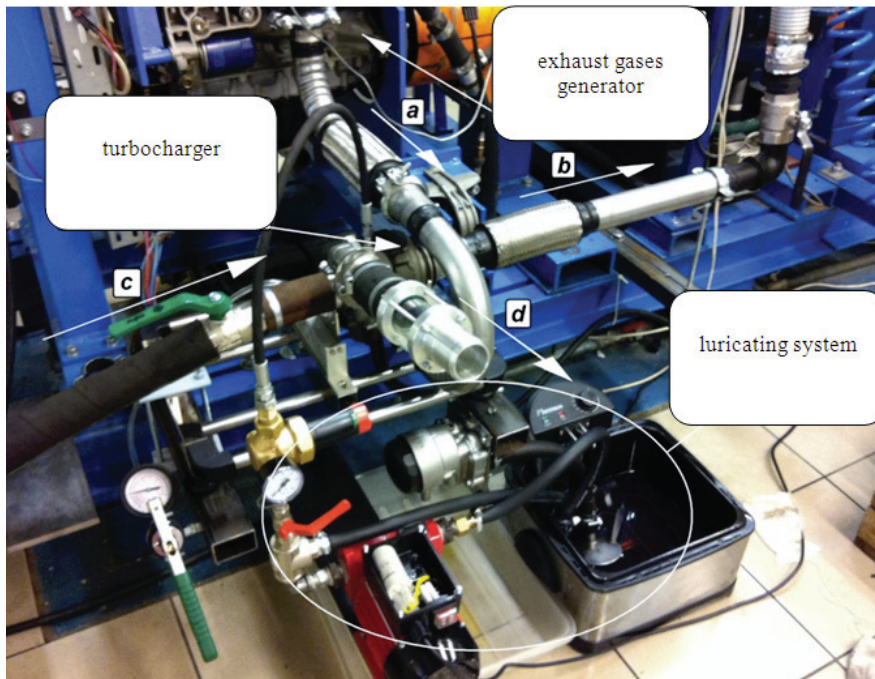
Fig. 16. View of turbochargers test stand
