# Analysis of a Castings Quality and Metalworking Technology. Treasure of the Bronze Age Axes

<sup>a</sup> AGH University of Science and Technology, Faculty of Foundry Engineering, Historical Layers Research Centre, Reymonta 23 Str., 30-059 Kraków, Poland

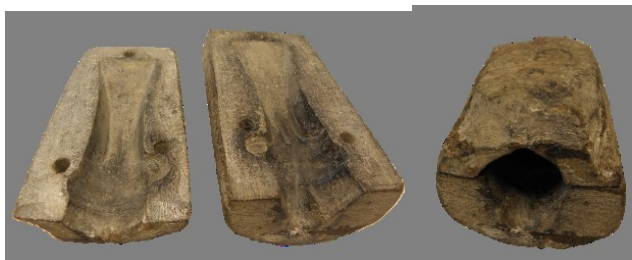
Fig. 1. Mould from foundryman graves, the Legnica cemetery (1100-700 BC); Stone mould for casting of axes [5]

Decorations and tools, in the Bronze Age were cast in clay moulds by the investment casting method [2-4], as well as in permanent moulds [5]. Larger products such as axes, razors, knives, etc., were the most often cast in stone moulds. Moulds were made very carefully and precisely with taking into account mutual joining of both halves. Moulds for casting of axes had to have the core for the bushing reproduction. Articles cast in stone moulds required often more work at their finishing e.g. removal of flashes called also foundry seams, marking the dividing plane of casting in the contact place of both halves. Mould parts were joined and heated before pouring to remove the humidity residue, which could cause the metal gasification during pouring. Stone moulds, after being used for a long time, become less tight and finishing of castings required more work. Stone two-part moulds for casting axes, with a bushing and a lug (Fig. 1), were found in the Legnica cemetery in foundryman graves (Lower Silesia, Poland) [5]. Accessories related to the foundryman work, including foundry moulds, are known from other places too [6-8].

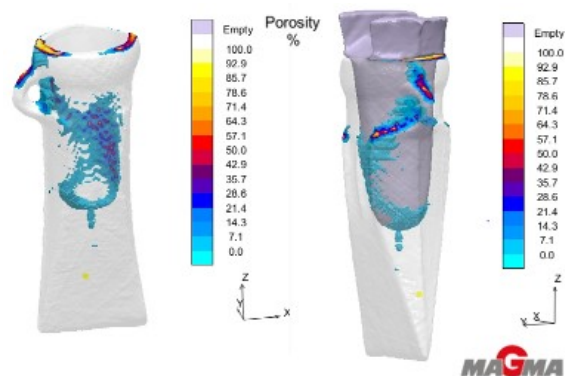
Fig. 3. Simulation of casting porosity when using double-channel main runner [5]

Current investigations indicated various solutions of introducing metal - along the core - into the mould cavity, including the use of two or four channels of various cross-sections (Fig. 2) [5, 9-10]. Using the analytical methods and the reverse engineering in investigations of the found moulds allows to reconstruct the technology of casting of axes (Fig. 3) [5].

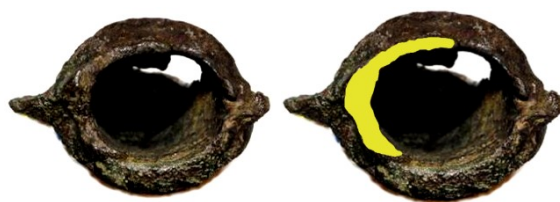
Fig. 5. Axe, visible remains of gating systems – marked in yellow (axe No. NG25)

The gating system with introducing channels is the waste product, usually subjected to remelting. The snap-off or cut-off by means of sharp tools from the rough casting left traces on the axe circumference. Observations revealed various shapes and placements of gating channels (Figs. 4, 5). Usually there were two channels of the same cross-section, which were symmetrically leading from the gating tank cone to the casting edge. There were also overflow channels assuring the proper mould filling and the removal of gases and the metal excess from the mould.

Numerous surface defects were noticed on castings. There were flashes along the line joining the mould, being a result of not sufficient fitting of mould halves, which were not removed during the surface treatment (Figs. 6b, 7b). Another typical casting defects, deciding on the castings quality are mainly external bubbles and incomplete fillings – called in the foundry environment as misrun (Fig. 6a). External bubbles are formed when gases and air bubbles cannot get out, since the mould has too low permeability [18-21]. Low permeability together with insufficient flowing power can bring the misrun occurs on the cast surface, as observed on figures 5 and 7a.

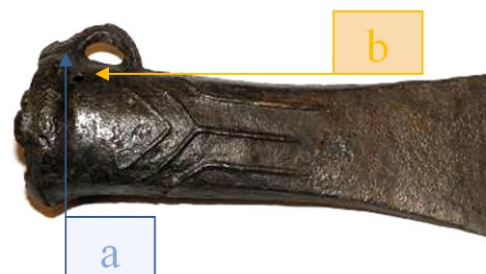
Fig. 6. Axe (No. NG7) with remained elements of the gating system and casting defects: incomplete filling - misrun (a) and flashes along the line joining the mould (b)

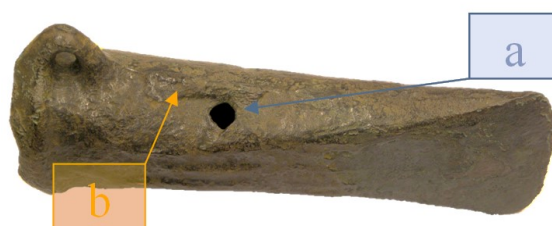
Fig. 7. Axe (No. NG26) with casting defects: incomplete filling - misrun (a) and flashes along the line joining the mould – casting seam (b)
