Monitoring Coastal Erosion and Deposition in Sam Son City, Vietnam – a Contribution from Remote Sensing Data

Abstract

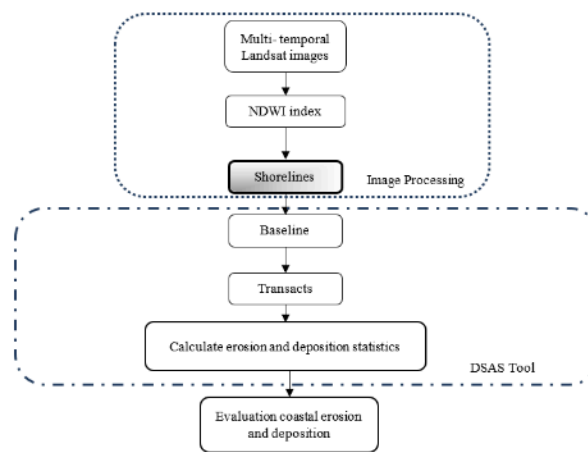
Fig. 2. Flowchart of the overall methodology for assessing coastal erosion and deposition

The detailed methodology and objectives of the whole study is presented in Figure. 2. First, shorelines were extracted from Landsat in 1989, 2001, 2013 and 2022 using NDWI. The NDWI indexes were manually digitized the water – land boundary. The manual digitizing method is seen as the most straightforward technique for shoreline detection when dealing with study sites that are not extensive [27] like Sam Son city. The Digital Shoreline Analysis System (DSAS) tool was utilized to analyze the multi-date shorelines and compute statistics regarding shoreline change.

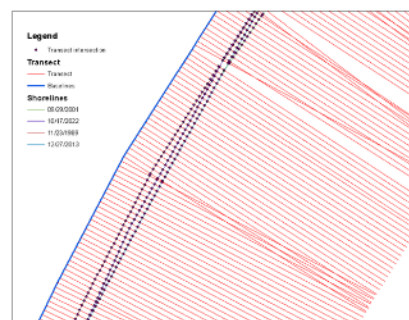
Fig. 3. Initiating transects from the baseline in parallel to the coastline vectors

It is essential to establish the baseline next to the series of shoreline positions. Transects should be deployed perpendicular to this baseline at a spacing determined by the user to intersect the shorelines and establish measurement points. The orientation of the transect through the shorelines is significantly influenced by the position of the baseline. In this paper, 854 transverse transects, each 1700 meters long and positioned perpendicular to the offshore baseline, were created at 30-meter intervals along the shoreline (Figure. 3).

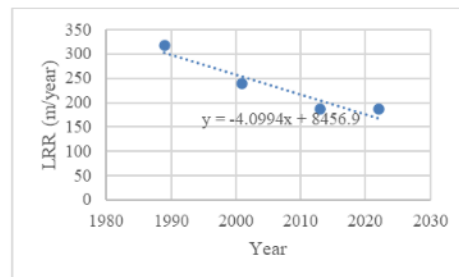
Fig. 4. Representation of a typical cross-plot showing LRR for shoreline change

The DSAS modul was employed to assess the erosion and deposition rates of shoreline positions using the end point rate (EPR), rate of shoreline change(RSC) and linear regression (LRR) techniques. EPR was calculated as the ratio of the time elapsed between the oldest and most recent coastline positions. Beside, The calculation of the rate of shoreline change in the LRR method is based on the assumption of a linear trend between the earliest and latest shoreline dates (Figure. 4).

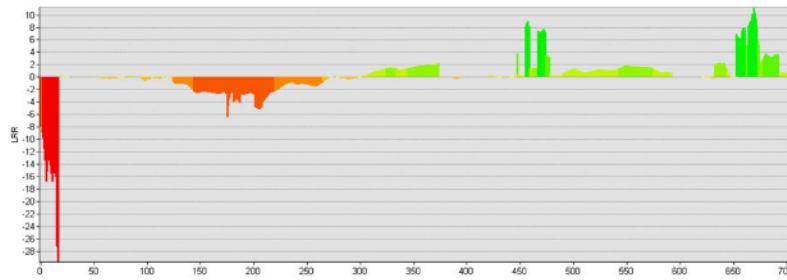
Fig. 5. Coastal accretion and erosion of Sam Son coast with LRR
Rys. 5. Akrecja przybrzeżna i erozja wybrzeża Sam Son z LRR

The identification of beach conditions, particularly coastal erosion, relies significantly on the geomorphological attributes of the coastline. The coastline is a dynamic system that undergoes rapid and continuous evolution, and its trends are monitored by mapping at different time intervals through field data collection or satellite imaging [34]. Coastal erosion and accretion are indicators of shoreline changes. The LRR method has been utilized to analyze the rate of shoreline change for Sam Son. According to the study, Sam Son exhibited both erosion and deposition along its coastline. The rate of 854 transects, erosion rates ranged from -0.12 m/year

to -29.74 m/year, whereas the deposition rate along the coast ranged from 0.47 m/year to 11.22 m/year (Figure. 5)

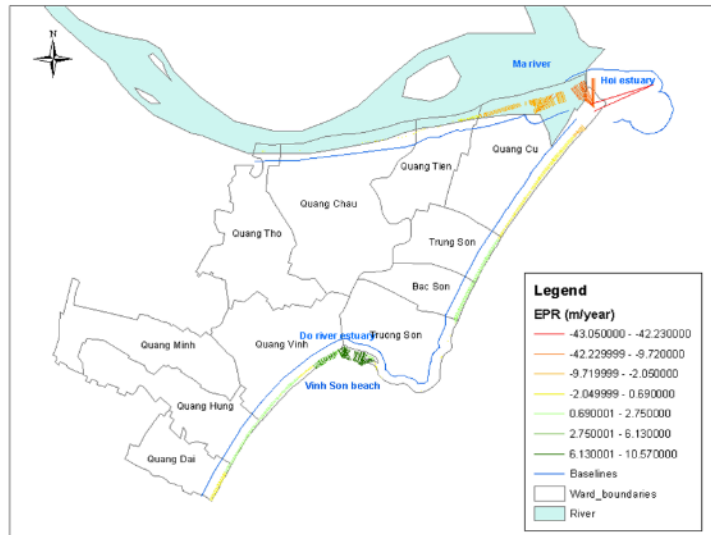
Fig. 6. Coastal accretion and erosion of Sam Son coast with EPR.
Rys. 6. Akrecja przybrzeżna i erozja wybrzeża Sam Son z EPR

Moreover, The end point rate (EPR) is calculated by dividing the distance of shoreline movement by the time elapsed between the oldest and the most recent shoreline. The EPR suggests that stable and negligible coastal deposition distances are concentrated in Bac Son, Trung Son, Quang Vinh, Quang Hung, and Quang Dai regions (Figure. 6). However, the EPR shows that significant coastal deposition distance are contributed in Quang Cu and Truong Son communes where the EPR reached from 0.69 m/year to 10.57 m/year. In addition, coastal in Quang Cu region is eroded strongly with EPR reached - 43.05 m/year.

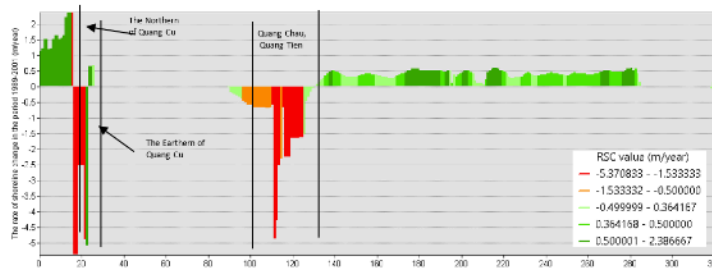
Fig. 7. The rate of erosion and deposition in the period 1989–2001 in Sam Son
Rys. 7. Tempo erozji i osadzania się w latach 1989–2001 w Sam Son

The Figure. 7 shows the change of erosion and deposition from 1989 to 2001. The RSC vary between -5.37m/year and 2.39m/year. The coastal deposition was focused in the northern of Quang Cu ward from 0.5m/year to 2.39m/year and accretion is insignificant in Trung Son, Bac Son, Truong Son and Quang Vinh wards (below 0.5m/year). However, the shoreline was eroded from -5.37m/year to - 0.5m/year that was distributed in the Eastern of Quang Cu, Quang Chau and Quang Tien wards.

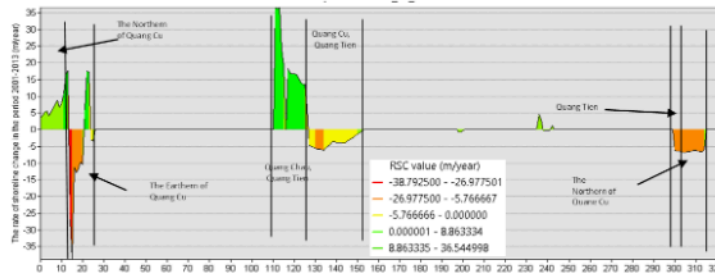
Fig. 8. The rate of erosion and deposition in the period 2001–2013 in Sam Son
Rys. 8. Tempo erozji i osadzania się w latach 2001–2013 w Sam Son

The change of erosion and deposition from 2001 to 2013 was shown in Figure. 8. Compared to the period from 1989

to 2001, the shoreline change in the period 2001–2013 was increased rate strongly which ranged from -38.79 m/year to 36.54/year.

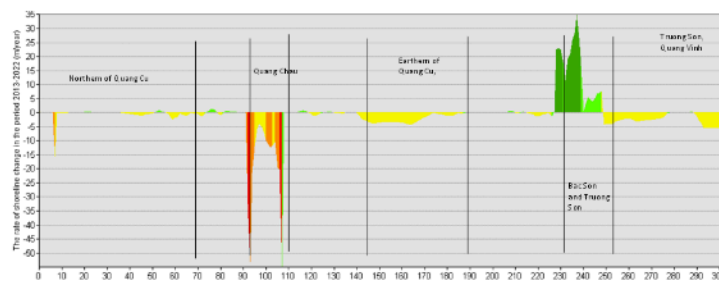
Fig. 9. The rate of erosion and deposition in the period 2013–2022 in Sam Son
Rys. 9. Tempo erozji i osadzania się w latach 2013–2022 w Sam Son

In the period 2013–2022, the shoreline change in Sam Son city was popular erosion (Figure. 9). The rate of erosion was largest in Quang Chau ward reaching - 55 m/year approximately. On the contrary general erosion trend, Bac Son and Truong Son were deposited strongly from 5 m/year to 35.1 m/year.

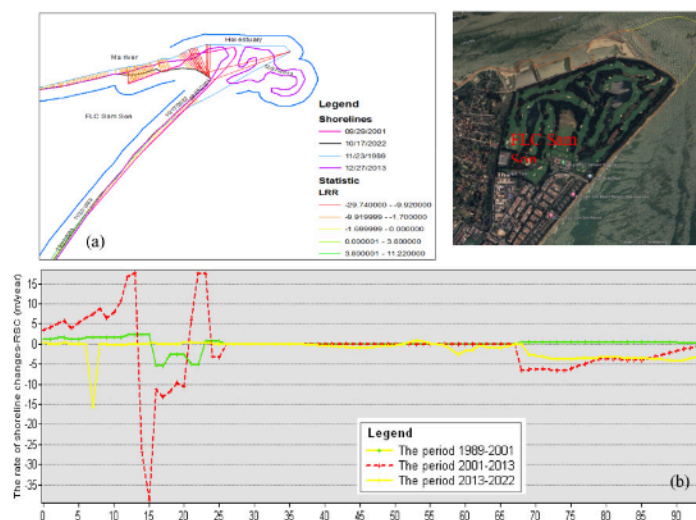
Fig. 10. The rate of shoreline change in Hoi estuary (LRR)
Rys. 10. Tempo zmian linii brzegowej w ujściu rzeki Hoi (LRR)

Figure. 10(a) shows LRR ranged from -1.7 to - 29.74. the LRR values proved that the shoreline was eroded in during period 1989–2022. However, as depicted in RSC in Figure. 10(b), the deposition process is specifically concentrated in the southern part of the Hoi estuary, with rates reaching 17.69 meters per year during the period 2001–2013. This accretion rate is the result of the transportation of sediment by the Ma River. The Hoi estuary is situated in the downstream area of the Ma River system, annually releasing millions (around 5.17 million) of tons of sediment into the sea. [35]. Contrastingly, the northern region of the Hoi estuary witnessed substantial erosion, characterized by erosion rates of -4.2m/year in period 1989–2001, -38.79 m/year, and -6.67 m/year in period 2013–2022. In this region, coastal erosion is attributed to a combination of natural elements and activities related to land exploitation. Natural elements comprise climatic events like storms, waves and increasing sea levels [36, 37]. Land exploitation activities contribute to coastal erosion, including urban development, sand mining, infrastructure construction. One of the notable land exploitation activities involves the establishment of tourism accommodation facilities, such as the Sam Son FLC complex and Van Chai resort. Consequently, sand mining in this tourist area has depleted the sediment deposition source, and this activity also generates a turbulent wave current that washes away the sediment, resulting in coastal erosion.

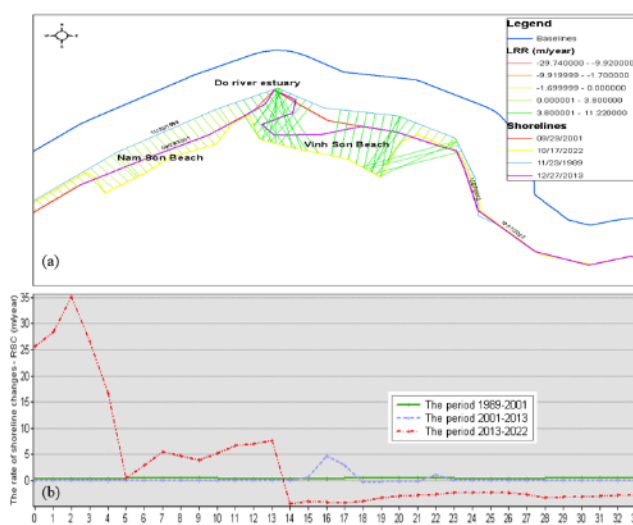
Fig. 11. The rate of shoreline change in Do river estuary
Rys.11. Tempo zmian linii brzegowej u ujścia rzeki Do

The Do river mouth, situated to the west of the Truong Le mountain range, is the site where sedimentation and the formation of Vinh Son Beach and Nam Sam Son Beach occur. As a result of wave and tide action, sediment and sand get deposited, leading to an accumulation rate of up to 11.22 m/year (Figure. 11(a)) in during 1989–2022. In the region of Do river estuary, deposition processes was dominated with RSC value reaching 35.1 in period 2013–2022 (Figure. 11(b)). The sediment deposition at the mouth of the Do River provides the foundation feature for the development of resort areas aimed at catering to tourism. Currently, this area has undergone sand filling and the establishment of boundaries to facilitate the construction of resorts and hotels.
