Thermal cracks of large area insulating glasses

5. Assessment of the causes of broken glazing in the Municipal Art Gallery building in Częstochowa

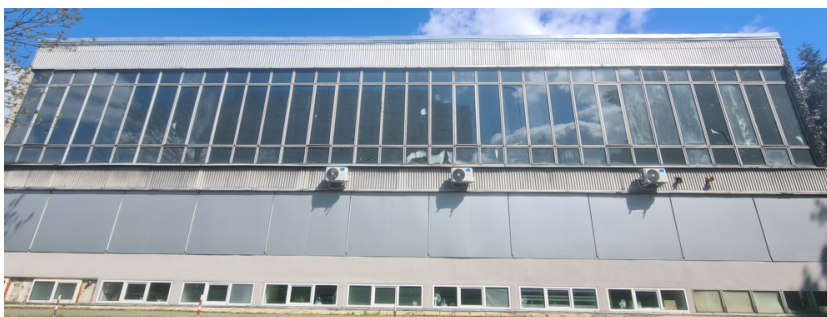
Fig. 1. Western elevation of the Municipal Art Gallery building in Częstochowa

The following are the results of an expert opinion on determining the causes of glass cracking in the windows of the west facade of pavilion of the Municipal Art Gallery in Częstochowa (Fig. 1).

Segment F of the building of the Municipal Gallery of Art in Częstochowa constitutes the north-western corner of the object consisting of a complex of 6 pavilions forming a one-storey complex with a fragmented body. All pavilions featured an aluminium and glass façade in the form of strips of corrugated aluminium sheet and window displays. The window panels were 3 m high, divided by horizontal crossbars with the largest central pane measuring 1.0 m x 2.0 m, the lower and upper panes measuring 1.0 x 0.8 m (Fig. 2). In the building, insulating glass units were installed in which the thickness of the two panes of glass was 5 mm and the gap between the glass panels was 12 mm.

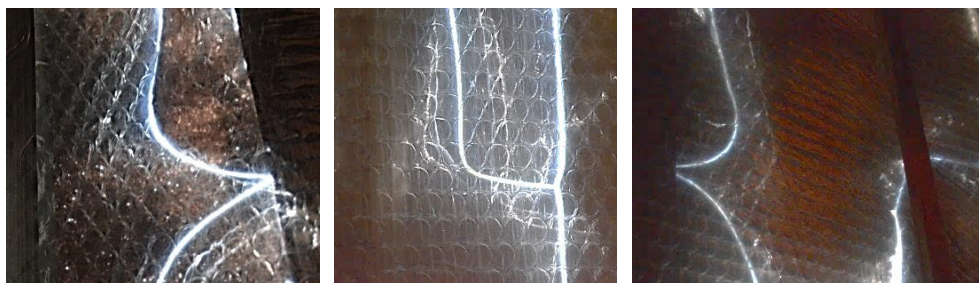
Fig. 3. Cracked glass on the inside

After the renovation of the tapestry room, the internal temperature was normalised and remained between 19°C and 25°C, while almost all the double-glazed windows developed cracks on the inside (Fig. 3).

Visual inspection confirmed the presence of cracks extending at right angles from the side edges of the windows with no chipping at the edges of the glass panes. The outgoing cracks are in some cases divided into several cracks also running rectilinearly. The hooked end of the crack or the splintering occurring in the area of the change of direction of the crack was rare.

The calculations showed that in the period prior to the refurbishment of the exhibition hall, the maximum deflections of the glazing did not exceed the permissible deflection at the centre of the span of the vertical glass panes supported at all edges $f_{dop} \leq a/100 = 1000/100 = 10$ mm. The stresses in the glazing did not exceed the permissible stresses $f_{g,d} = 17.48$ MPa. In order to take into account the heating of the internal pane due to the positioning of the thermal insulation mat in close proximity to the window and the lack of ventilation of the gap between the window and the mat, additional calculations had to be carried out for the load combination taking into account the corrective temperature increase: $\Delta T = 35$ K. The numerical calculations further assumed that, during the winter period, the indoor temperature in the building, within the windows of the exhibition hall, was $t_w = +20^\circ\text{C}$ and the steady-state outdoor temperature $t_z = -10^\circ\text{C}$. The temperature difference between inside and outside was therefore 35°C . As the inside of the glass was coated with a spray layer of black latex paint that absorbed heat from solar radiation, it was assumed that a temperature rise of 5°C at the surface of the glass should be included in the thermal gradient value. Since the thickness of the glazing was: $h = 0.005$ m and the thermal gradient at steady state was: $dt = 35/0.005 = 7000$ K/m. The calculations showed that at a temperature difference of 50°C between the heated central area of the glass and the colder edge area (along the aluminium profiles), the stress difference reached approximately 22 MPa. At the most unfavourable load combination, tensile stresses of 20 MPa were present in the edge area, leading to thermal cracks.

Calculations carried out have shown that if there is a temperature difference within one pane of the order of $\Delta T = 40$ K, this does not necessarily cause the glass to break. In the case of a greater temperature difference and when the glazing is heated unevenly, dangerous stresses develop in the cross-section of the glass, which can lead to breakage. Factors causing excessive heating of the glazing include the application of light-impermeable film to the glazing, painting the glazing with black paint and the positioning of heating units and thermal insulation too close to the window. In such situations, it is necessary to use double-glazed windows with toughened safety glass.
