## Working conditions for the low location lighting system on passenger ships

Małgorzata Zalesińska, Krzysztof Wandachowicz

Poznan University of Technology, Institute of Electrical Engineering and Electronics  
5 M. Skłodowskiej-Curie Sq., 60-965 Poznań, Poland  
e-mail: {malgorzata.zalesinska; krzysztof.wandachowicz}@put.poznan.pl

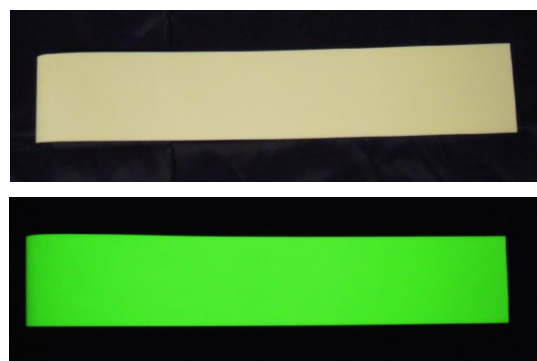
Figure 1. Photoluminescent material strip view (top) and lighting effect of the strip after main lighting goes out (bottom)

As per the stipulations of the IMO Resolution (IMO, 1993) and the SOLAS Convention (SOLAS, 1974) of 1997, all passenger ships intended to carry more than 36 passengers are to be fitted with a low location escape route lighting system (Low Location Lighting; LLL). The LLL may utilize an electrically powered self-illuminating design, e.g. a system utilizing light emitting diodes, or use sections of strips made of photoluminescent materials, which mark the escape route after the main and emergency lighting is disengaged. Due to its reliability (electrical power is not required for operation), passenger ships commonly use LLL solutions based on photoluminescent strips for egress path marking. Figure 1 shows a section of the strip made of photoluminescent material, as well as the lighting effect after the main lighting goes out.

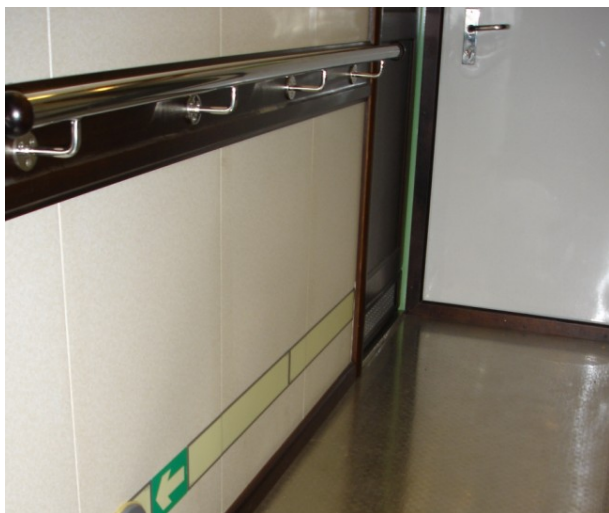
Figure 2. Marking of egress path with photoluminescent strips

route to leave the ship can be found, even in very dense smoke. Hence, this egress path lighting is located at a low height in relation to the floor level. An example of egress path marking via photoluminescent strips on a passenger ship is shown in Figure 2.

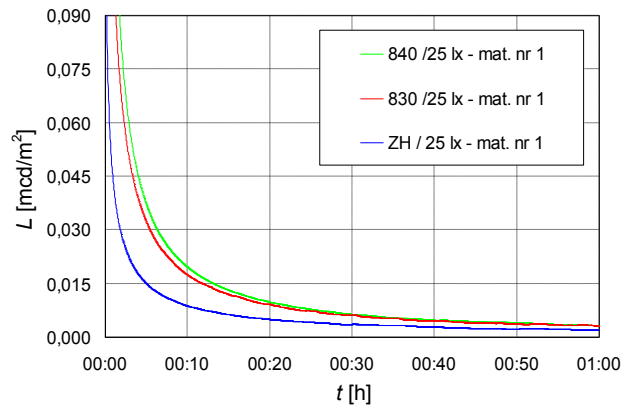
**Figure 8.** Luminance drop curves for material 1 and all sources of illumination with illuminance for strip surface equal to 25 lx

Example luminance drop curves for tested illumination sources and illuminance on the material surface equal to 12.5 and 25 lx are shown in figures 6–9. Figures 10 and 11 show luminance drop curves for fluorescent lamp color No. 840, for different illuminances on the surface of tested materials.

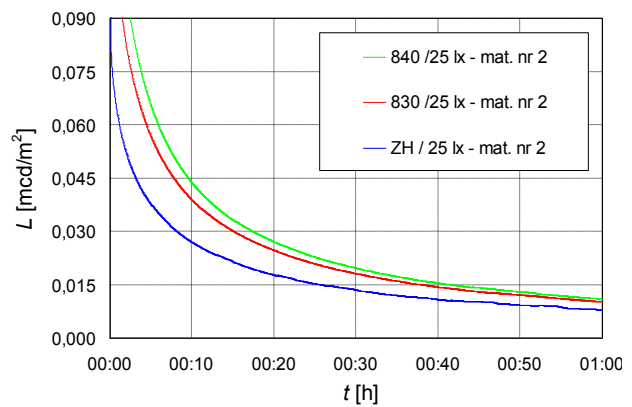
**Figure 9.** Luminance drop curves for material 2 and all sources of illumination with illuminance for strip surface equal to 25 lx
