## UNDERWATER WET REPAIR WELDING OF API 5L X65M PIPELINE STEEL

Grzegorz Rogalski  
Dariusz Fydrych  
Jerzy Łabanowski  
Gdansk University of Technology, Poland

*This paper presents results of the research of effect of polymer insulation of pipeline made of API 5L X65M steel as well as underwater wet welding parameters on properties of joints made by covered electrodes. Effect of heat input on structure and hardness of joints during repair of underwater pipeline was analyzed. Welding defects like microcracks, micro-lacks of fusion, slag inclusions, as well as HAZ hardness increase over an assumed acceptance criterion for welded joints in pipes without anticorrosion polymer insulation, were identified. A significant effect of polymer insulation on structure and properties of welded joints, was found.*

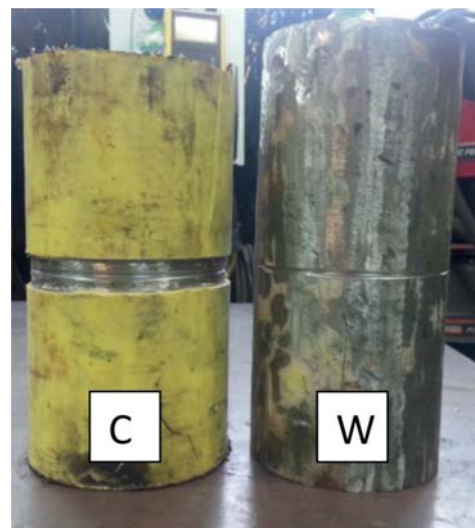
Fig. 1. Specimens prepared to welding. C – specimen covered with anticorrosive polymer coating; W – specimen without the coating.

For the experiments two pipe segments of the dimensions:  $\phi=102.9 \times 5.7 \times 250$  mm were taken from the water pressing pipeline installed at the underwater crude-oil field (Fig. 1). The specimen C was covered with an anticorrosive polymer coating of 2.5 mm in thickness. The specimen W had metallic surface after mechanical removal of the anticorrosive coating. Over 75% circumference of the pipes 1.5 mm-deep grooves simulating the repair - demanding defects (cracks, corrosive wear) on pipeline surface, were cut.

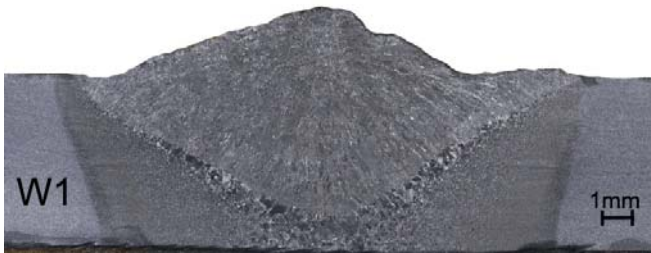
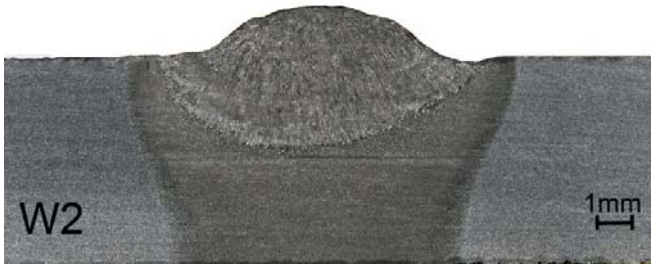
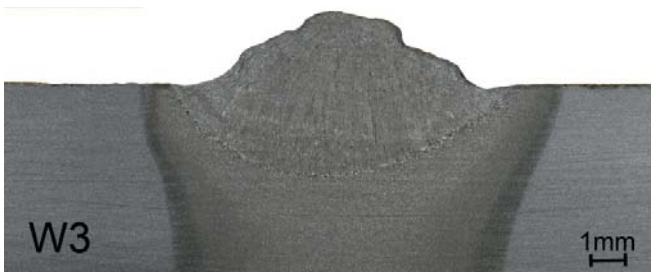
Fig. 3. Macro cross-section of the welded specimens W1, W2 i W3 (specimen without insulation W). Etch. Nital

The specimens presented in Fig. 2 and 3 show full depth of fusion and fully filled groove, only the specimen C2 exhibited undercuts in face of the weld. In case of underwater welding such defects are caused by an improper angular position of electrode against welded element. The remaining joints have a correct, symmetrical structure. On all specimens the wide heat affected zone caused by influence of the water present inside and outside the pipe, can be observed. In the insulated specimens (C1, C2, C3), the HAZ covers a smaller area than in the specimens without insulation (W1, W2, W3). It can be explained by a lower cooling rate of the joint due to presence of polymer coating on pipe surface. The largest fusion penetration was observed in the specimen without

polymer coating (W1) where the largest heat input, equal to 1,52 kJ/mm, was applied.

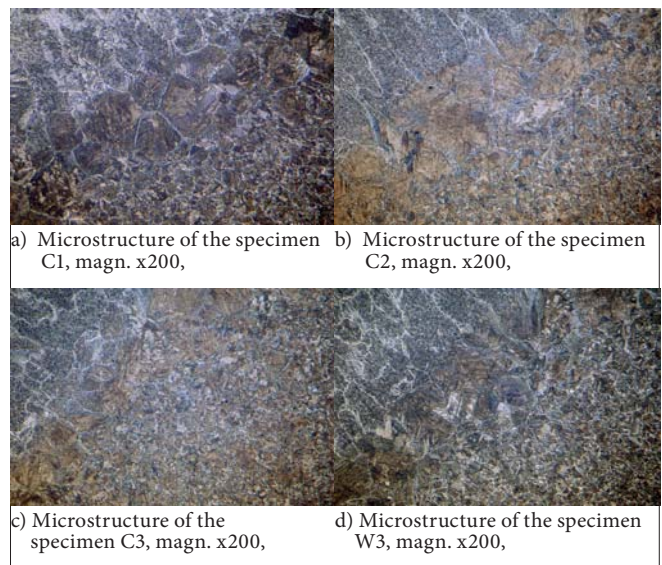
Fig. 5. Microstructure of HAZ in the joints where no cracks were found; a) the specimen C1, b) the specimen C2, c) the specimen C3; d) the specimen W3, magn. x 200

In the welded joints in insulated pipes no cracks were found. Fig. 5 shows microstructures along fusion line of the joints. There are visible characteristic areas: the dendritic structure of the weld, coarse-grain structure of the HAZ, normalized area of the HAZ, as well as the structure of the base material. As can be observed, in HAZ microstructure of the C1 specimen made with the highest value of heat input the biggest grains were formed close to the fusion line, Fig. 5a. In the remaining joints (C2 and C3) size of the grains in the HAZ is significantly smaller, Fig. 5b,c.

The tests revealed presence of trans-crystalline cracks in the HAZ microstructure of the specimens without insulation (W1 and W2), Fig. 6. They are characteristic cold cracks which are formed at high cooling rate of the joint in the conditions of stress and diffusible hydrogen occurrence. In both the specimens the cracks propagated along the fusion line: in the specimen W1 – across the area of bainitic structure (Fig. 6a), and in the specimen W2 (Fig. 6b) the crack occurred in the coarse-grain area of the HAZ. In the specimen W3 welded with the lowest value of heat input no cracks were found (Fig. 5d).

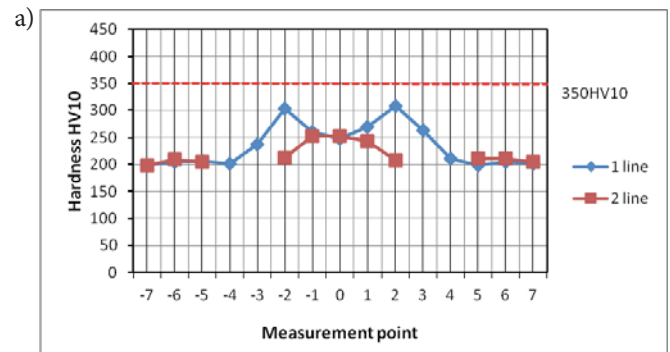
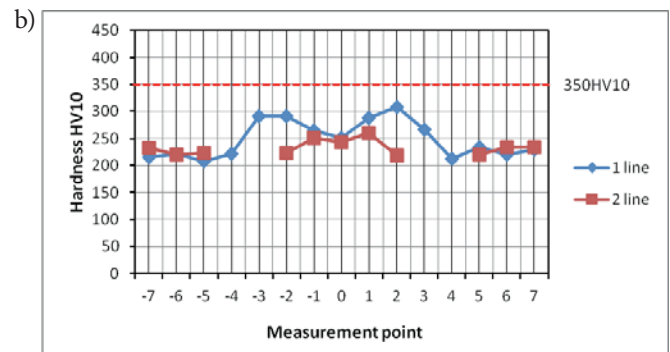
Fig. 8. Distribution of HV10 hardness values along the measurement lines 1 and 2 for the welded joints of the pipes with insulation coating : a) C1, b) C2, c) C3

The hardness acceptance criterion for the tested joints was taken equal to 350 HV10 on the basis of the DNV-OS-C401 Offshore Standard (Fabrication and testing of offshore structures). Maximum hardness values of the HAZ in the insulated pipe specimens amounted from 300 to 318 HV10, hence the values were distinctly lower than the acceptance one equal to 350 HV10. In the specimen W1 (without insulation)

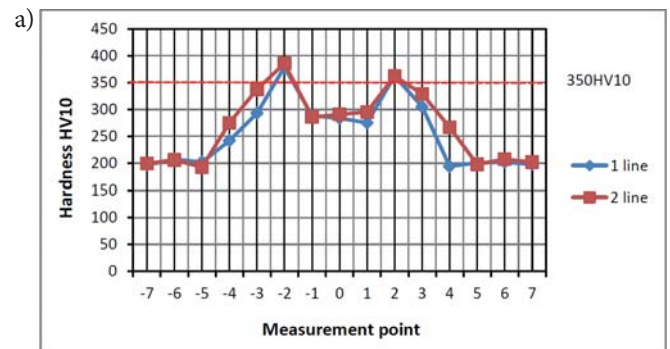
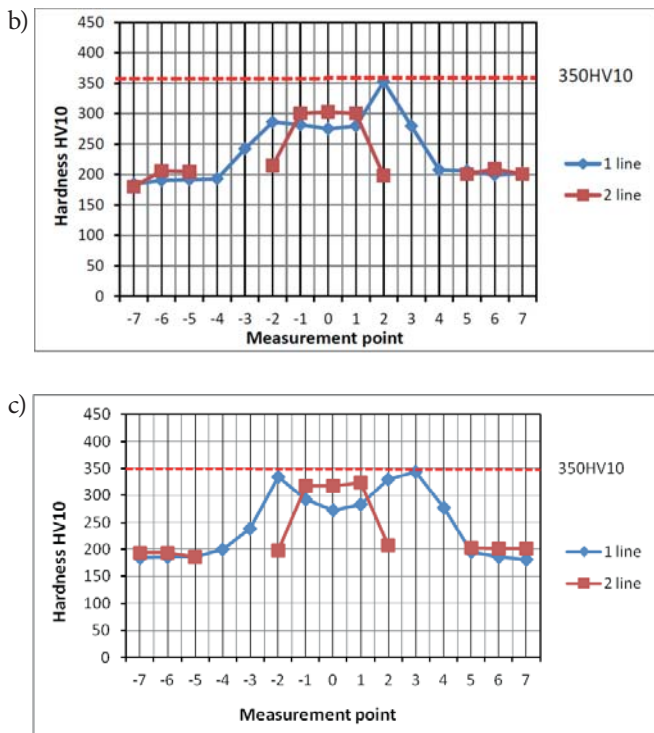
Fig. 9. Distribution of HV10 hardness values along the measurement lines 1 and 2 for the welded joints of the pipes without insulation coating: a) W1, b) W2, c) W3

an excessive increasing of the maximum hardness in the HAZ, up to the level of 386 HV10 and 385 HV10 for the upper and lower measurement line, respectively, was observed. In HAZ of the subsequent specimens without insulation coating (W2 and W3) the maximum hardness values equal to 343 and 353 HV10, respectively, i.e. close to that of the selected criterion, were measured.
