Monitoring of Groundwater in the Area of a Reclaimed Municipal Waste Landfill

Janina Piekutin¹

¹ Białystok Technical University, ul. Wiejska 45 A, 15-350 Białystok, Poland

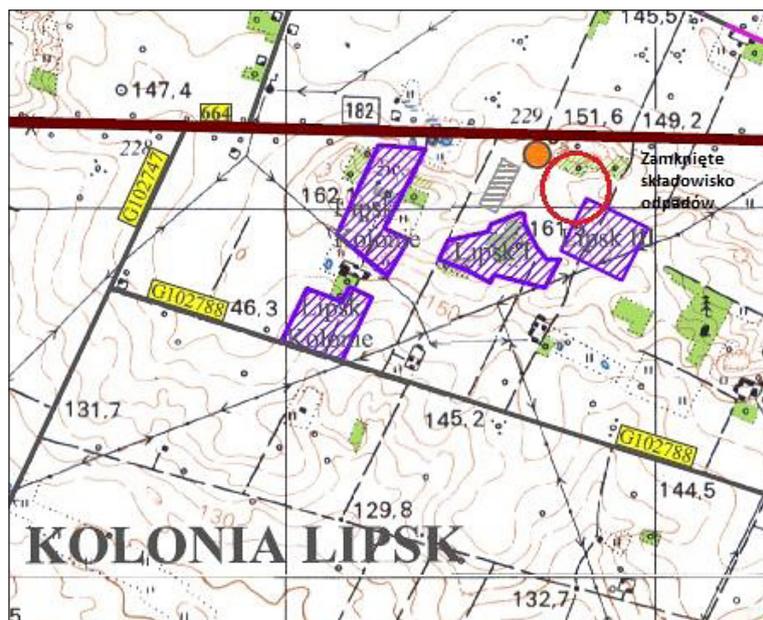
Figure 1. Location of a closed landfill in Kolonia Lipsk

The water for analyses was collected from the piezometers located around the tested landfill. Farm wells, located in households were used as piezometers. These farms are located near the landfill site. The first piezometer was located in the village of Kolonia Lipsk at a distance of about 600 m from the landfill, the second also in the same town at a distance of about 500 m. The third research and control point was located in the village of Kurianka at a distance of about 1000 m from the place of waste depositing. The following parameters were tested in water samples: pH,

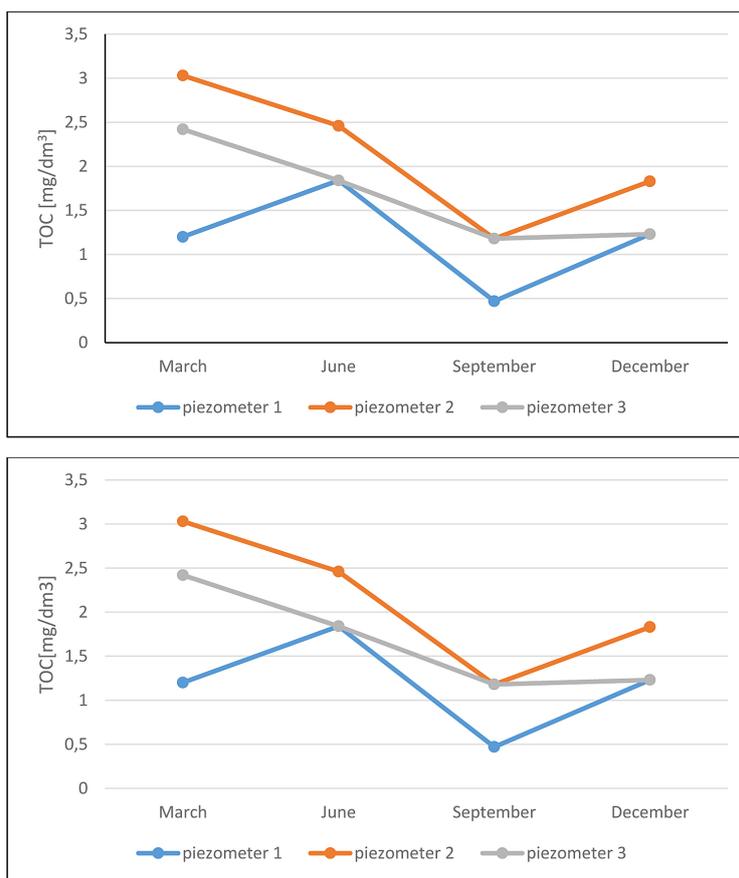
Figure 3. Changes in OWO values in piezometers around the landfill

The concentration of total organic carbon (TOC) is included in the total parameters used to assess the degree of water pollution (Szymański 1999, Regulation 2015). The highest OWO value was found in piezometer No. 2 and amounted to $3.03 \text{ mg}/\text{dm}^3$ (March) (Figure 3). Throughout the

year, the size of this parameter at this point was maintained at a high level as compared to other control points. The lowest concentration of total organic carbon was recorded in piezometer No. 1, $0.47 \text{ mg}/\text{dm}^3$ (September). The content of the discussed parameter in the tested waters was variable. This indicates the impact of the deposited wastes on the state of groundwater pollution near the landfill in the town of Kolonia Lipsk (Wiater 2011, Szymański K. 1999, Tałałaj 2003).

The increased PEW values prove that the mineral substances that come from mineral waste stored in a landfill infiltrate into the waters and they can also be caused by the incoming anthropogenic pollution. The content of TOC in groundwater is the effect of the effluents entering the waters. There are sand and gravel deposits in the area of the landfill, which caused the pollution to penetrate without any obstacles.
