IMPACT OF BUILDING WALLS OF HISTORIC OBJECTS FROM HALF-TIMBERED WALL IN THEIR STATE OF THERMAL PROTECTION

Agnieszka SZYMANOWSKA-GWIŹDŹ¹, Tomasz STEIDL²
The Silesian University of Technology; Gliwice, Poland

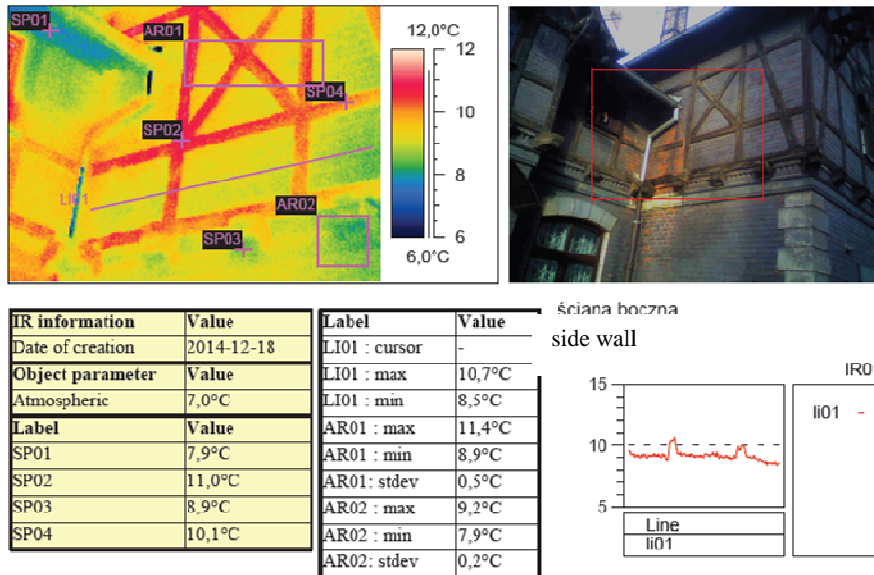
Fig. 5. Thermogram made on the outside of the building of State Music School in Gliwice

Thermographic survey was carried from the premises floors side, enclosed with frame construction, and from the facade of the building. As a result one obtained thermograms (Figure 4 and 5) showing the temperature at several selected points marked with a cross and the number (e. g. SP01, SP02) and areas (spaces) corresponding to the characteristic distributions of temperatures on tested barriers (e. g. AR01, AR02). For such marked areas, values of minimum and maximum temperatures were determined.
