# Monitoring system for the construction of buildings in the area of mining exploitation impact

## Abstract

This study presents the results of measurements conducted on a testing ground that includes three special-purpose building structures located in an active mining area.

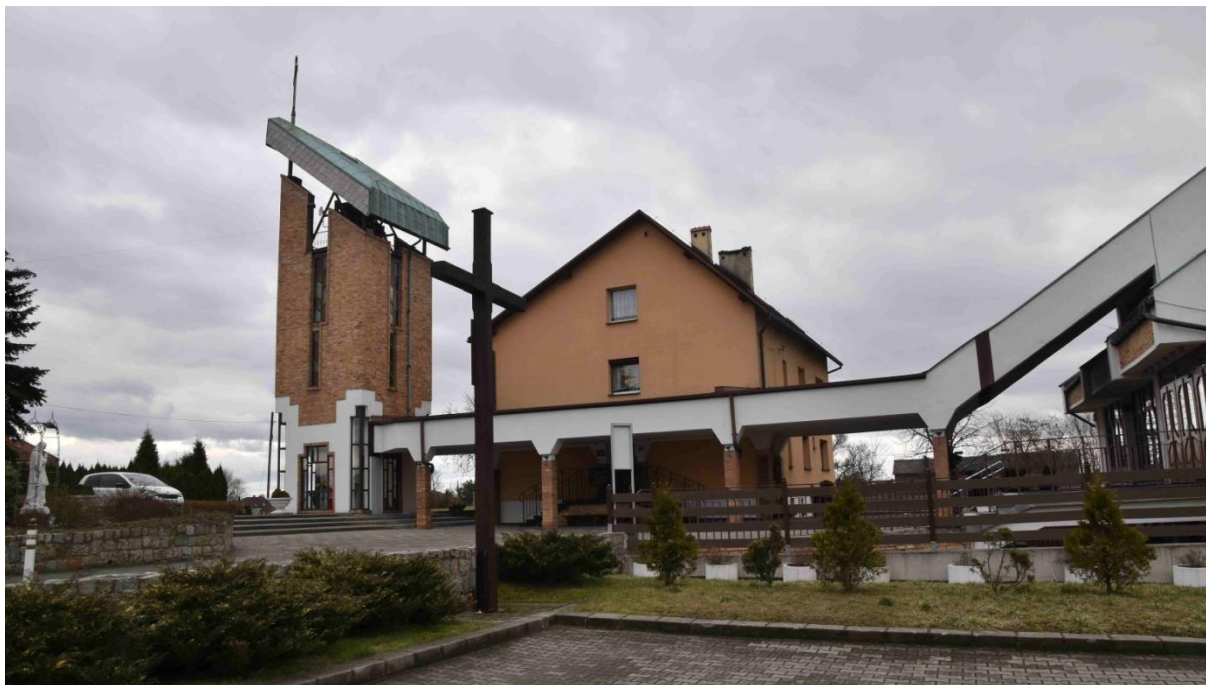
**Fig. 3** Structure A of the testing ground - bell tower, parish buildings visible in the vicinity

Structure A – is a free-standing bell tower that is part of the development of the church complex. Architecturally, the tower is connected to the church and rectory building by an elongated pergola (Fig. 3).

At its highest point, the tower is approx. 15.00 m high, built on a quadrilateral plan with a horizontal projection of approx.  $4.50 \times 4.70$  m. The tower structure is founded on a slab foundation. The walls up to a height of approx. 4.00 m are reinforced concrete, above that they are clay brick. The vertical cross-section of the structure distinguishes three storeys, with reinforced concrete floors. Additional bracing of the tower structure is provided by a steel frame, made of rolled sections, mounted on two storeys: from the 4.25 to 10.30 m level. The bracing structure was constructed in 2015 as a protection of the building against the effects of mining, after numerous cracks were observed, visible on the external and internal planes of the walls.

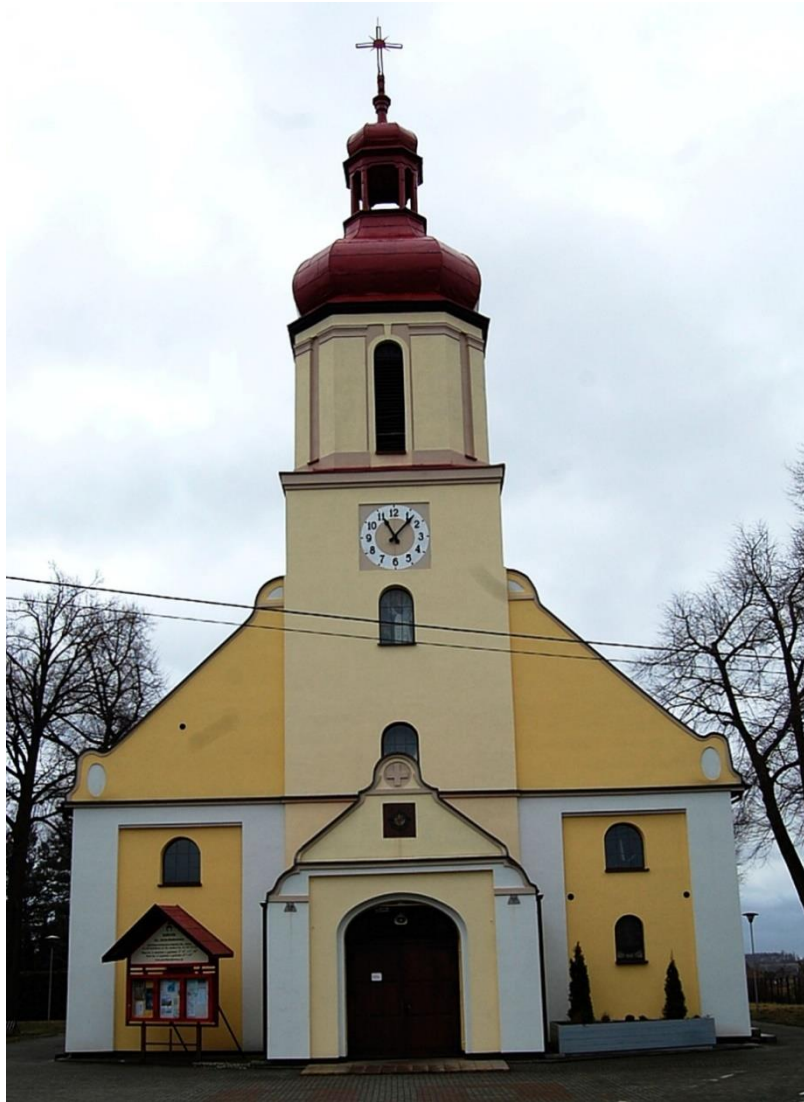
**Fig. 4** Structure B of the testing ground - church building, visible bell tower and main entrance

Structure B - is a church building, built around 1922 on a single nave plan, with a bell tower on the side of the main entrance (Fig. 4).

The length of the church building, including the chancel and vestibule, is approximately 41.50 m, with a nave width of approximately 17.00 m. The height of the bell tower structure is approximately 27.70 m. The above-ground part of the building is built in traditional masonry construction. The foundations of the church are made of rubble stone, the walls of burnt brick with lime mortar. The ceiling over the nave is wooden, suspended from the wooden roof truss. The bell tower is brick in the lower part and wooden in the upper part. The nave side of the tower has a choir balcony, which is of reinforced concrete, supported partly on the masonry wall of the tower and partly on two brick columns. The staircase to the choir and in the lower part of the tower is reinforced concrete; in the higher part of the tower it is wooden, ladder-like. The church structure has been reinforced with a reinforced concrete ring around the nave, external pilasters and internal tie-beams in the ceiling plane.

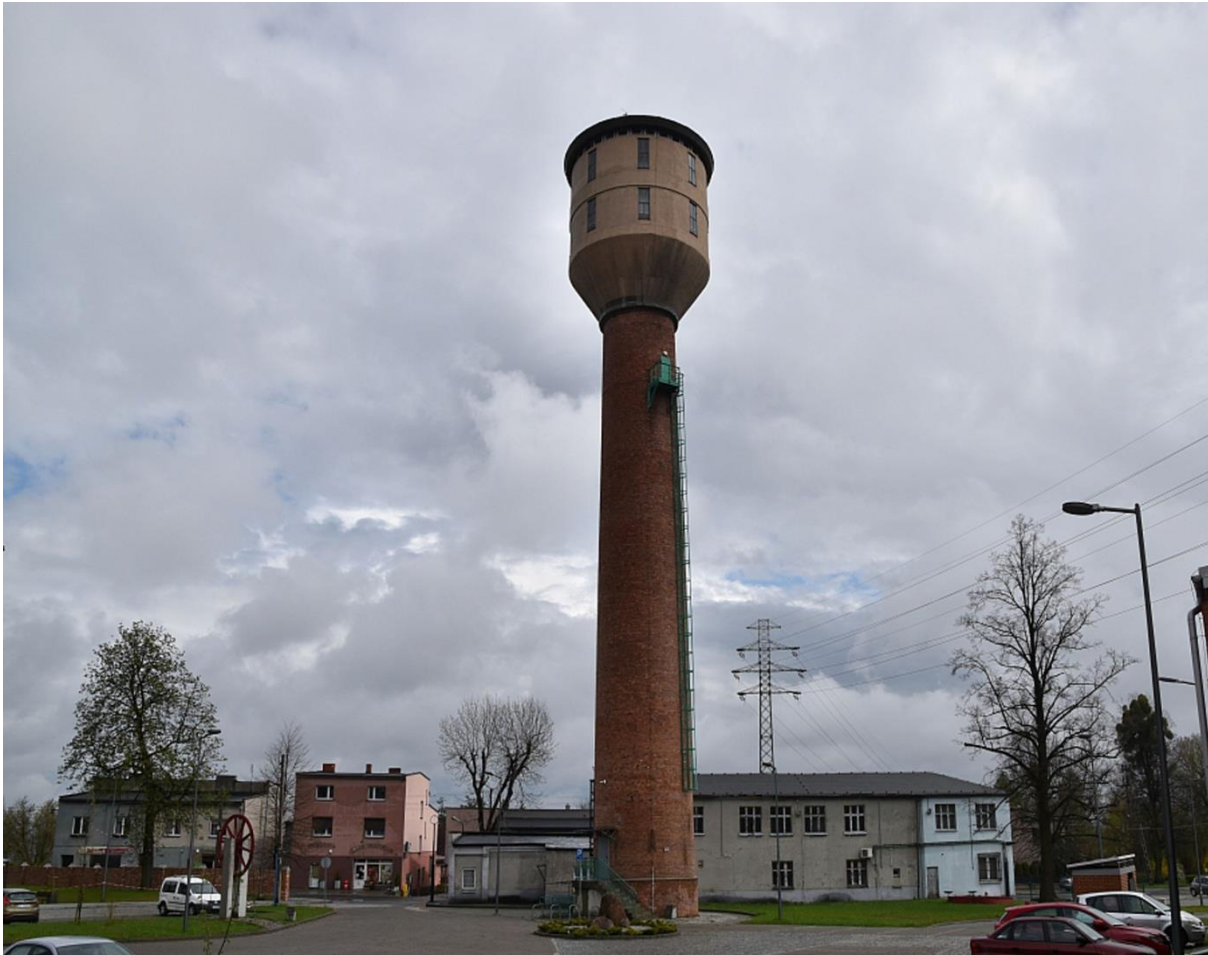
**Fig. 5** Structure C of the testing ground - view of the viewing tower after the rehabilitation of the industrial water tower

Structure C - is a viewing tower, opened to the public after the post-mining facilities were rehabilitated (Fig. 5).

The tower structure is the remains of a brick chimney built around 1880. In 1952, as part of an adaptation, the height of the chimney was reduced and a steel industrial water tank was installed on top. The structure served as a water tower until 1994. Today, the tower is open to the public as a viewing point. The core of the tower, made of solid brick, is 35.00 m high. The outer diameter at the base is 6.00 m, with a wall thickness of 1.00 m. At the level of the top of the shaft, the diameter is 4.60 m and the wall thickness is 0.50 m. The tank has an internal diameter of 8 m. The total height of the structure, the tower including the tank, is 45.00 m. Inside the core of the tower, there is an accessible staircase leading to the viewing platform.

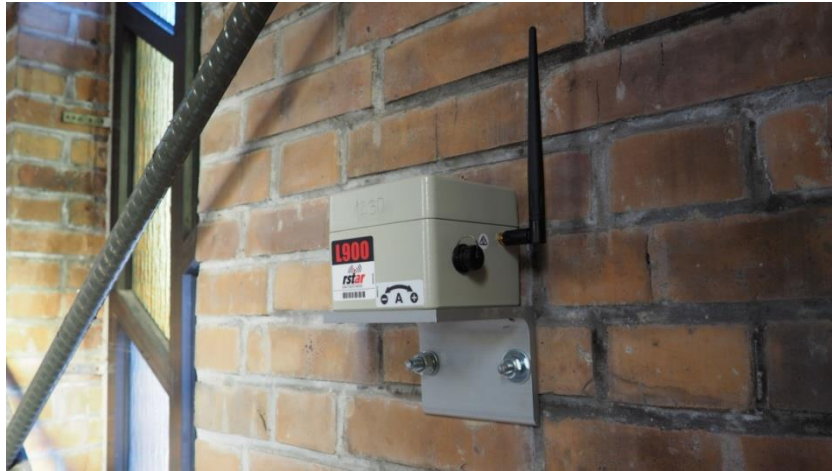
**Fig. 6** Biaxial tilt sensor - visible mounting method using a steel bracket anchored to the wall of the structure

The measurement equipment used on the testing ground were tilt meters produced by RST Instruments Ltd., specifically the DTL202B model (Biaxial Digital Tilt Loggers), which utilise MEMS (Micro-Electro-Mechanical Systems) technology. These meters allow for measuring the tilt of an element in two planes. The measuring range of the instruments is  $\pm 15^\circ$ , the resolution:  $\pm 0.0006^\circ$ , non-linearity  $\pm 0.002^\circ$ . The devices have 4 MB built-in memory and a 5-year battery capacity; they allow operation with the RSTAR radio transmission system (distributed sensor topology) and the DT Link radio transmission system (sensor-hub topology). During the measurements on the testing ground, the equipment operated in the sensor-hub topology, with the tilt logger data transmitted to a hub, and then via a USB connection to a computer. The plan is to launch a system that allows for remote reading of measurement data.

The system installed on the structures performs automatic measurements at a user-defined frequency of every 6 hours. The measured quantities are the sine values of the tilt angles in two planes (TILT 1, TILT 2). The sine values are provided with an accuracy of up to 6 decimal places. Proper mounting of the sensor using a custom-made steel bracket (Fig. 6) ensures that the measurement yields the sine values of the tilt angles in the axis parallel and

perpendicular to the wall to which the sensor is attached. This enables the determination of the tilt magnitude and the calculation of the tilt vector direction. The measurement readings are then converted into appropriate units, such as angle measurement in degrees or tilt in millimetres per metre [mm/m].

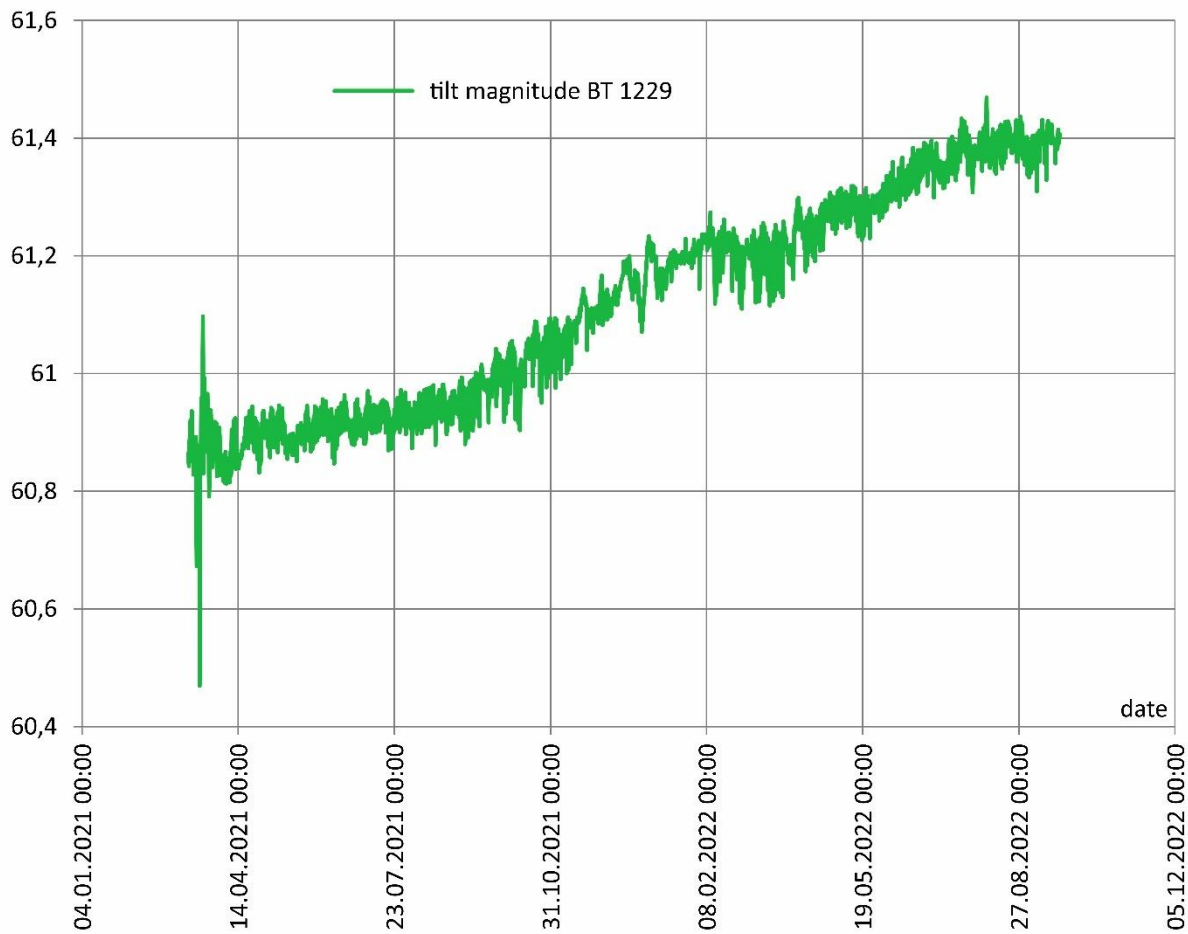
**Fig. 8** Structure A of the testing ground - tilt magnitude of sensor BT1229 [mm/m]

Figures 8 and 9 present the tilt magnitudes of sensors BT1229 and BT1230 recorded from March 2021 to October 2022. It is noticeable that the tilt magnitude of sensor BT1229 is significantly larger, ranging from approximately

60.8 mm/m to 61.4 mm/m, while the tilt magnitude of sensor BT1230 is considerably lower, around 10.0 mm/m. This indicates that the tower walls were already tilted before the installation of the sensors, and their planes are not perpendicular. As the tower structure has been influenced by mining activities in the past, resulting in tilting and deformation of the masonry, this observation aligns with the actual condition.

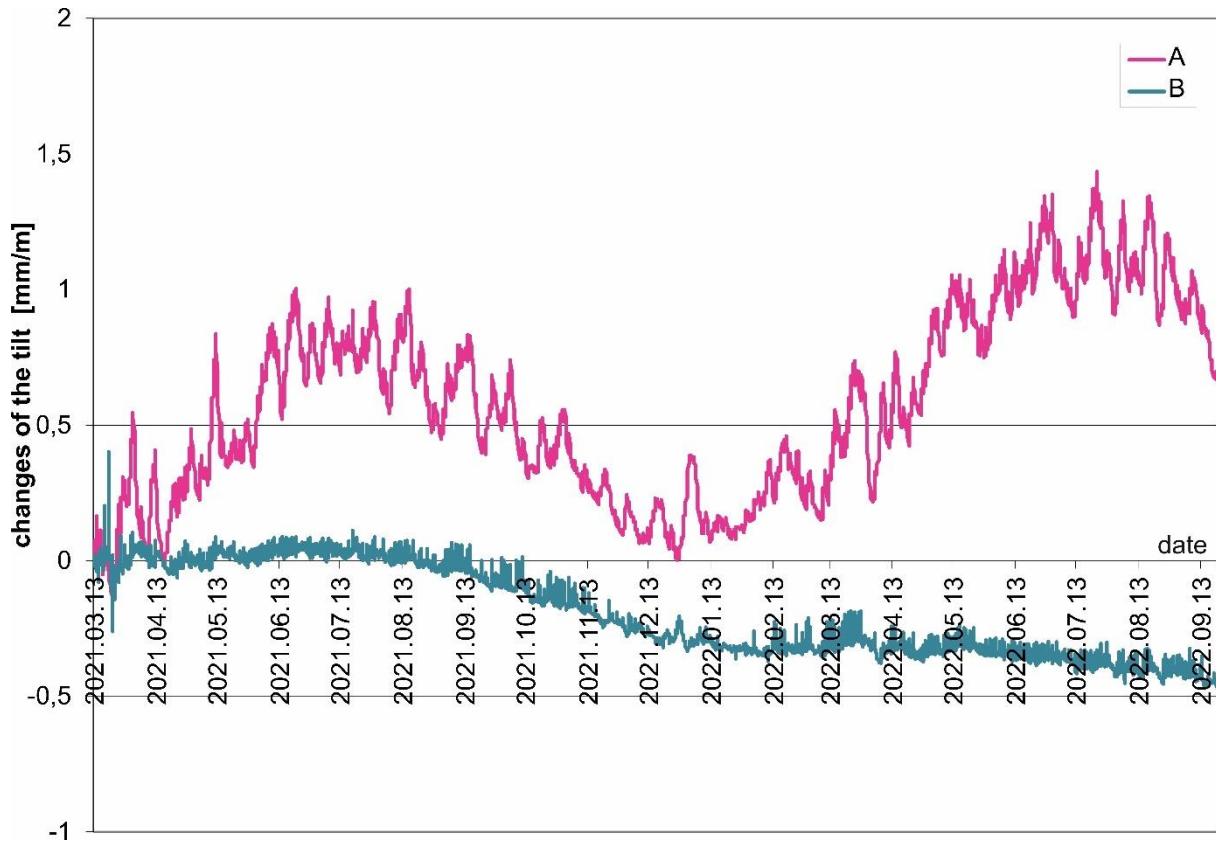
**Fig. 10** Structure A of the testing ground - sensor BT1229, changes of the tilt [mm/m] measured on axes A1: E-W and B1: N-S, from March 2021 – September 2022

Figures 10 and 11 display the variations in tilt on the sensor axes. Using the measurement results, it is possible to analyse the spatial behaviour of the closed-section masonry structure, which was subjected to mining activities in seams 703/1-2 and 713/1-2 from March 2021 to September 2022 (see Fig. 2).

By comparing the measurement results of recorded wall tilts with the location of mining plots relative to the structure, it can be concluded that the main influence during the period from March 2021 to September 2022 came from fields 713/1-2 marked as IVE1, VE1, XE1, and XIE1. In relation to the structure, the predominant direction was southeast-southwest (measurements B1: 0.0 mm/m to 0.5 mm/m; A2: -0.4 mm/m to +0.2 mm/m; B2: -0.8 mm/m to +0.2 mm/m). Recorded on sensor BT1230, the dominant tilt in the N-S direction (measurement A1: 0.0 mm/m to 0.5 mm/m, 0.0 mm/m to 1.5 mm/m) illustrates the influence of mining in field IV-E-E1. A characteristic feature of the measurement results on the sensors is the registration of slight tilt values with changing directions (+/-) over time. For a masonry structure, this means that its geometry undergoes dynamic changes in a short period, affecting stress distributions in horizontal and vertical cross-sections of the wall. This observation is particularly important for assessing the impact of these changes on the disintegration process of the wall, which occurs due to variable directions of influence, even with small magnitudes.

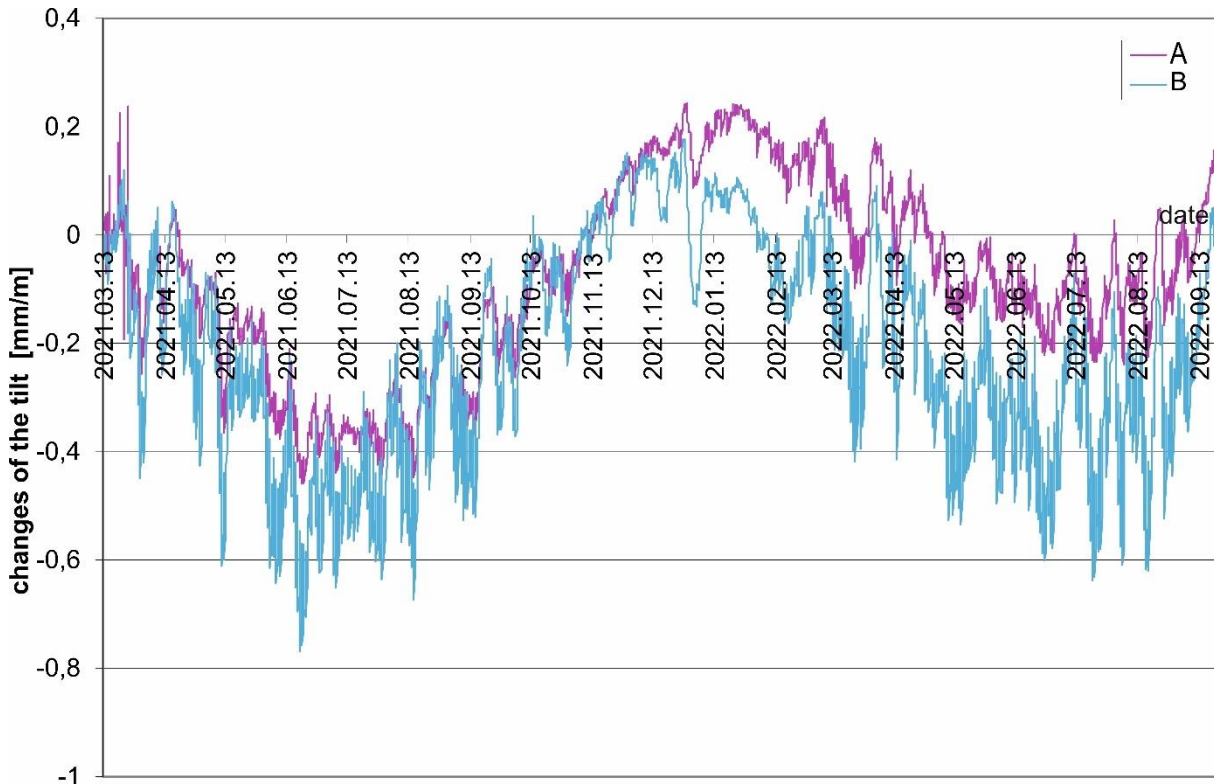
**Fig. 11** Structure A of the testing ground - sensor BT1230, changes of the tilt [mm/m] measured on axes A2: N-S and B2: E-W, from March 2021 – September 2022

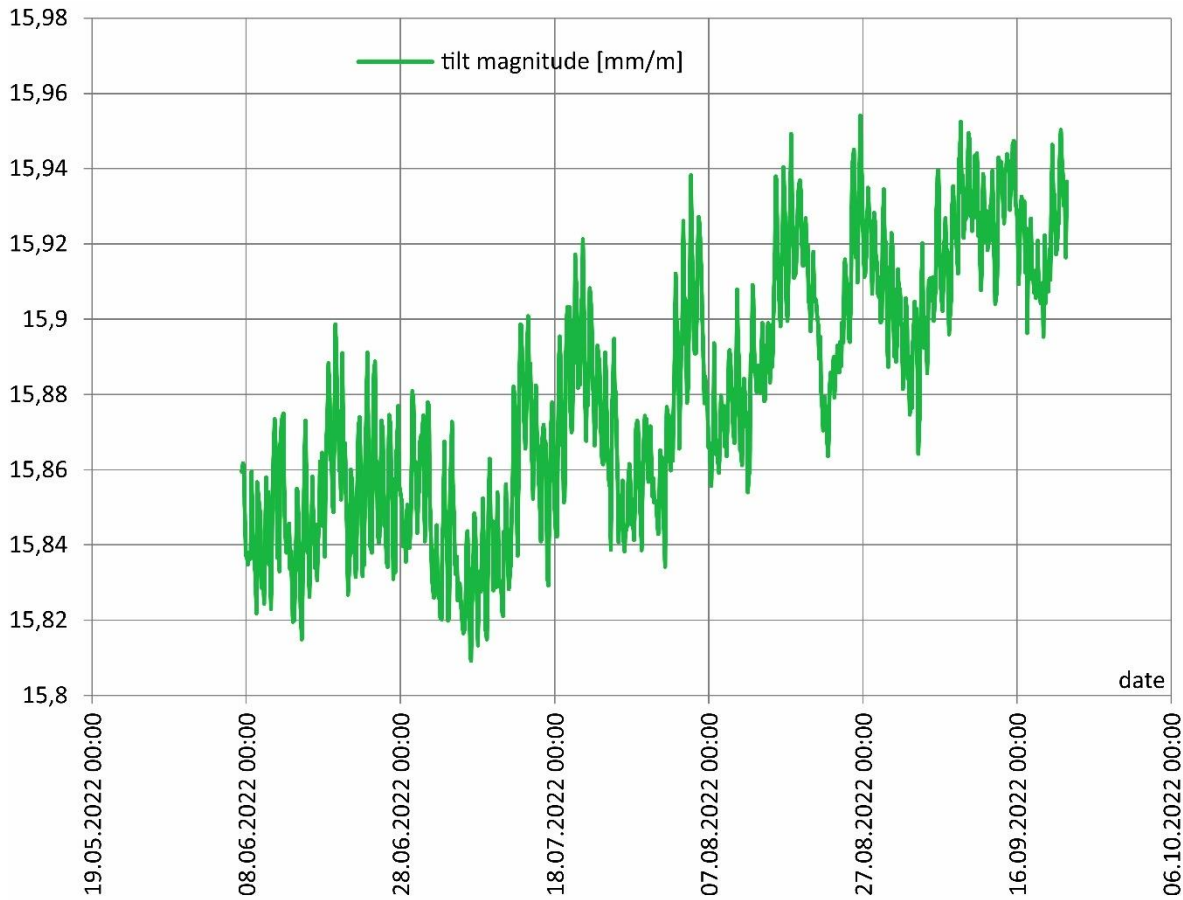
**Fig. 12** Structure B of the testing ground - tilt magnitude [mm/m] recorded on sensor DT050727

Measurements on Structure B began in June 2022. The nature of this structure differs from Building A, despite both serving as bell towers. Tower A is essentially a separate structure from the church, while the tower in Building B is an integral part of the church's structure. As seen in Figure 12, it was already tilted due to previous mining activities on the building. The initial tilt magnitude was approximately 15.8 mm/m. The variations in tilt during the

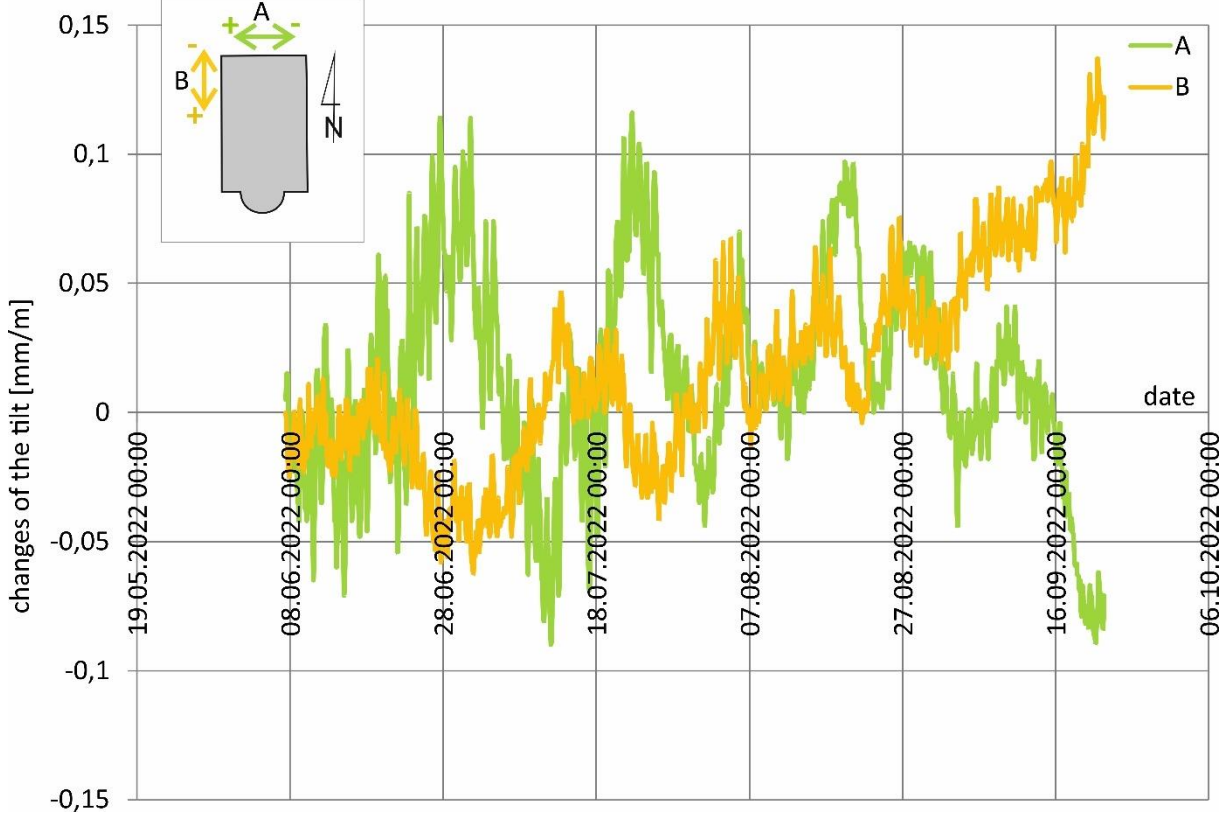
**Fig. 13** Structure B of the testing ground – changes of the tilt [mm/m] over time, sensor DT050727

observation period are shown in Fig. 13. The recorded values demonstrate a slow deformation process, but the measured magnitudes so far do not pose a threat to the safety of the structure.
