Mining Activities in the České Středohoří Mountains Protected Landscape Area

Abstract

Keywords: the České středohoří Mountains, Protected Landscape Area, volcanic relief, quarrying, human induced damages, D8 highway

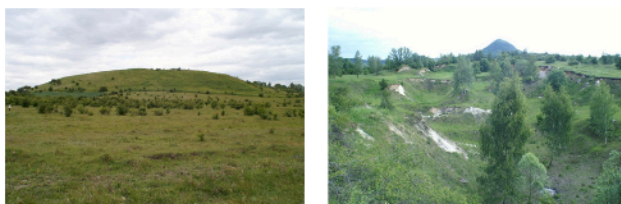
Fig. 2. The Písečný vrch near the village of Bečov
Rys 2. 2. Písečný vrch w pobliżu wsi Bečov

maar of Písečný Vrch – Sandy Hill – near the Village of Bečov) (Fig. 2). The main phase of utilizing local sources came with the medieval development of residential places. Nevertheless, there was no serious survey; old drawers simply used to set-up quarries and extract sources until they stroke altered rocks, tephra or their hardened forms.

This maar was a rich source of quality quartzite in prehistoric times. The hill is now covered with scrub (here the situation in 2009).

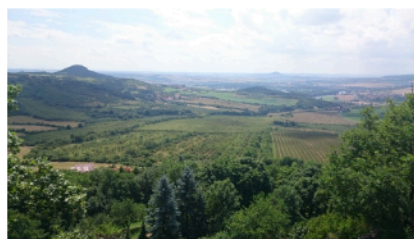
Fig. 3. The Radobýl is a lonely hill near Litoměřice and was exploited in two ways – in addition to a large wall quarry on the western slope, quality limestone was mined here by a system of underground chambers

Radobýl – described in the following chapter (underground limestone mining) it was also affected by a huge, abandoned shelf quarry (Fig. 3).

crust. After this crust is damaged or eroded, loosened grains screen out and the process can continue deeper and deeper. There are also abandoned limestone deposits – for example Radobýl (Fig. 3 above) hill near the City of Litoměřice. The deposit was accessible via an adit below the volcanic complex. During the WWII, the underground labyrinth was utilized by Germans for producing aerial components, having its own “accessory” concentration camp and even its crematory. Now inaccessible, the mine serves as the deposit of radioactive wastes from hospitals and laboratories.

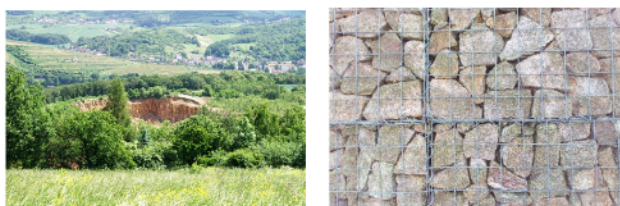
Fig. 5. The Kubo quarry near Malé Žernosky is almost perfectly hidden from human eyes. Quarry stone as one of the products; here the filling of gabions

Kubo – established in 1842, this open pit quarry is almost perfectly hidden in the terrain above the Labe river (left bank). Lying some 3 km from the City of Lovosice center, it is still the source of superior construction stone (walls, beddings, gabions, decorative elements (the stone is cut or cleaved and polished) and even of various crushed fractions for transportation purposes (Fig. 5). The stone is probably of the Carboniferous age, being a part of the so called Altenberg Caldera. [16]

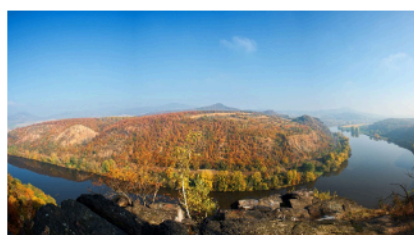
Fig. 6. Panoramic image reveals a series of smaller wall quarry in the ortorula of the Czech Gate. The dark hill in the background of the picture is the Radobýl [21]

are huge blocks of crystalline rocks [17] with several smaller quarries close to the railway line from Litoměřice to Ústí nad Labem (the Labe right bank), (Fig. 6). The stone was identified as a kind of red ortogneiss. The same material had to be removed from the left bank in the course of building the railway between Praha and Děčín (before 1850). Blocks were considered a result of vertical uplifts caused by the Tertiary lavas, other authors emphasize fault systems [3], [15]. Both railway lines are protected by safety nets now.

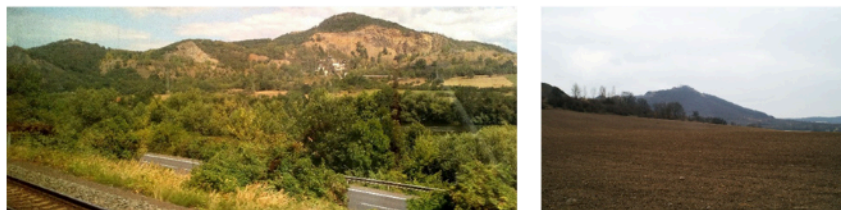
Fig. 8. Deblík, the highest hill slightly to the right, is now only a technological base (left); mining takes place in neighbouring Trabice; Trabice and the broken horizon line (right)

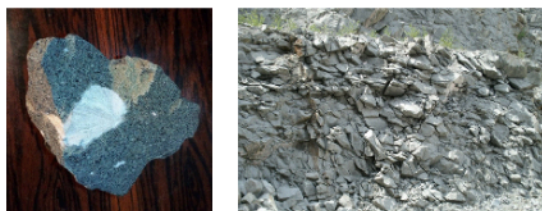
Fig. 9. Natrolitic trachyte, mined by the quarry in Mariánská skála; fracturing of the rock as a result of stress relief during the outcrop of the massif (laccolith) during Saxon tectogenesis

Mariánská skála (Marienberg) in Ústí nad Labem – this open pit quarry was established inside a huge massif near the Ústí nad Labem center. In medieval times, the rock was a good source of construction material which enabled to build the whole borough by virtue of smaller quarries. Originally the massif extended into the Labe river; rocks had to be partly blasted off because of building the railway line between Prague and Děčín (later Dresden). J. E. Hibs, a famous Vienna mineralogist, called the stone Marienbergite (he often saw minor differences in mineral composition and called such rocks according to the place of their occurrence). Of course, from the present-day point of view it would be somewhat impractical – the rock is generally called phonolite and more exactly natrolitic trachyte (Fig. 9a) [8]. The quarry itself was opened inside the massif; because of strict spatial limits, it could only proceed downwards to the level of about 90 meters below the rock surface (present day situation). The stone seems crushed (Fig. 9b) but reasons are very different. The massif (called laccolith) was slowly uplifted and after opening the quarry, the internal stress got loose. The future of this quarry is not sure; spatial limits are still very strict.
