## INCREASED TEMPERATURE AND LONG-TERM IMPACT OF THE AGEING PROCESS ON CHANGES IN THE MICROSTRUCTURE OF THE HR6W ALLOY

The study was carried out to determine the effect of long-term ageing (1,000 and 10,000 hours) at 700°C and 750°C on the microstructure of the HR6W alloy. The study indicates that the long-term effect of high temperature causes significant changes in the microstructure of the examined alloy:

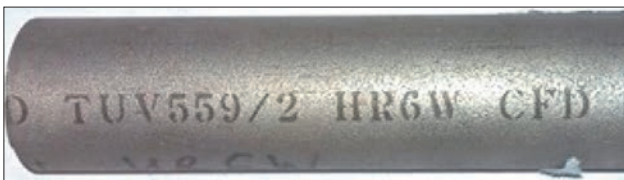
Fig. 1. Section of an HR6W (23Cr-45Ni-6W-Nb-Ti-B) alloy superheater coil

φ38×8.8 mm coil segment made of the as-delivered HR6W (23Cr-45Ni-6W-Nb-Ti-B) alloy, which is shown in Fig. 1, was obtained for testing. Table 1 presents the chemical composition of the tested superheater section in relation to the requirements of the standard.

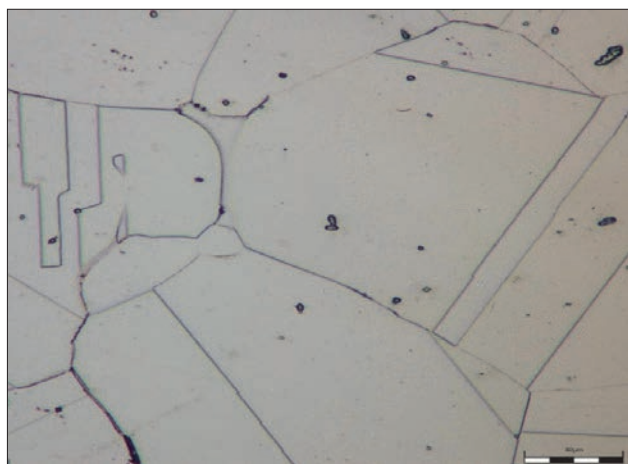
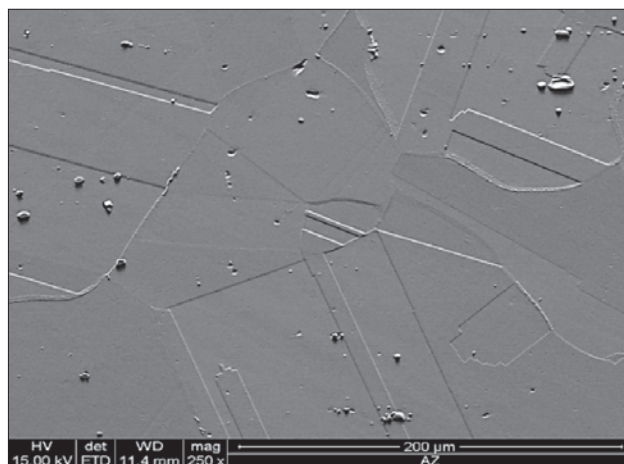
Fig. 2. Microstructure of the as-delivered HR6W alloy (LM)

The as-delivered HR6W alloy after solution heat treatment has an austenitic microstructure with a small content of primary carbides (Nb,Ti)C. Figure 2a shows the alloy's microstructure observed using a light microscope (LM). Figure 2b shows the microstructure observed using a scanning microscope (SEM).

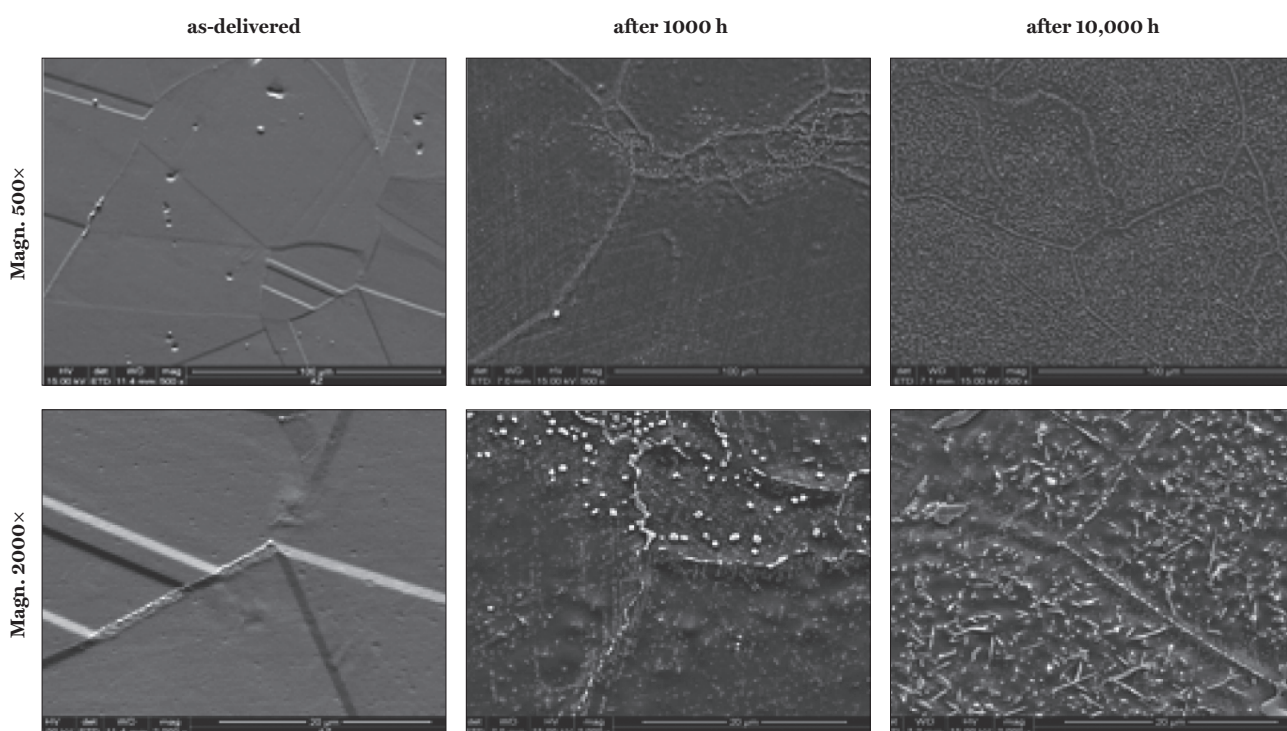
Fig. 3. Comparison of the microstructure of the HR6W alloy as delivered and after ageing at 700°C

The image of the observed microstructure of the HR6W alloy after ageing (time  $t = 1,000$  and 10,000 hours, temperature  $T = 700^\circ\text{C}$ ) differs from the as-delivered microstructure (Fig. 3).

It was shown that the ageing process of the HR6W alloy intensifies the processes of precipitation of secondary phases. In the microstructure along grain boundaries, an increase in the number of and size of M<sub>23</sub>C<sub>6</sub> precipitates and intermetallic phase – Fe<sub>2</sub>W Laves rich in tungsten was observed. Evenly distributed fine precipitates of M<sub>23</sub>C<sub>6</sub> and MX carbides were observed inside the HR6W alloy grains. The beginnings of Laves phase precipitations were observed inside the grains in the form of elongated particles (1,000 hours), while after a longer time (10,000 hours) a significant increase in the Laves phase inside the grains in the form of elongated particles of irregular shape was observed.

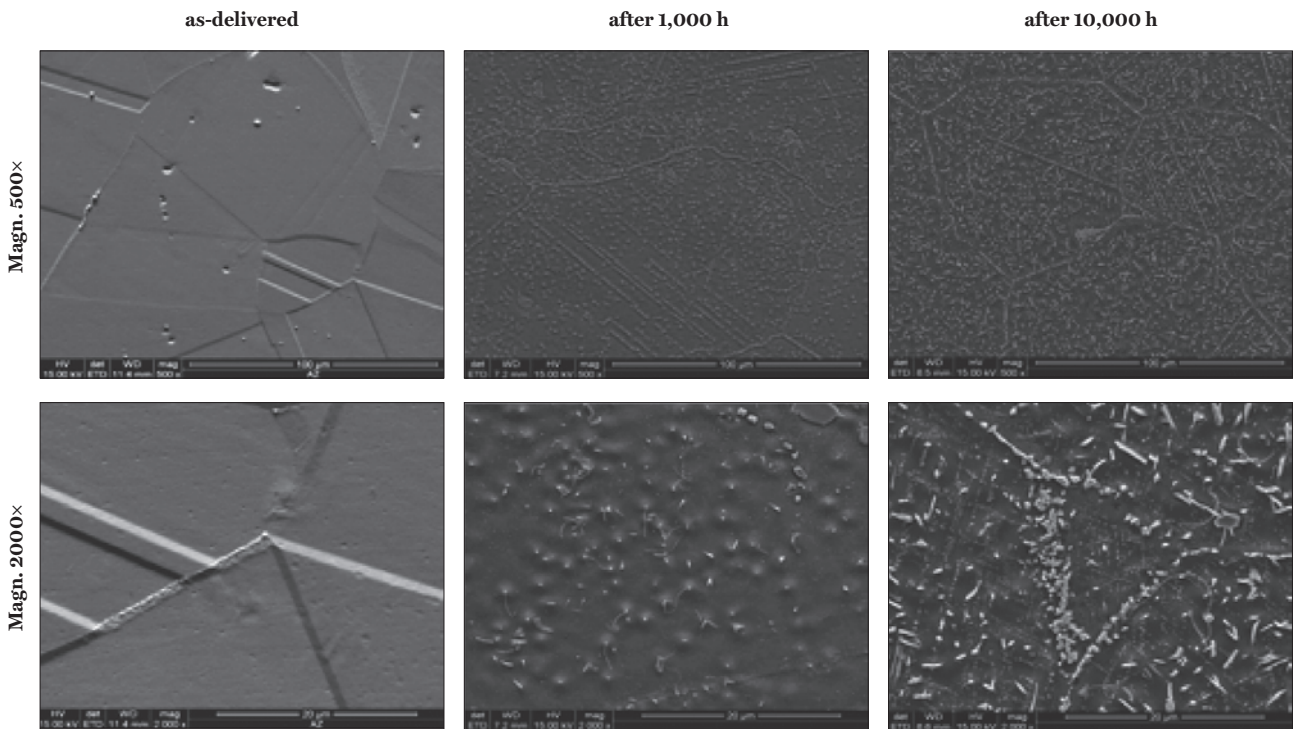
Fig. 4. Comparison of the microstructure of the HR6W alloy as delivered and after ageing at 750°C

The increase of the ageing temperature to 750°C caused a significant acceleration of the **precipitation process after just 1,000 hours**. In addition to a network of  $M_{23}C_6$  precipitates along austenite grain boundaries, their coagulation and an increase in the size of the Laves phase precipitates inside the austenite grains was observed. The extension of the ageing time to 10,000 hours at 750°C contributed to a significant increase in the size of Laves phase precipitates inside austenite grains (Fig. 4).

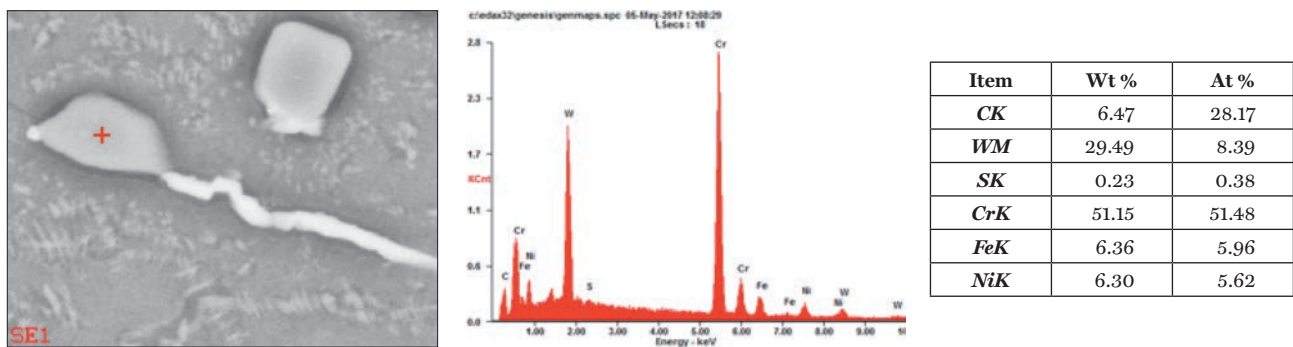
Fig. 5. Analysis of the chemical composition of the  $M_{23}C_6((Cr,Fe,W)_{23}C_6)$  precipitate in the HR6W alloy after ageing for 1,000 hours at 700°C

After the ageing of the tested material, the microstructure was investigated using light microscopy (LM), scanning electron microscopy (SEM) and transmission electron microscopy (TEM), as shown in Fig. 5–8.

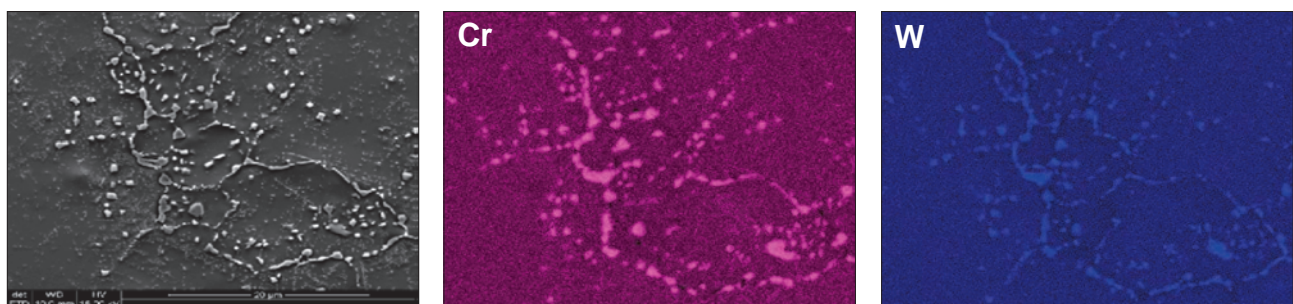
Fig. 6. Distribution of chromium and tungsten concentration in the microstructure of the HR6W alloy after ageing at 700°C for 1,000 hours. SEM observation (map of precipitates)

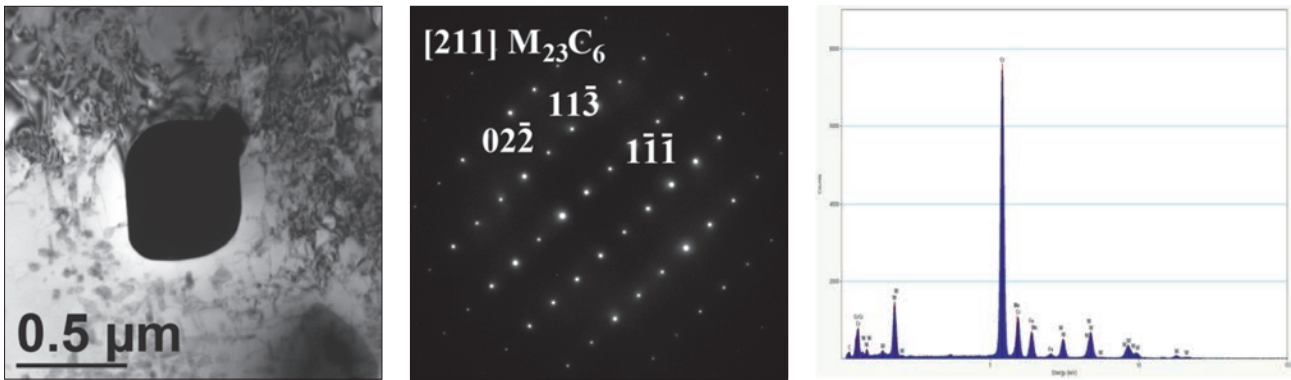
Fig. 7. Identification of the  $M_{23}C_6$  precipitate in the HR6W alloy after ageing for 1,000 hours at 700°C (TEM)

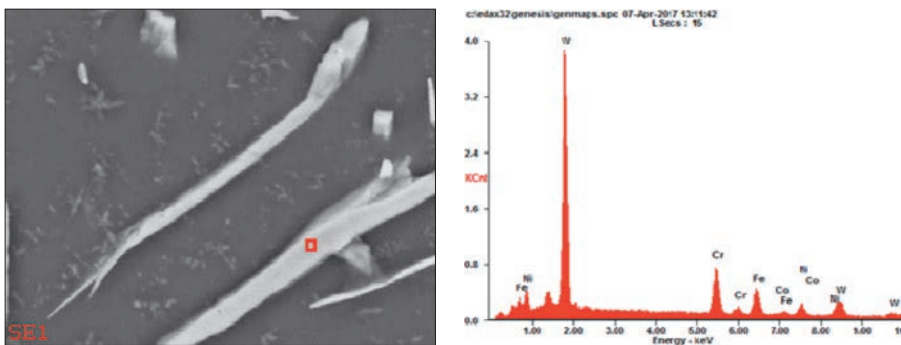
Fig. 9. Analysis of the chemical composition of the Laves phase precipitate in the HR6W alloy after ageing for 10,000 hours at 750°C

After ageing the HR6W alloy at  $T = 750^\circ\text{C}$  and for  $t = 10,000$  hours, the microstructure was investigated using scanning electron microscopy (SEM) (Fig. 9–10).

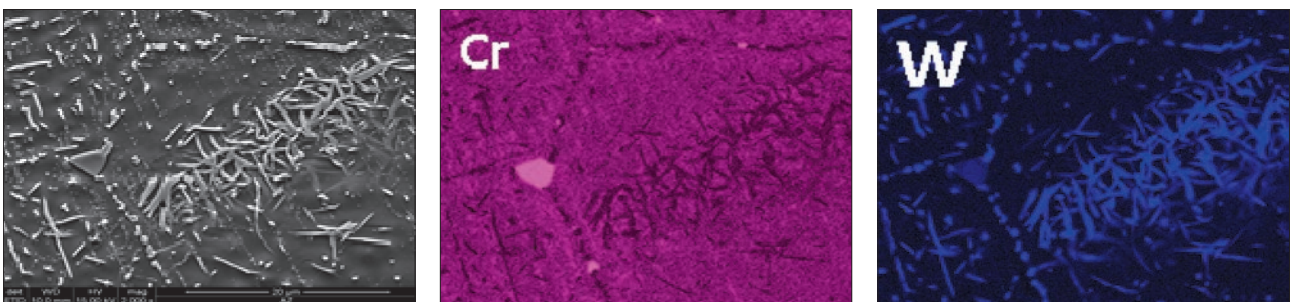
Fig. 10. Distribution of chromium and tungsten concentration in the microstructure of the HR6W alloy after ageing at 750°C for 10,000 hours. SEM observation (map of precipitates)

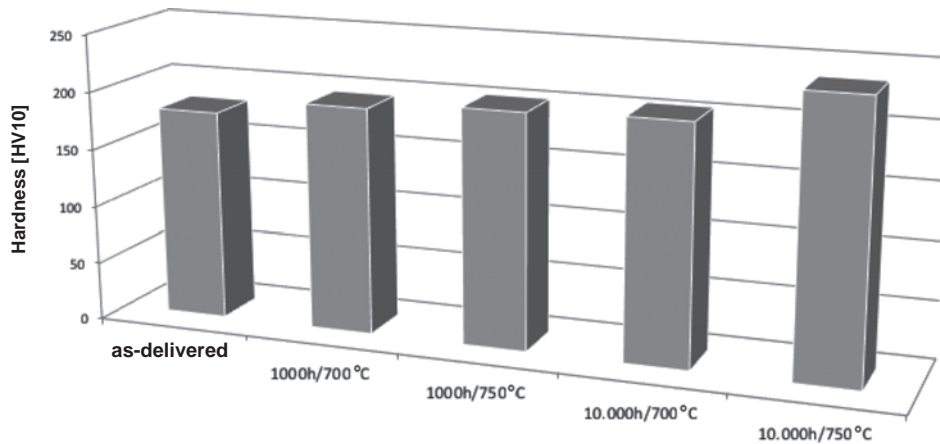
Fig. 11. Graph showing a summary of the average hardness value of the HR6W alloy from measurements (median calculated from 5 unit measurements)

The ageing of the HR6W alloy caused an increase in its hardness. The as-delivered alloy's hardness was approx. 181 HV10. After performing individual heat treatment variants, the hardness of the alloy was:

$t = 1,000$  hours at  $T = 700^\circ\text{C}$  – hardness: 193 HV10

$t = 10,000$  hours at  $T = 700^\circ\text{C}$  – hardness: 205 HV10

$t = 1,000$  hours at  $T = 750^\circ\text{C}$  – hardness: 202 HV10

$t = 10,000$  hours at  $T = 750^\circ\text{C}$  – hardness: 236 HV10.

The increase in hardness of the examined alloy is associated with the precipitation of secondary phases in its structure. Figure 11 presents a graph showing a summary of the average hardness value of the HR6W alloy from measurements (median calculated from 5 unit measurements).
