FATIGUE LIFE TESTING OF THE ROUND LINK MINING CHAINS

Ryszard Kandzia
Thiele GmbH

Mariusz Szot
GIG Research Institute

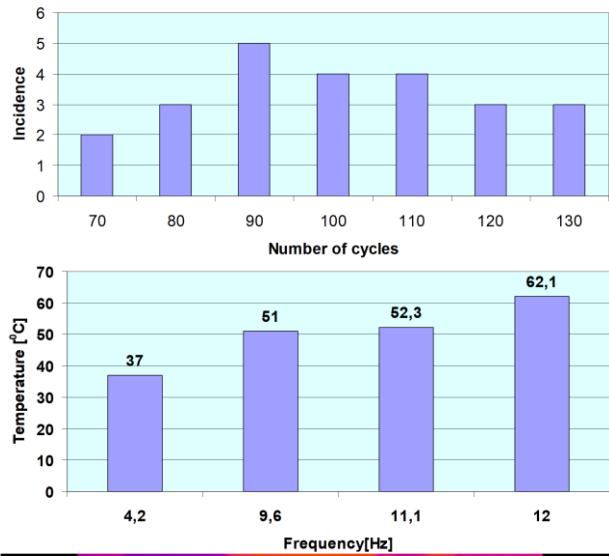
No significant changes were observed when analysing the courses of chain loading and displacement during the test. At the final test stage, failure is preceded by a visible loading decrease and a displacement amplitude increase, which confirms the character of the fatigue process. Temperature recording for the assessed chain link exhibited a rise in the tested object temperature together with the increase in the chain loading frequency during the test and frequency distribution with the results presented in Fig. 3.

Fig. 3 Graph of sample temperature increase as function of loading frequency

The fatigue test results obtained across all 10 samples qualified the chain as fit for operation and highlighted the sample loading frequency to have no influence on the results. The sample loading frequency was found to have an influence on temperature with an increase in temperature being observed as the sample loading frequency increased.

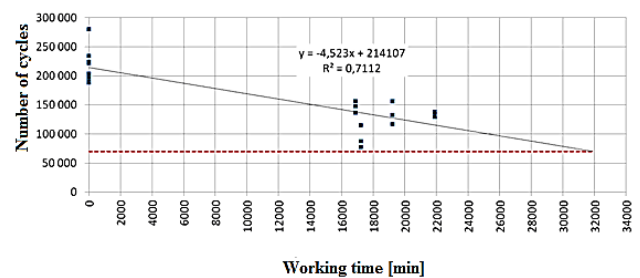
The tested used chains achieved the number of fatigue cycles exceeding 70,000, just as required for new chains by standard DIN 22252. Given the similar characteristics of the tested chains, the loss in fatigue life can be considered collectively with regard to all the tests. The trend of all the tests conducted for the three manufacturers' chains operating from 20.08.2020 to 19.03.2021 is presented as a chart in Fig. 5. It demonstrates that the average operation time required to achieve the standard threshold of 70,000 fatigue cycles is about 32,000 minutes.

Fig. 5 Trend graph of a fatigue endurance decrease as a result of chain operation

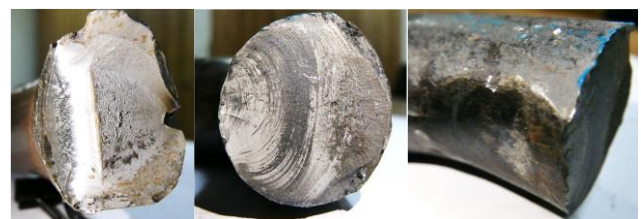
The chain user delivered link fragments for analysis, which constituted the results of plough chain failure during the studied time of operation. Selected pictures of link macro fractures and surface conditions are presented below in Fig. 7.

Fig. 7 Ruptured chain link

In most of the fracture cases, the point of fatigue cracking initiation was the top of the indentation generated on the

inside of the link as a result of its displacement and the impact tension of the link by adjacent links. The exception are Thiele chain links, which fractured as a result of:

The resulting fatigue fractures presented in Fig. 7-11 are in line with typical fatigue damage fractures, and the mechanism and nature of their formation is consistent with those described in the literature [17, 18, 19, 20].

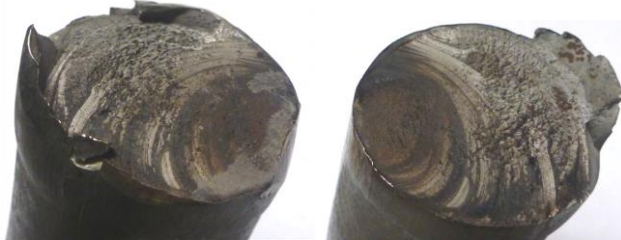
- cracking initiation from the indentation on the outside in the area of friction influence at the weld (Thiele 10.03.2021), Fig. 8,

Fig. 8 Ruptured chain link

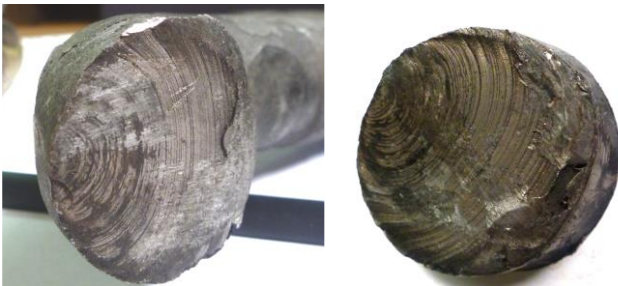
- cracking at the link curve (Thiele 18.03.2021), characterised by a very large focal point of fatigue fracture – a long time of fracture development, Fig. 9.

Fig. 9 Ruptured chain link

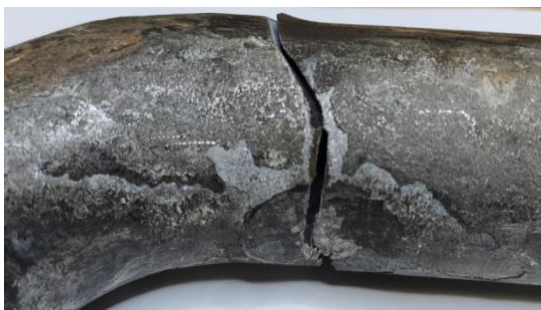
It was therefore decided to examine the influence of mechanical deformation on fatigue life. An indentation was identified on the inside of a supplied used chain strand link. After subjecting a sample taken from this area to fatigue testing, the result obtained was 20,342 cycles. This is considerably lower compared to the strands with normal operational wear. Cracking developed at the indentation, which is displayed in Fig. 10 used Thiele chain link cracking at the indentation.

Fig. 10 Ruptured chain link

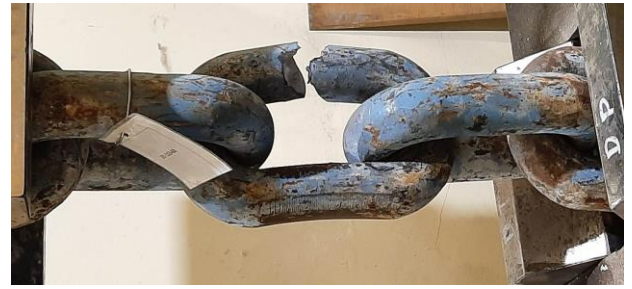
An indentation was identified on the inside of a supplied used chain strand link also in the case of chains transferred back into operation. After subjecting a sample taken from this area to fatigue testing, the result obtained was 25,343 cycles. This is also considerably lower compared to the strands with normal operational wear. The chain is presented in Fig. 11.

Fig. 11 The chain after fatigue testing
