## EXAMINATION AND ASSESSMENT OF THE IMPACT OF WORKING CONDITIONS ON OPERATING PARAMETERS OF SELECTED CONVEYOR BELTS

**Abstract:** The effect of the operation of two textile-core conveyor belts, type B-1600 P-1600/5 8+4 H, which operated in one of the lignite mines, on their strength and operating parameters was determined. During the operation of the belts on the conveyor, the amount and type of spoil transported were recorded, as well as the belt's operating time. The results of tests on the strength parameters of the belts in operation were compared with the results of tests performed on the same belts before their operation.

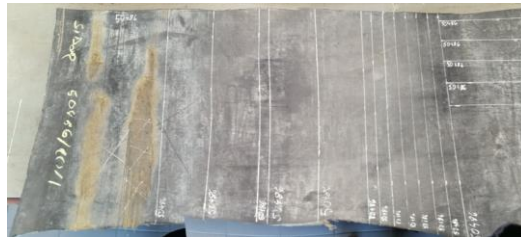
The section of this belt taken for testing was approximately 1555 mm wide and 590 mm long. The thickness of the top cover ranges from 3.8 mm to 4.3 mm, while the thickness of the running cover ranges from 0.2 mm to 2.2 mm. The overall thickness of the belt is between 15.0 mm and 16.4 mm. The hardness of the top cover is 78–79 °ShA, while the hardness of the running cover is 78–81 °ShA. The belt is quite heavily worn, as can be inferred from the thicknesses of the covers and the change in belt width created by edge rubbing. A view of the belt is shown in Figure 1, where the locations from which the samples were taken for testing are indicated. As can be seen, the left side of the belt shows signs of abrasion and damage to the core plies, so this part of the belt could not be used for testing.

Fig. 1. Belt sample A-10, view from running cover side

When comparing the condition of the two belts, it can be seen that the greatest wear on the rubber, as well as damage, is on the running side of the belt, with belt B-07 appearing less worn (Fig. 2). Therefore, it can be assumed that the damage to the belts was not caused by excavated material, but by contact between the belt and the conveyor's structural components. The thickness of the bottom cover of the A-10 belt ranges from 0.2 to 2.2 mm. Due to the insufficient thickness of the cover, it was not possible to test the strength parameters, the abrasion resistance, and the adhesion force between the cover and the fifth ply of the belt core.

The loss in thickness of the belt running covers was most likely due not to the difference in abrasion resistance of the rubber, but also to the conditions of the belt movement over the idlers, which caused the rubbing of the covers and other damage seen in Figures 1 and 2.

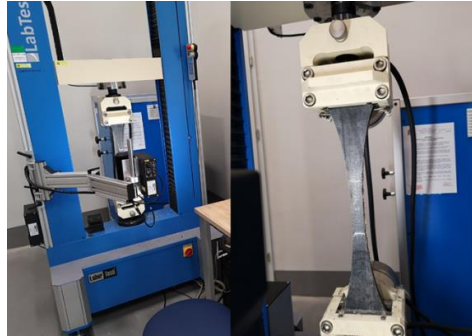
Fig. 3. LabTest 6.100 test stand

stretched at a speed of 100 mm/min until it broke. During the measurement, the stretching force and elongation of the belt were recorded using a video-extensometer. The elongation was measured at a force value that corresponded to 10% of the actual strength of the belt at the moment of breaking. Figure 3 shows the LabTest 6.100 tensile strength belt testing machine, which consists of a 100 kN force sensor located on a sliding machine frame and a video extensometer.

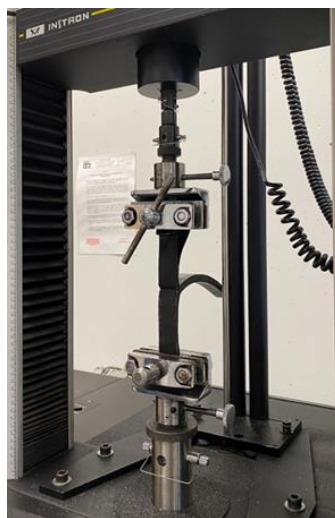
The test of adhesion strength between the belt elements was carried out by PN-EN ISO 252:2008, using method B, with the INSTRON 4464 testing machine (Fig. 4). Method B, involves separating every second belt element from each other. The average value of the force required to delaminate the covers from the core, as well as each ply from each other, is determined using a testing machine with a constant cross-beam speed of 100 mm/min.

Fig. 4. Sample of belt during delamination

Each test specimen should be a strip of a belt of rectangular cross-section with evenly trimmed edges, with a width of  $(25 \pm 0.5)$  mm and a minimum length of 200 mm to allow delamination over a section of not less than 100 mm. The top cover was delaminated first from the first ply (On-1p), the second ply from the third (2p-3p), and the fourth ply from the fifth (4p-5p). The order is reversed when testing the second specimen, i.e., the running cover is delaminated first from the fifth ply (Ob-5p), the fourth ply from the third (4p-3p), and the second ply from the first (2p-1p). In this way, the strength of adhesion between all elements of the belt is tested.

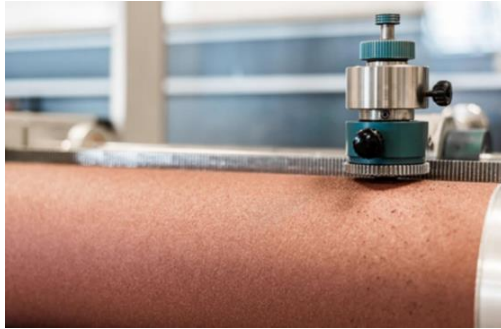
The abrasion resistance test was carried out in accordance with EN ISO 4649:2007 method A, using an apparatus with a rotating drum (Figure 5). The test determines the volume loss of the rubber cover as a result of the abrasion of the sample, on an abrasive cloth of known granulation. During the test, the sample is held stationary and its entire surface is in contact with the abrasive surface. The test result is expressed as a relative volume loss of the rubber being tested. It is therefore necessary to determine the specific density of the rubber. The density of the rubber was determined using a hydrostatic method by weighing the rubber sample in air and in distilled water of known density and temperature.

Fig. 5. Apparatus with rotating drum, including sample holder

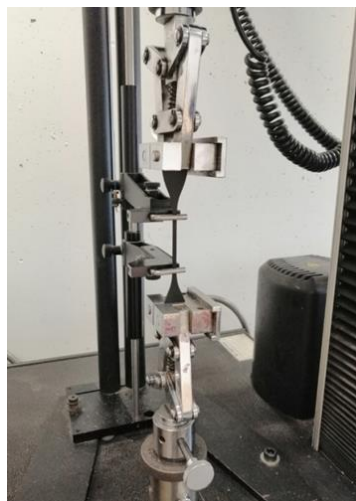
Fig. 6. INSTRON 4464 strength testing machine, and installed in the grips a rubber sample

Figure 6 shows the test rig, and the rubber sample mounted in the self-clamping jaws, on which the mechanical extensometer is clamped.

Tensile testing of the rubber was carried out in accordance with EN ISO 37, using an INSTRON 4464 machine, testing paddle-shaped rubber specimens of type 1A. The length of the test section for this type 1A specimen is  $20 \pm 0.5$  mm. The rubber specimens are stretched at a constant speed of 500 mm/min until they break. During the test, the force values and corresponding elongations are recorded. A 500N force sensor was used in the test, as well as a mechanical extensometer to measure the elongation of the rubber.
