**THE PROBLEMS OF MAINTENANCE OF DRAINAGE DEVICES WITHIN
MUNICIPAL AND DISTRICT ROADS**

Zbigniew RESPONDEK
Czestochowa University of Technology

The article presents technical aspects of maintenance of proper condition of drainage devices of public roads, and municipal and district roads in particular. The importance of road drainage is discussed, basic surface drainage devices discussed together with their location within the road. With use of actual examples we indicated the typical errors made during repairs and overhauls of the road, that have the consequence of disrupted continuity of drainage or the risk of quick loss of functions of drainage devices. The results of survey of technical condition of roadsides and the drainage device within a selected rural municipality were presented, indicating main problems of road keepers connected with keeping the drainage infrastructure in appropriate condition. The need of growing awareness in planning and designing road investment was indicated in the field of consequences of performing insufficient drainage.

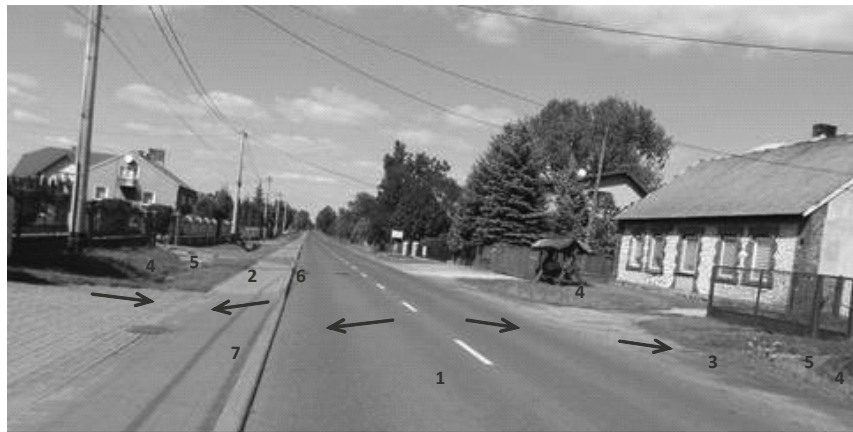
Fig. 1 Drainage devices of exemplary road in built-up area, the arrows show the perpendicular flow directions: 1 - road pavement with roof-like sloping, 2 - sidewalk, 3 - roadside (unpaved), 4 - road ditch, 5 - culvert under an exit, 6 - simple near-curb gutter, 7 - an exit with lowered curb

Fig. 1 shows an exemplary location of drainage devices within a road.

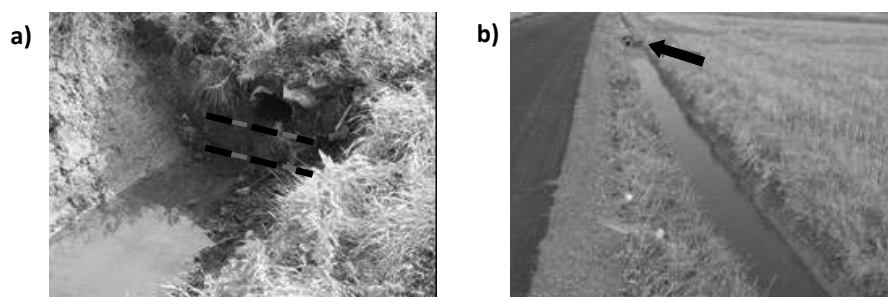
Fig. 2 Errors connected with ditch cosmetics: a) ditch deepened below culvert level, b) results of lack or raising culverts – precipitation water stays in the ditch

When the pavement is repaired frequently also the so called "ditch cosmetics" are performed, that is the existing ditches deepened and profiled. Such actions, without placement or replacement of culverts do not lead to the bettering of drainage condition - just the opposite it negatively influences the condition of road core, as without continuity of drainage the water staying in the ditches undermines the road core. Such detrimental situations are illustrated in Fig. 2.

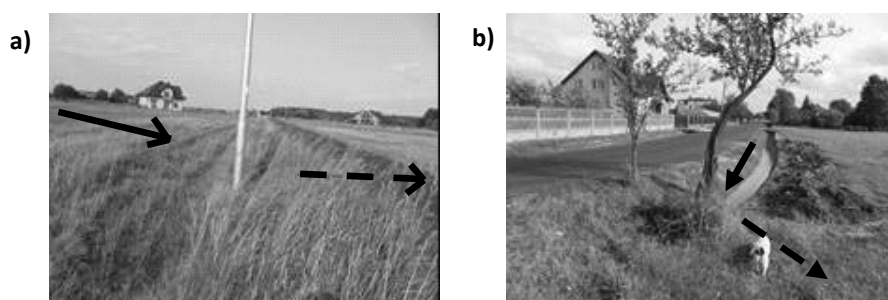
Fig. 3 Lack of drainage devices: a) water staying in a lowered terrain on roadside – lack of culvert, b) lack of water outlet to reservoir

Fig. 3 show examples of lack of drainage devices where they are needed.

As we see on Fig. 3a the water from melting snow or heavy rainfall can't flow to the ditch located lower on the other side of the newly repaired municipal road – there is no profiled ditch nor a culvert. Another error is to construct a ditch, without a water reservoir connection (Fig. 3b).

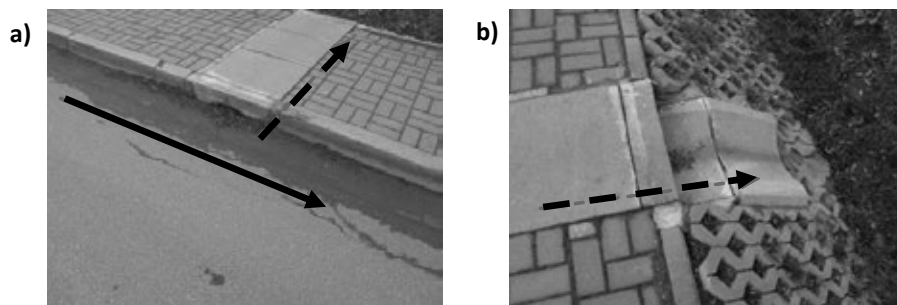
Fig. 4 Chanel drain of the curb gutter:
a) inlet blocked with rubble, b) lack of water run-off at the outlet

And the inlet of the channel drain presented on Fig. 4 and designed to drain water from the gutter to the ditch has a too low cross-section, causing the water flow to be blocked.

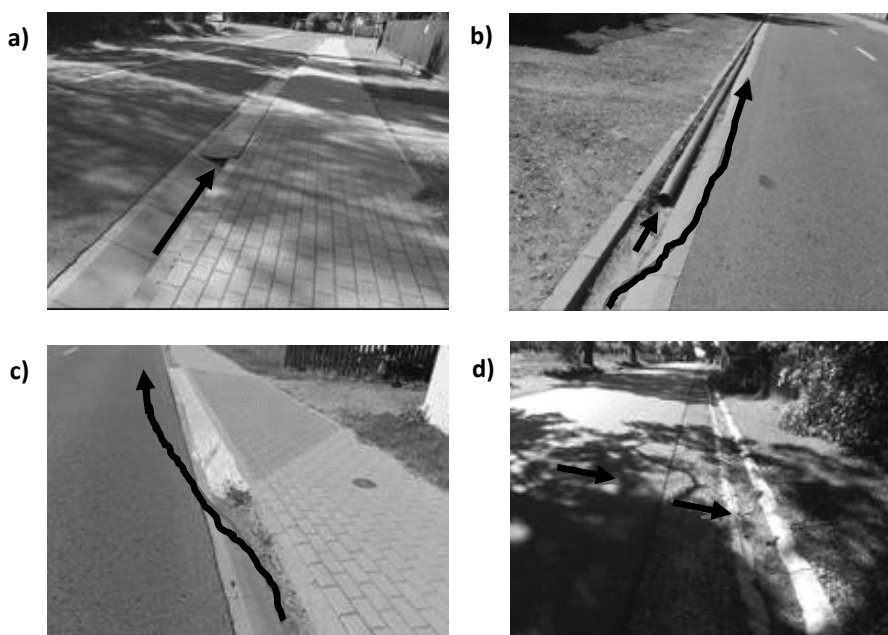
Fig. 5 Details of constructions connected with gutters:
a) covering a triangular gutter with metal sheet, drainage preserved, b) use of steel pipe, drainage limited, c) pouring concrete – no drainage, d) filling an oval drain with material of wrongly placed roadside

Road repairs connected with construction of a sidewalk or sewage installation along the road, causes problems on house driveways. The drive through the sidewalk can be shaped in form of lowered curb (lack of evenness). In case of using triangular or oval gutters instead of curbs the road keeper should take into account, already at a design stage, devices that would facilitate driving over them, e.g. covering the gutter with metal sheets (Fig. 5a) or using a linear inroad with a comb-like profile [13]. Lack of such devices causes the inhabitants to “facilitate” the access with their own means, frequently doing that in a wrong manner (pouring concrete in the gutter, covering with gravel, placing wooden elements or steel pipes), that leads to blocking the flow of water and causing the silting of the gutter section above such an obstacle (Fig. 5b, 5c). Fig. 5d shows a

case of placing a loose stone material roadside between the pavement and the gutter, with the gravel quickly filling the gutter.

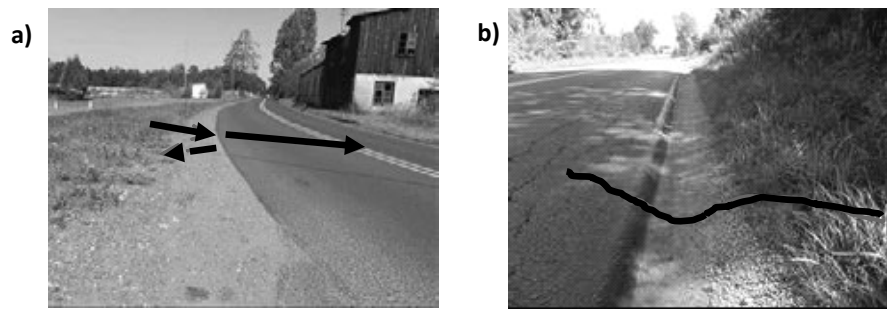
Fig. 6 Details of roadside construction:

a) a frequent case of roadside sloping down to pavement, b) tracked roadside that is too high at the same time

- wrong sloping (Fig. 6a); the roadside should be sloping down from the pavement,
- using poor quality material, e.g. small particle gravel can get wet during rain and quickly tracked by wheels of the vehicles (Fig. 6b).

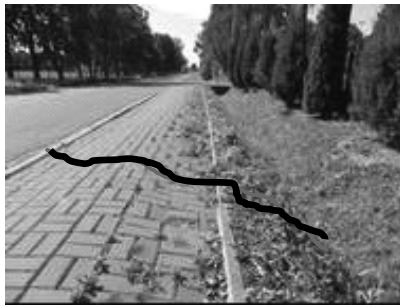
Fig. 7 Deformation of sidewalk due to collapse of ditch wall

Fig. 7 shows an example of deformation of sidewalk surface due to collapse of the neighboring wall that was inclined too steeply (even being reinforced with concrete openwork slabs) and undermined by the water flowing in the ditch.
