INVESTIGATION OF ROLLING BEARING LUBRICATION CONDITION

Andrzej JAŁOWIECKI, Marek FIDALI, Adrian KROL

Silesian University of Technology, Faculty of Mechanical Engineering,
Department of Fundamentals of Machinery Design, Poland

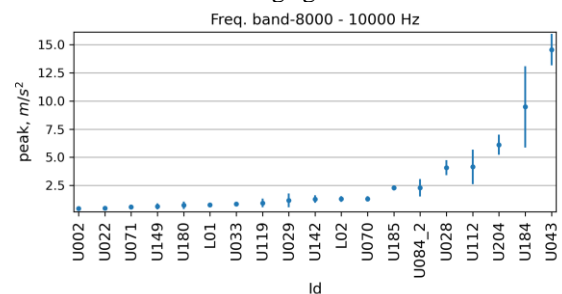
Fig. 3. Averaged peak values of acceleration signal with standard deviation during measurements.

After all measurements, plots for all estimators have been made. Fig 3 presents an example of elaborated plots for selected bearing. The given case is the plot of the mean Peak value in the band from 8 kHz to 10 kHz. More detailed discussion devoted to vibration analysis results of tested bearings can be found in [19]. The obtained values are placed in increasing order. What can be seen in the presented plot is that increasing the standard deviation is related to increasing the mean of the feature's value. The further considerations focused on using the mean and the standard deviation of selected signal features to assess bearings grease condition.

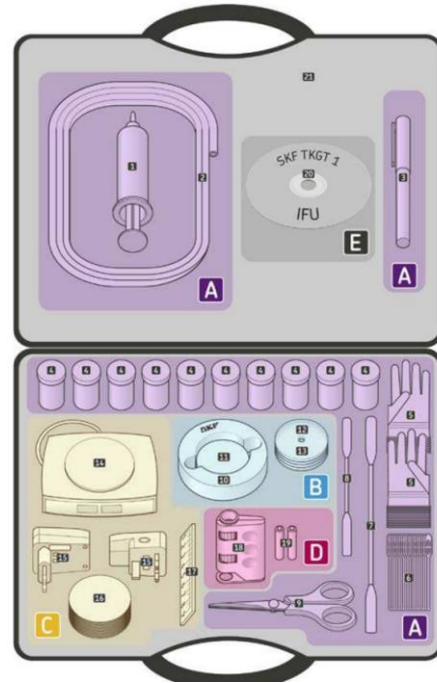
Fig. 4. The SKF grease condition test set. Sampling accessories (A), Consistency test accessories (B), Oil leakage test accessories (C), Contamination test accessories (D), Manual (E). [4]

The next step of investigations was the determination of the grease condition of the tested bearings. Bearings' grease was subjected to a series of tests using an SKF grease test kit (TKGT1) [4], presented in Fig 4. The following tests were carried out:

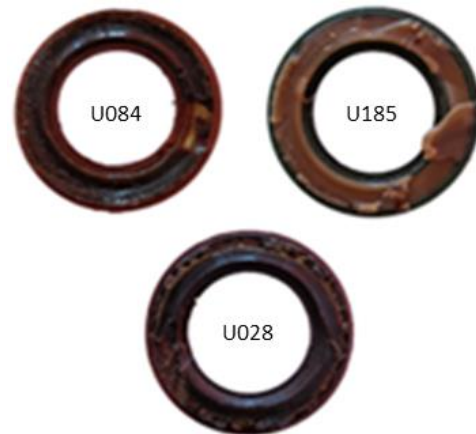
Fig. 5. The examples of grease samples

Fig 5 presents exemplary sealing rings with bearing grease for bearings with the highest vibration values.

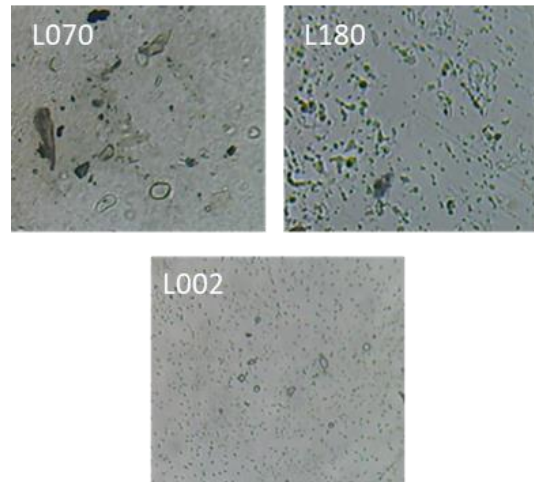
Fig. 6. Selected microscopic images of tested samples

The last performed test consisted of an assessment of contaminations in the grease. The test was carried out using an optical microscope. The main goal of the test was to find out any marks of the wearing process in grease, such as small metallic particles, dirt nuggets, and so ones. Microscopic images presented the three most contaminated grease samples are shown in Fig 6. On those images, we can see many intrusions in grease in the form of different-sized forging particles.

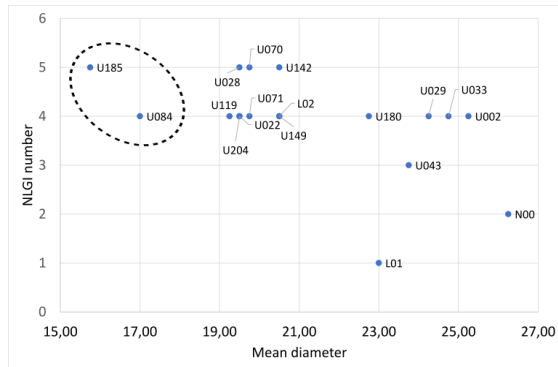
Fig. 7. The diagram showing the relation between the NLGI number and mean diameter of oil leakage mark

Quantitative parameters like the NLGI number and mean measured diameter of oil mark (from test 3) were compared in Fig 7. Comparison of the two reliable quantitative parameters indicates that the grease condition of bearings U185 and U084 (dotted line ellipse) are not satisfactory due to dry grease. For comparison in Fig 8 presented the result of SPM HD vibration measurements where parameter HDc confirms the worst lubrication conditions of those bearings.

differs the most from the other bearings, as shown in Fig. 7.

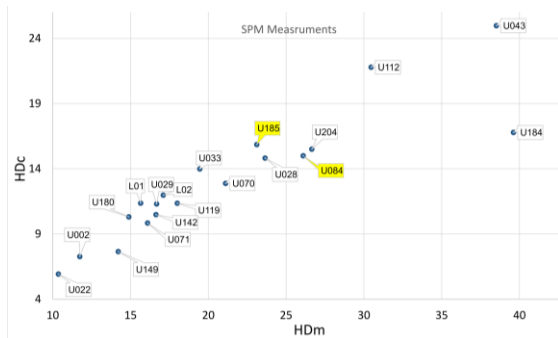
Fig. 8. Results of SPM HD measurements of investigated bearings

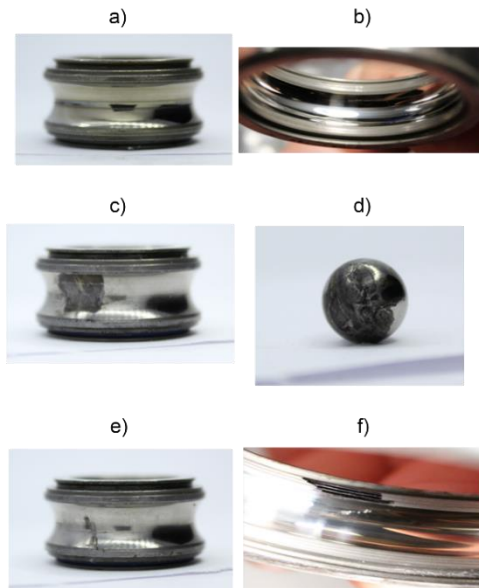
Fig. 9. Images of defects of specific bearings: a) discolouring on the inner ring of U028. b) scratch on the outer ring of U028. c). d). e) pitting of U043 bearing's elements. f) pitting of U084 bearing's outer ring

Fig. 9. are shown examples of found defect.

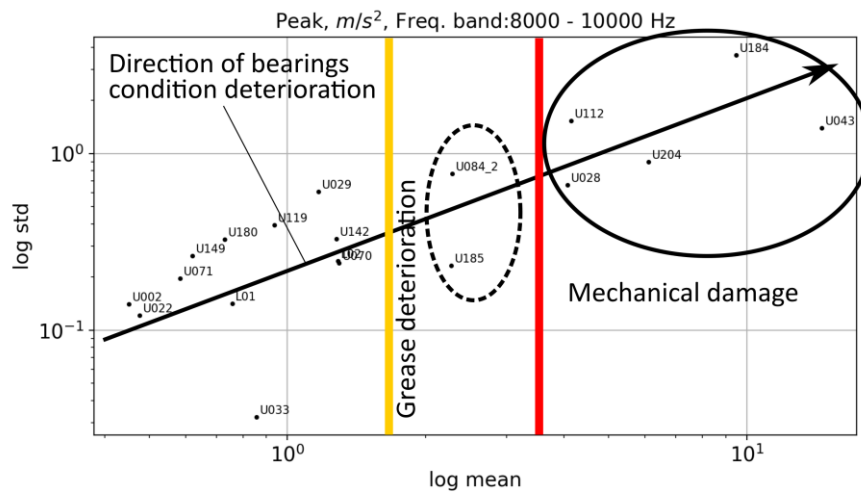
Fig. 10. Plot of mean and standard deviation values of Peak accelerations of investigated bearings in band 8000 Hz to 10000Hz

The following research step was essential to answer the vibration signal that allows for the lubrication condition identification. To find such a relationship, the authors have prepared a series of graphs showing the relationship between the mean value of the considered signal features and standard deviation calculated on four measurements - Fig. 10 to Fig. 14 present examples of obtained plots.

The plots' axes are in logarithmic scale for better distribution analysis of mean value and standard deviation of considered signal features. The first step of the research has been looking for frequency band influences on the value distribution. The best separation and bearings identification is seen in a band between 8 kHz and 10 kHz. In the presented plots, it is also clear which bearings have some mechanical damage or poor grease condition. The best separation of defected bearings is observed for Peak (Fig 10) and Clearance (Fig 13) features. A hypothesis can be made that in the case of the investigated bearings before mechanical damage occurs, gradual deterioration of the grease condition and mechanical wear of the bearing occurs. It leads to fatigue damage. Such a process can be associated with the distribution of Peak and Clearance values visible in the plots. It has been observed that Kurtosis (Fig 14) is a feature that mainly identifies mechanical damage of the bearings.

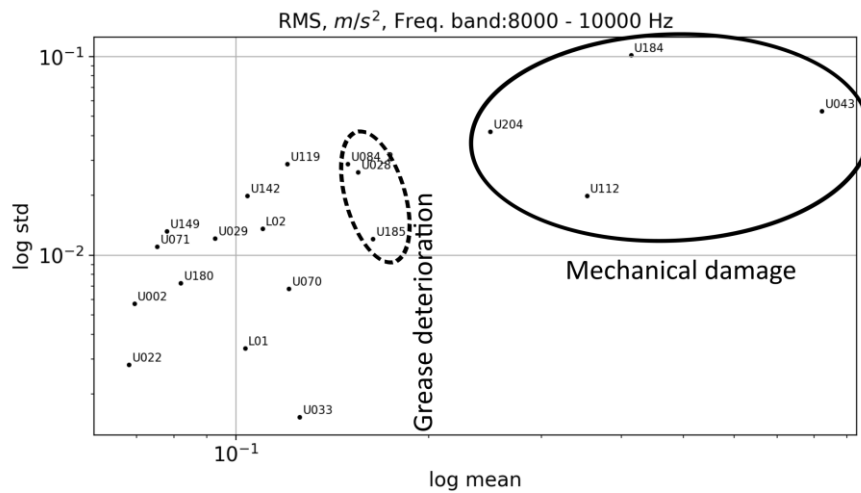
Fig. 11. Plot of mean and standard deviation values of RMS accelerations of investigated bearings in band 8000 Hz to 10000Hz

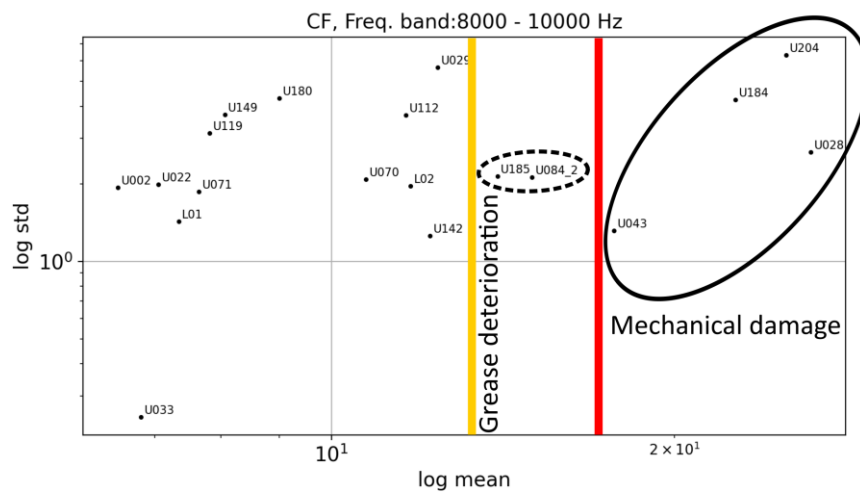
Fig. 12. Plot of mean and standard deviation values of Crest factor of accelerations of investigated bearings in band 8000 Hz to 10000 Hz

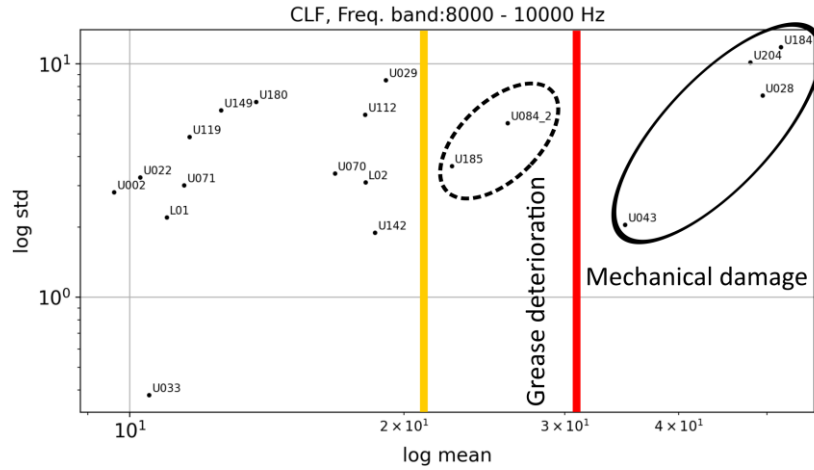
Fig. 13. Plot of mean and standard deviation values of Clearance factor of accelerations of investigated bearings in band 8000 Hz to 10000 Hz

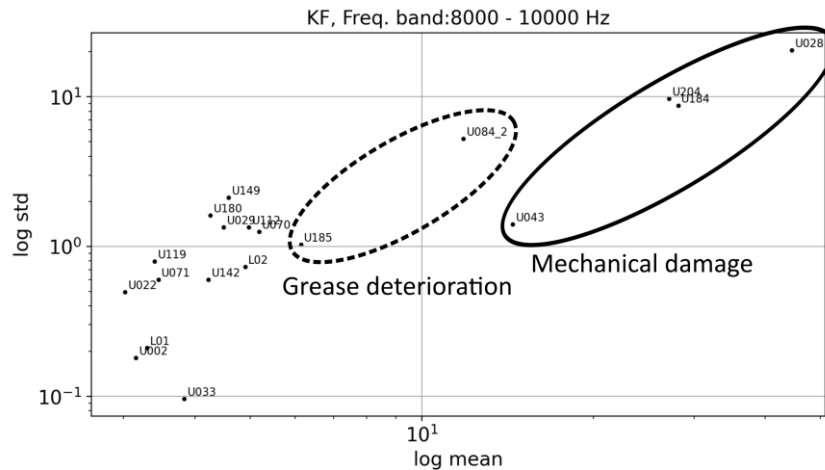
Fig. 84. Plot of mean and standard deviation values of kurtosis of accelerations of investigated bearings in band 8000 Hz to 10 000 Hz
