Ivan P. Kovalchuk¹, Mykytchyn O.I.², Andreychuk Yu.M.³, Ivanov E.A.³, Zhdanyuk B.S.⁴

Assesment of minor rivers flood-plain and stream-way complex condition (case study of the Berezhnytsya River, Dniestr basin)

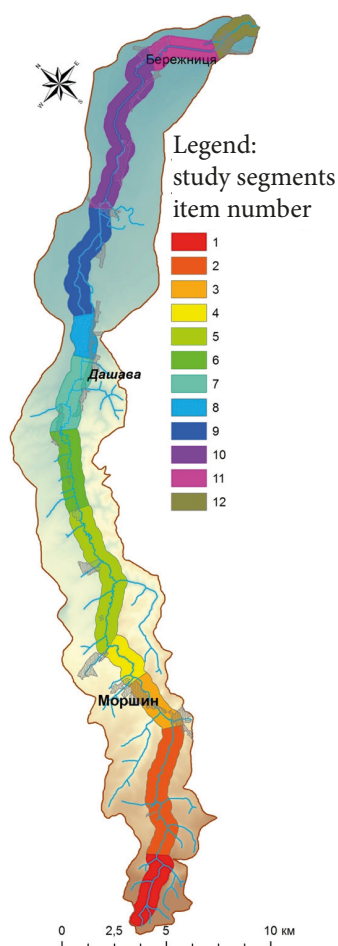
The examined water body was divided into twelve study areas (Figure 1). Their boundaries were determined subject to the set of uniform features. Each of these segments was assigned a passport. Based on the total number of points the conclusions on river condition and its flood-plain complex were made. Defining the like segments of flood-plain and stream-way complex allowed to assess the condition of each of them and on this basis to identify the most problematic river segments requiring urgent environmental protective measures.

Figure 1. Location of the study river segments at examining the flood-plain and stream-way complex within the Berezhnitsya river basin geosystem

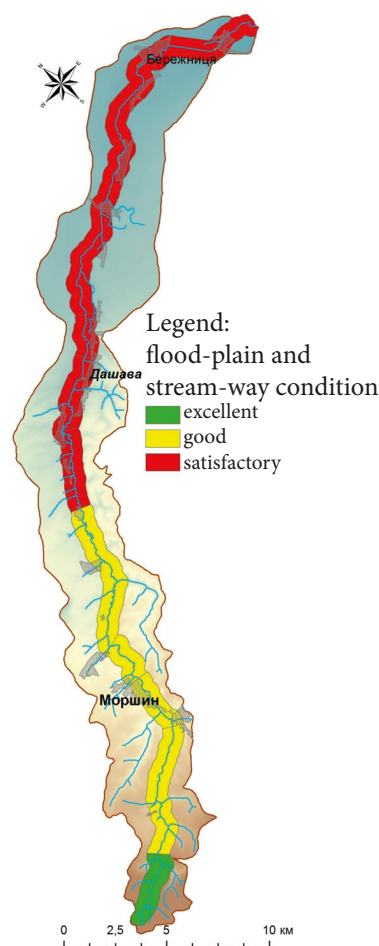
Figure 2. Flood-plain and stream-way complex condition within the Berezhnitsya river basin geosystem

According to the observations and assessment of twelve river segments there was a map chart showing the Berezhnitsya condition drawn

(Figure 2). The picture shows that only a segment close to the riverhead may be assessed as "excellent" since in this part the Berezhnitsya

Based on the assessment results it is possible to state that the condition of study segments of the Berezhytsya river flood-plain and stream-way complex was marked as “excellent”, “good” and “satisfactory”. “Unsatisfactory” and “catastrophic” river and flood-plain condition has not been detected yet, although within Dashava urban settlement the river area condition is close to the “satisfactory” grade. The best situation is at the riverhead as human impact is minimized here and natural vegetation is preserved. Downstream we trace the tendency of condition worsening as anthropogenic load on the basin system and flood-plain and stream-way complex increases. Its negative impact is balanced by large forests, thus in segments limited by Banya Lysovytska village and Lotatnyky village the river and flood-plain condition is rated as “good”. So, downstream the named village the value of such an

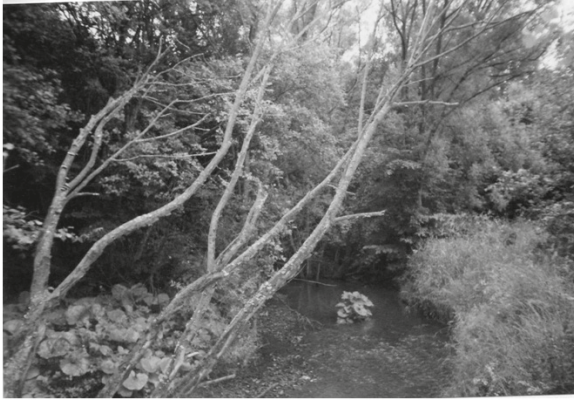
Figure 3. Aquatic and flood-plain vegetation at the first study segment along the Berezhnytsya river

sya is a true the Carpathian mountain torrent. Its stream-way is of natural character and possesses elements peculiar to mountain rivers, i.e. shallows and broads, meanders, slow flow parts are interchanged with fast flow ones, in the stream-way one may find bars and other natural stream-way formations. Water is clear and transparent up to the bottom (1 m depth), slightly muddy, has no smell and is tasteless. Large variety of aquatic vegetation (with no clear predominance of one species over the others) is present in the stream-way. Fish fauna is diverse; there are several favourite places of fishermen here. The banks are natural, undestroyed, the forest areas take over 50% of the flood-plain (Figure 3). Rest of the flood-plain is used as grasslands, there is no plough land here but there are small farming plots occupying a little flood-plain part. Protective bank-line zone is in a good condition. However, a product pipeline crosses the river stream-way in this area (Figure 4). In 2002 as a result of illegal oil uptake its great amount entered from a pipeline into the river. This led to an environmental disaster downstream and, consequently, small ponds contaminated by oil products remained on the flood-plain. The second study segment is located downstream (from the bridge at Bolekhiv-Tanyava highway to the highway bridge in the Morshyn city). Its condition was assessed as "good" but degradation processes have been developing here actively. The stream velocity along this segment becomes slower, water is characterized by less transparency, in the stream-way and along the bank-line individual unnatural objects and garbage dumps are observed.

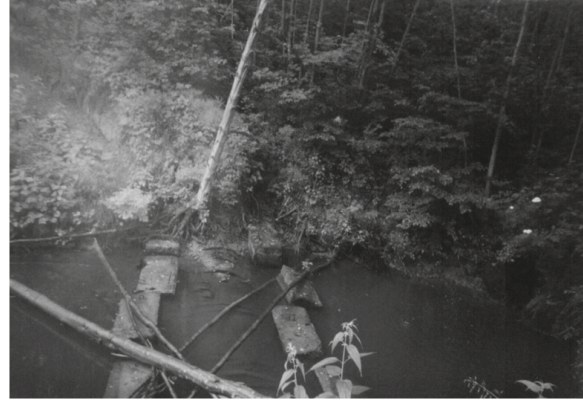
Figure 4. Product pipeline under the Berezhnytsya river stream-way

possibilities of getting water, contaminated with the toxic waste from toxic waste landfill “Shkirianyuk”, into the river and to ensure the oil pipelines crosses the stream-way under the due protection. It is also important to reduce the regulation of the runoff, because ponds are mainly lifeless and used for purposes other than intended ones. It is necessary to reduce the intensity of agricultural activity over the flood-plain lands.

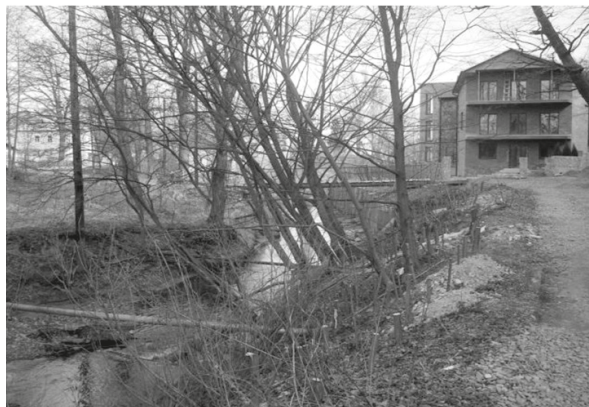
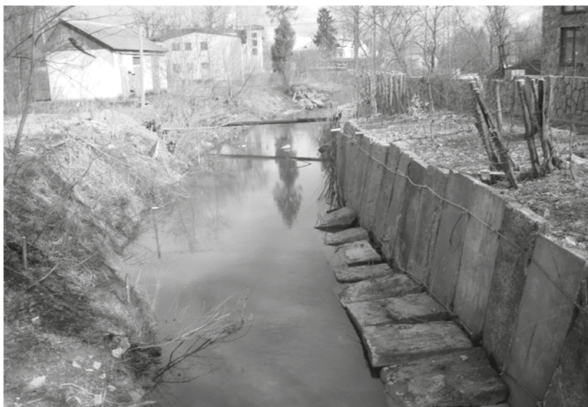
As compared to the first area, the variety of flora and fish fauna significantly decreases. The behaviour mode and limits being obligatory for water protective zones are not observed, urban territories dominate in the flood-plain, there are hayfields and motor roads here. The flood-plain is disturbed from both banks. Water intake for technical needs is also performed at this part of the river. The river needs public attention. In particular, it is necessary to clean the bank-line out of garbage. Within the limits of Morshyn city the river flow becomes slower, several natural stream-way and flood-plain formations were changed due to human activity (Figure 5). These facts make it impossible to decelerate the flood wave move. For this reason, during floods houses built in the region of flood-plain become drowned. Water is of swampy smell and muddy. Overgrown of channelled stream-way is noticeable as well. Fish fauna diversity has been decreasing. The banks are not destroyed, but there is scarce natural vegetation and it also degrades. Livestock systematically grazes at the flood-plain, the boundaries of bank-line protective zones within the city limits are violated.

Figure 5. Disturbance of limits of bank-line protective zone, Morshyn city

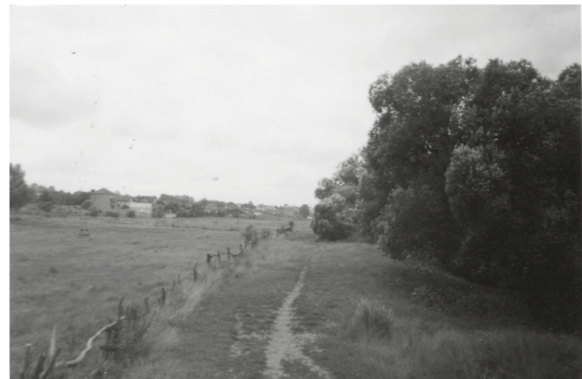
Figure 7. Degraded flood-plain vegetation, the Berezhytsya river (Yosypovychi village)

Next two segments are very similar to each other and for this reason we consider them as one. These segments stretch from Yosypovychi village to Berezhytsya village. Their condition is assessed as “satisfactory” because most of the flood-plain is covered with damaged or degraded agrobiocenoses, and the livestock permanently grazes here (Figure 7). The aquatic vegetation is very poor. The limits and regimen of bank-line protective zone is disturbed.
