Assessment of the Conveyor Belt Strength Decrease due to the Long Term Exploitation in Harmful Conditions

ABSTRACT

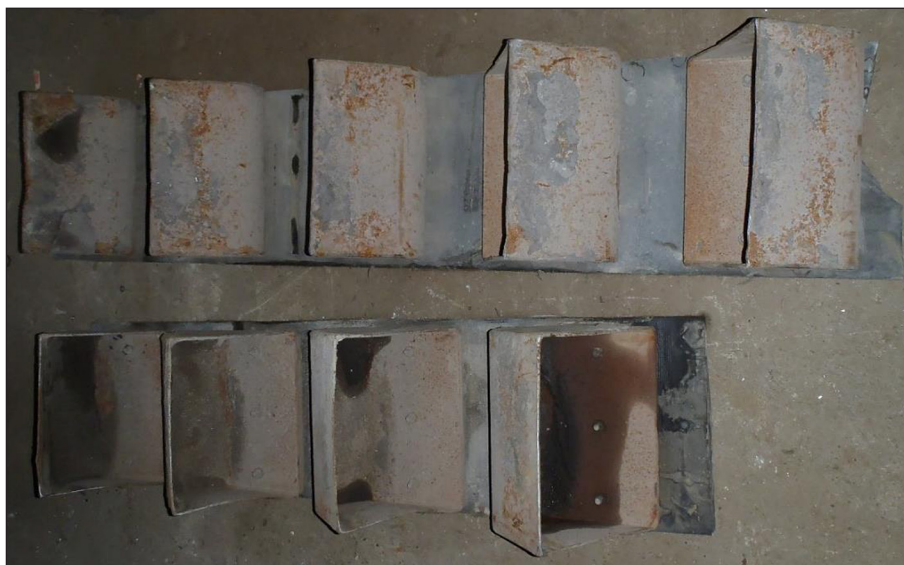
Figure 1. View of two parts of a bucket elevator constituting the sections of a conveyor intended for mechanical testing

indicating that the belt had five layers made of a polyamide-polyester fabric. The belt's width was 345 mm, and its strength was specified at 800 N/mm. The belt was employed for the vertical transport of loose asphalt material, with bucket spacings approximately 350 mm apart. The belt operated for approximately 10 years, posing a potential risk of degradation, which was the primary focus of the analysis. Figure 1 depicts sections of the belt designated for sample collection and an experiment involving chain transport, termed as a simulation of incorrect installation technique. After removing the buckets and contaminants, the belt was prepared for the subsequent procedures discussed in the following section.

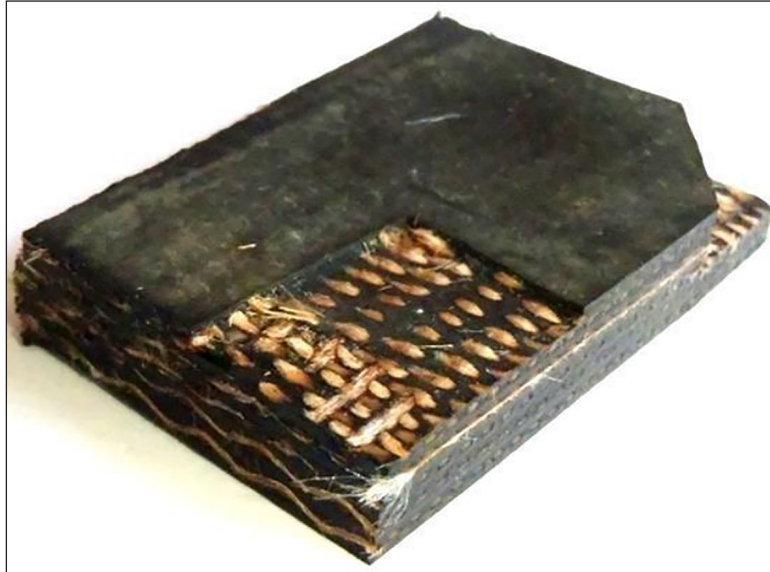
In order to identify the structure of the composite belt, an elemental piece was taken from the belt from which the rubber layer was removed revealing the geometry and nature of the weave (Fig. 2).

Figure 2. Belt section with selected geometry and weave character

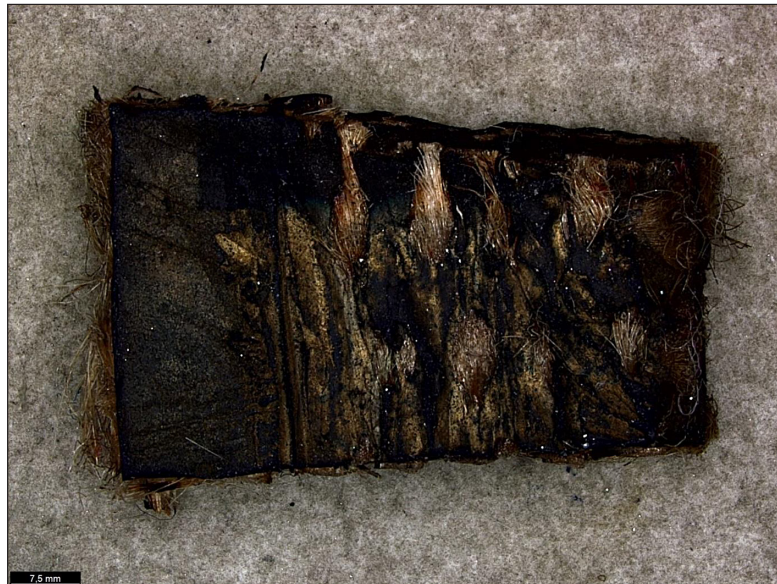
Microscopic observations were carried out using digital microscope Leica dvm6 (Keyence). In order to obtain more information of surface morphology the high-resolution Scanning Electron Microscope Supra 35 (Zeiss), equipment with SE (secondary electrons) detector was used. Additionally, chemical composition analysis in the micro areas was evaluated using an energy-dispersive X-ray detector (EDX, EDAX Trident XM4). Before microscopic observation of fracture surfaces, specimens were subjected to sputtering with a thin conductive silver-palladium layer using putter coater SCD050 (BAL-TEC). Figure 3 presents analyzed composed materials.

It can be observed, that the composite material has a layered structure - layers of rubber (matrix material) are separated by the layer of fibers.

Figure 3. Surface morphology in digital microscopy

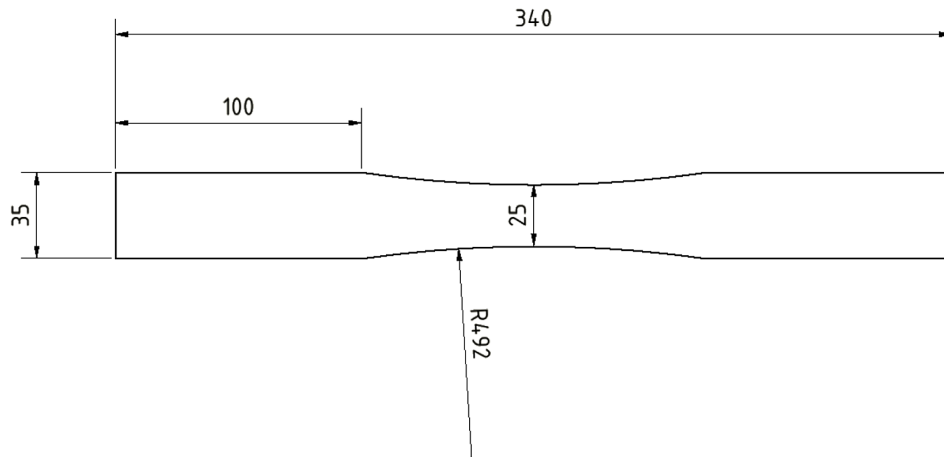
Wear degradation of the conveyor belt has been performed based on the tensile test. Based on ISO 527-4 [20] standard and considering the quantity and type of material subjected to testing, along with the provisions of the specialized ISO 283 [21] standard, a geometric shape for the specimens was proposed (Fig. 5). This procedure aimed to adapt the shape of the specimens to the requirements of ISO 527-4 and take into account the conditions under which the material would be tested. The proposed geometric shape of the specimens was developed to ensure compliance

with the standards while simultaneously reflecting the conditions in which the material will be in service. The detailed representation of the sample shapes is presented in Figure 5.

Figure 5. Geometry of tensile test specimens

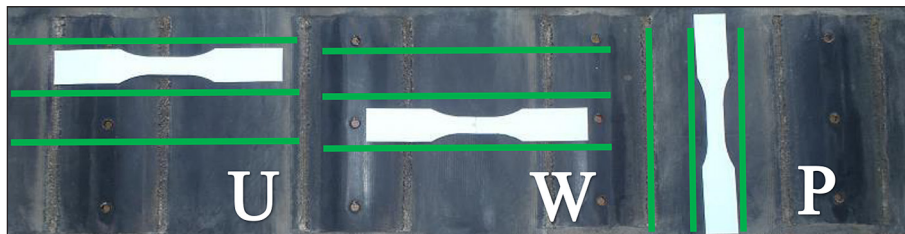
placed on the examined fragment of the belt, as depicted in Figure 6. The specimens have been described in Table 1.

Group P (Fig. 6) consisted of specimens taken from between the feeder buckets in the transverse direction. Group U and W (Fig. 6) populations were obtained from the longitudinal direction, with one group taken from the central part of the belt with no visible blemishes on the working (measuring) part, while the second group was obtained from a location bearing utility damage from the buckets (Fig. 7, 8), located in the central measuring part of the sample. This allowed us to

Figure 6. Specimens groups (U, W, P) for strength tests

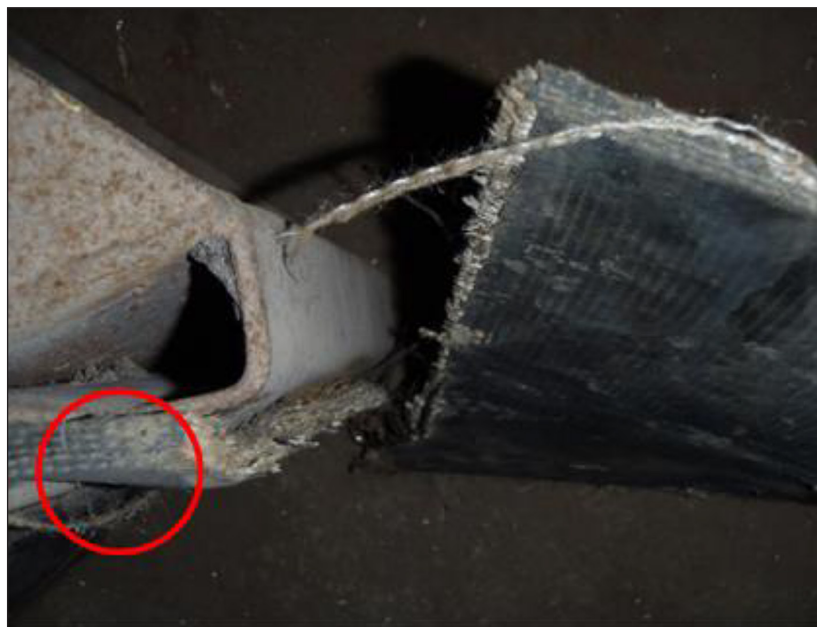
Figure 7. View of the damage location beneath the bucket

the belt during operation. Specimens taken longitudinally (which do not have a defect approaching from the base of the bucket in the measuring range) exhibit a strength decrease of about 3% compared to the nominal value. Specimens with damage at the measuring range have an average strength of 701 N/mm. Therefore the decrease of 12.5% relative to the nominal value is observed. The damages observed on these specimens originate from external sources, such as wear caused by friction from the buckets, which can be

particularly detrimental to the entire system. The obtained results indicate the necessity of more frequent inspections and monitoring of belt conditions, especially in applications where they are used with additional elements, such as buckets, which can cause mechanical damage. Additionally, it is worth noting that specimens taken longitudinally show varied strength reductions, with greater declines in areas under the buckets, which may hinder the detection of such damages without disassembling the belt apparatus. The

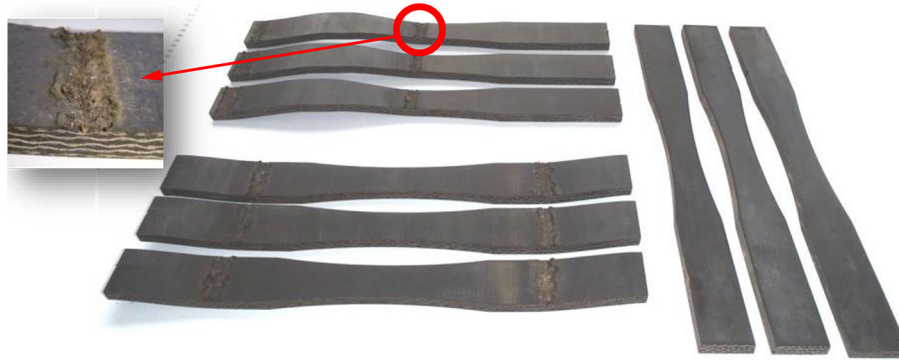
determine the degree of mechanical damage to the belt by the percentage decrease in strength in this area. Utilizing the water-jet cutting technique, specimens were chosen for conducting uniaxial strength tests (Fig. 8). To prepare the machine for testing, an additional test specimen labeled as K1 was cut out. The specimens underwent air drying and were conditioned for a period of 14 hours

Figure 8. Three groups, specimens designed to perform a tensile test

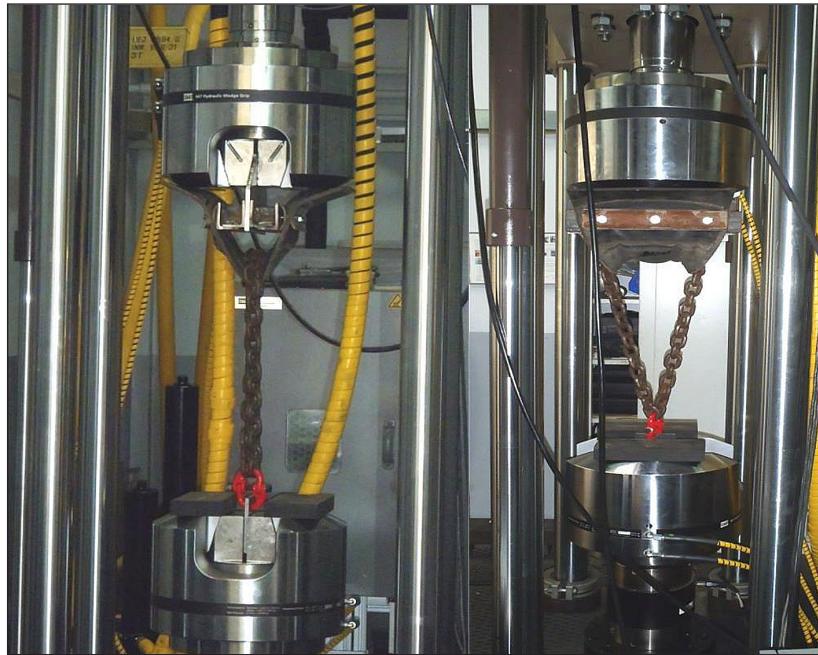
chain links, exerting pressure on the bucket conveyor belt during manipulative operations associated with its assembly or disassembly. For this purpose, a design was developed based on steel semi-finished parts, which were connected to a

section of the belt free from signs of mechanical. The force applied in the experiment corresponded to the weight of the belt, aiming to verify whether the belt would not tear during machine retooling operations. Chains are frequently used

for handling and transporting conveyor belts. The utilization of chains, and consequently the specific arrangement of links, significantly influences the belt's deformation. In areas where the most substantial deformations occur, particularly at belt corners, links may embed themselves, cutting into the drive belt, causing damage, and concentrating stress. Severe deformation occurs where links press against the belt on its sides. As a result of the conducted experiment, an adverse impact of the chain on the belt surface was observed. Due to the dynamic nature of the chain, composed of interconnected links capable of arbitrary movements relative to each other, and in the context of the static susceptibility of the belt, which, as a result of relative motion associated with increased load, may lead to visible damage, especially in the region of the largest displacements. To conduct this type of test, a system capable of simulating high loads was necessary. In the experiment, a four-column servo hydraulic testing machine was used (with a column diameter of approximately 10.16 cm – MTS 311.31), and the gripping mechanism was provided by hydraulic wedge grips (MTS model 647). The machine is capable of generating a load of 1 MN. A test speed was set as 50 mm/min. Test was conducted until reaching the maximum force of 50 kN. Additionally, the ambient temperature was 19 °C with an air humidity of 74%. It was fitted with a steel belt retaining device. And on the underside,

a component for mounting the chain. This made it possible to simulate the loading conditions when lifting the belt. As mentioned earlier, such lifting is potentially degrading. This test was used to verify this hypothesis.

Figure 9. Belt during the lifting test with use of the special fixture

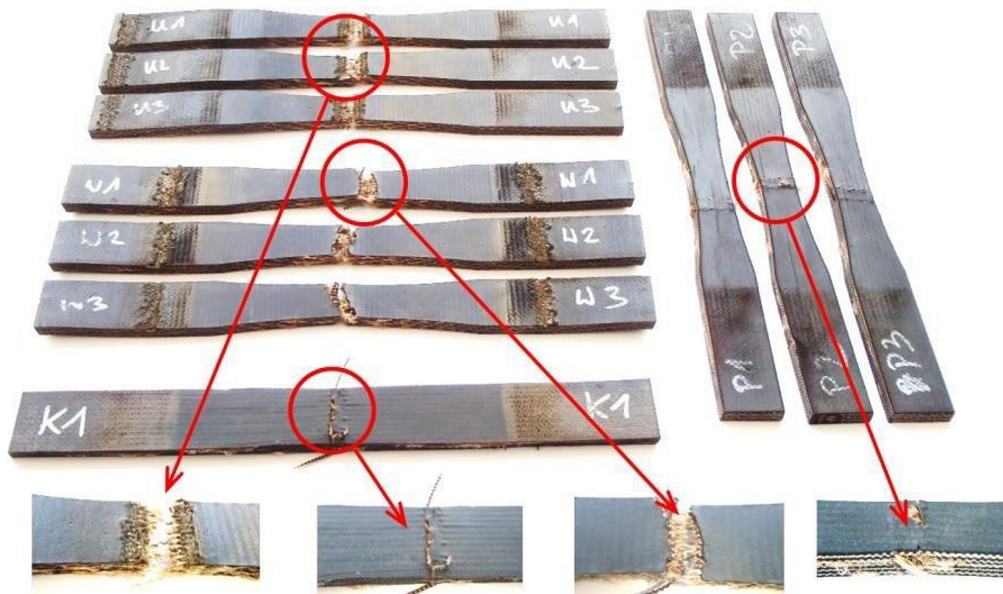
On the basis of the conducted tests it was proved that the specimens show lower strength (ability to carry loads) in relation to the nominal strength (declared by the manufacturer). The probable reason could be the operational wear of the structure of the conveyor belt. The slight differences in test results between specimens taken from the same direction but with damage to the base of the conveyor buckets in the measuring section are due to damage to the surface layer (facings) of the belt without breaking the continuity of the braid of the conveyor belt. The strength of the specimen taken from the conveyor belt was determined on the basis of a tensile test. Information on the width of the specimens, the force at break and their strength is presented in Table 2. The obtained results were compared with the catalog data of the belt. According to the belt designation, the nominal strength of the belt should be 800 N/mm. Comparison of the information obtained from the tensile test and the catalog data indicates a decrease in the strength properties of

Figure 10. Damage to specimens after tensile testing

strength of specimens taken from the transverse direction is much lower than from the longitudinal direction. This may be due to the use of reinforcing fibers, a different type of weave than in the longitudinal direction. The strength in the transverse direction is much less because the longitudinal direction is its main load carrying direction. As a result of the experiment, a negative effect of the chain on the belt surface was observed. Due to the nature of the chain work which consists of interconnected links which can move freely in relation to each other and due to the static susceptibility of the belt which, due to the relative movement occurring as a result

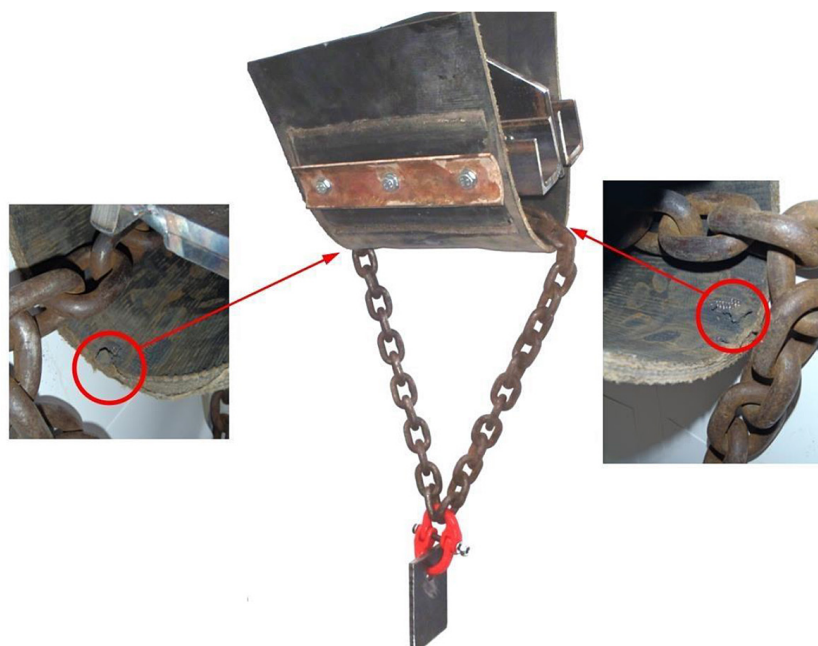
of the load increase, causes visible damage in the form of abrasions observable particularly in the area of the largest displacements (Fig. 11). However, these damages are not strictly degrading in structure and have a noticeable effect on the mechanical properties. Due to the cooperation of the steel links of the chain with the rubber surface of the belt, the friction force between the cooperating elements increases simultaneously as the load increases, and due to extensive deformations of the belt and considerable relative displacements of the chain, shearing of the rubber coating of the belt occurs, but without violating the structure of the composite.

Figure 11. Damage formed in the analyzed belt during the lifting test

While lifting with chains generally functions, there is observed damage occurring on the edges of the belt, which may lead to its weakening. The results suggest that such connection with the buckets exposes the belt to damages, potentially leading to its rupture under load. Regular inspection of such belts is recommended to prevent accidents that may harm individuals, as well as to avoid unexpected failures and incidents.
