The microstructure and properties of the 7CrMoVTiB10-10 steel welded joint

7CrMoVTiB10-10 is modern steel used to build boilers across Europe. Welding is very important operation during the process of building boilers. Microstructure and properties in the heat affected zone are changed by welding process. Consequently the properties of the whole welded element are different. The aim of this paper is to show microstructure and selected mechanical properties of welded 7CrMoVTiB10-10.

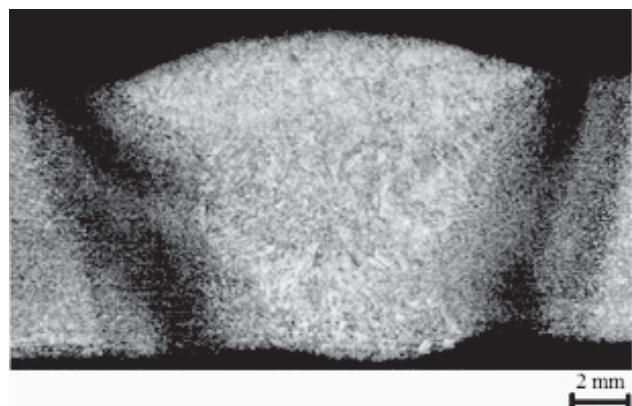
**Figure 3.** The macrostructure of the welded connection**Table 3.** The selected parameters of welding

The macrostructure of the welded connection is shown in Figure 3.

The clear look of heat affected zone, sequence of passes and the differences in microstructure of the base material, the heat affected zone and the joint was observed due to macrostructure examination.

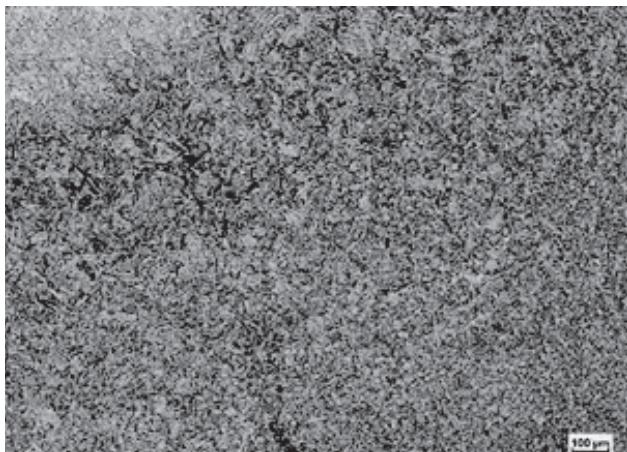
Figure 6. The zone of normalization and growth of grain

The coarse and patchy prior austenite grains were observed in area of normalization and growth of grain. The bainite was discovered inside the prior austenite grains. Farther needle-shaped was observed there. It can suggest the presence of martensite.
