Grey cast iron as construction material of bridges from the 18th and 19th century

G. Pękalski, J. Rabięga

Institute of Materials Science and Mechanics, Wrocław University of Technology
Institute of Civil Engineering, Wrocław University of Technology
Smoluchowskiego 25, 50-370 Wrocław, Polska
e-mail: grzegorz.pekalski@pwr.wroc.pl

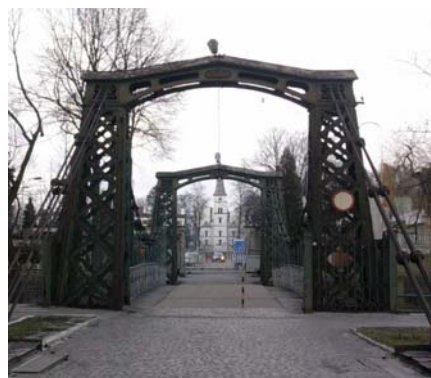
Fig. 2. View of the suspension bridge over the Mała Panew river in Ozimek [8]

within 1825 – 1827 (Fig.2). For its build 14,2 tons of the „construction iron”, as well as 57,8 tons of the iron casts were used [5]. The cast iron was used for making the segmented openwork pylons. Samples for tests were collected just from the pylons material.

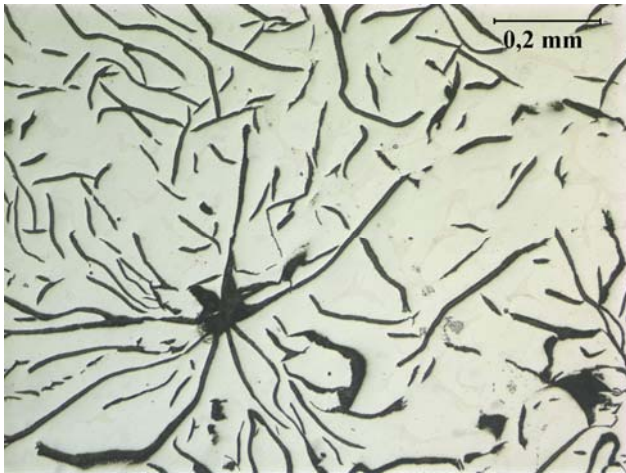
Fig. 5. Bridge in Ozimek – cast iron with flake graphite.
 Graphite precipitations shape: flaky – I,
 Graphite precipitations arrangement: non-uniform – C,
 Graphite precipitations size: from 0,25 to 0,50 mm – 3.
 Non-etched state, light microscopy
