PRODUCTION ENGINEERING ARCHIVES

Vibration Diagnostics as an effective Tool for Testing Engines of Internal Combustion

Ferenc Dömötör¹, József Zoltán Szabó²

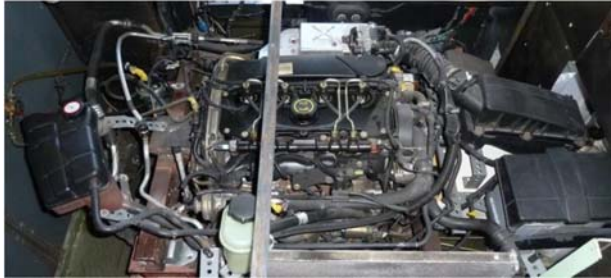
Fig 1. Layout of the Ford Mondeo Diesel engine

Initially, a Diesel engine of a Ford Mondeo TDCi vehicle was tested (Fig. 1.). It has been installed and operated on a block-testing stand of Schönebeck type, i. e. it was not measured while working in a vehicle. Technical data of the engine are shown in Table 1.

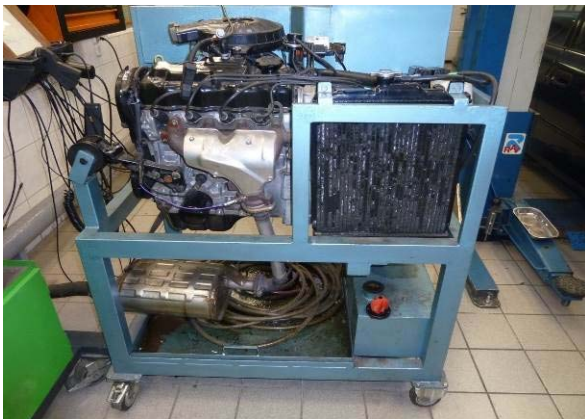
Fig 2. General layout of the Suzuki Swift 1.3 engine

In the second part of the project two different Suzuki engines were tested. One of them was a Suzuki Swift 1.3. installed on a block-testing stand (Fig.2). Technical data of the engine and the main parameters of the vibration measurements are shown in the first column of Table 2.

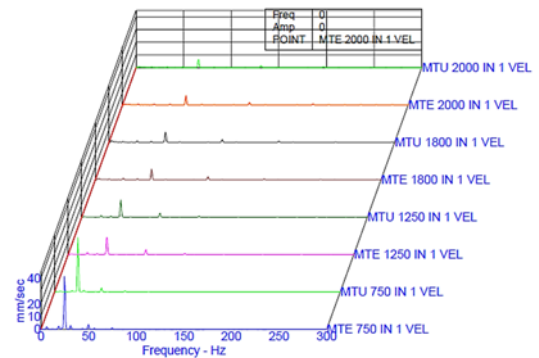
The picture below shows the vibration velocity spectra at four different rotational speeds. It seems interesting, that the vibration severity is not growing proportionally with the rotational speed. It is the strongest at the basic (750 rpm) rotational speed.

Fig 5. Vibration velocity spectrum at 4 different rotational speeds of a four stroke Diesel engine

verity is proportional to the rotational speed in the case of Otto engines. However, this was not observed in the case of Diesel engines. The number of cylinders has a significant effect on the vibration spectrum. In the case of 4 cylinders the 2X, while in the case of 3 cylinders the 1.5X order appears on the spectrum.

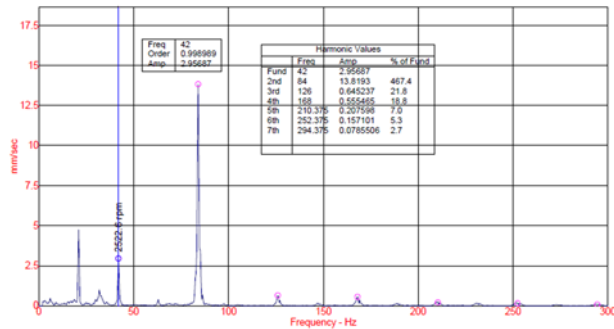
Typical vibration velocity spectra of a four cylinder Otto engine (Suzuki Swift 1.3), running at 2400 rpm is shown in Fig. 6. It can be seen, that the highest peak is at the 2X of the rotational speed of the main shaft. The spectrum contains further harmonics, but in spite of the spectrum of the Diesel engine, here not only the even harmonics are strong. Moreover, there is a strong component at 0.5X, which might be the reason of the loose support (foundation). In the spectrum of a three cylinder Otto engine (Suzuki Swift 1.3), contrary of the four cylinder engines, apart from basic vibration component (1X), the 1.5X harmonic also appears. There are harmonics of 2X and 3X too, but no more.

Fig 6. Typical vibration spectrum of a four stroke Otto engine

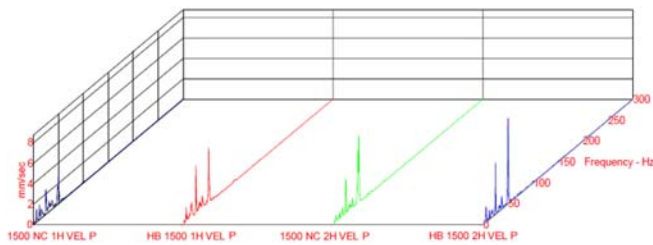
Taking into account the effect of the clogging of an exhaust system (see Fig. 7), there are considerable changes. A strong increase in the amplitudes of the 1X and 2X in the horizontal directions can be seen. The reason for this might be the clogging of the catalytic converter. As a consequence, the engine becomes less powerful, because the exhaust gas cannot leave the engine. The engine itself and the exhaust system can be overheated.

Fig 7. Effect of exhaust clogging on vibration spectrum

The replacement of ignition spark plugs by wrong ones has no significant effect on the spectra. It might be unexpected, but the clogging of the air filter has no considerable effect on the spectra. On the other hand, clogging of the exhaust system has a considerable effect both on the vibration severity and on the spectra.
