LANDSLIDE GEOHAZARD MONITORING, EARLY WARNING AND STABILIZATION CONTROL METHODS

ZBIGNIEW BEDNARCZYK

Institute of Opencast Mining, "Poltegor-Institute", Wrocław,
e-mail: zbigniew.bednarczyk@igo.wroc.pl.

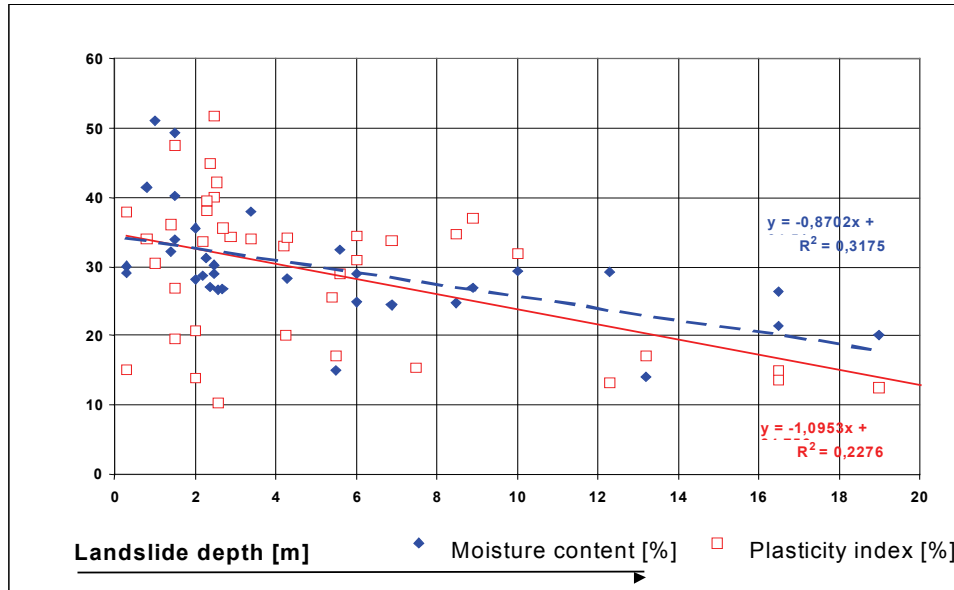
Fig. 2. Results of index laboratory tests

mately 2–10 m (Fig. 2). The depths of the slip surface were in a good correlation with maximum values of moisture content and plasticity index.

Geotechnical laboratory tests included index test – grain size, natural moisture content, plastic and liquid limit, bulk density, grain-size density, and content of organic/bituminous material. Other types of tests were direct shear test, IL oedometer, CIU and CID triaxial tests. The results of grain size tests detected that colluviums represented silty clays, loams, gravely loams, claystones and sandstones (bedrock). The soil samples investigated had a very high natural moisture content 18–37%, varying strength 0.1–0.8, 6.5–10 kPa consistency, with an angle of internal friction of 11–15° and very high compressibility. The highest values of moisture content and plasticity were observed in samples taken near the slip surface to depths of approxi-

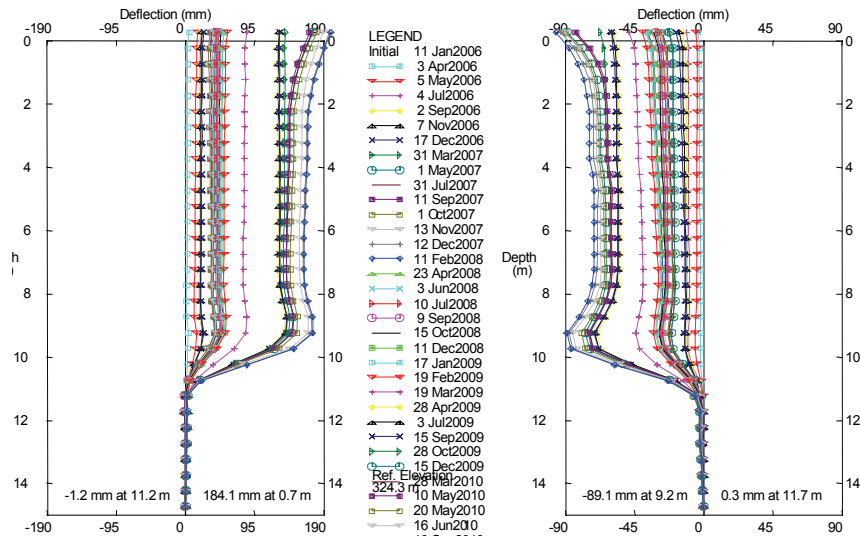
Fig. 3. Cumulative displacements – Szymbark

The inclinometer casing at Szymbark landslide was damaged by displacements of 150–180 mm in size and at a depth of 11 m (Fig. 3). The highest monthly displacements of 12 mm were observed during May–June 2006 at Sekowa landslide. They occurred after record monthly rainfall 230 mm, which contributed to high pore pressures values of 45–50 kPa. Movements were usually activated after a period when the pore pressure on the slip surface reached 50–65 kPa (Fig. 4). The size of displacements has a better correlation with the values of pore pressure than the depth of the groundwater level. The monitoring data obtained was used for numerical slope stability analysis. They provided the recognition of stabilization possibilities. At the end of May 2010 the first real-time monitoring system in Poland was

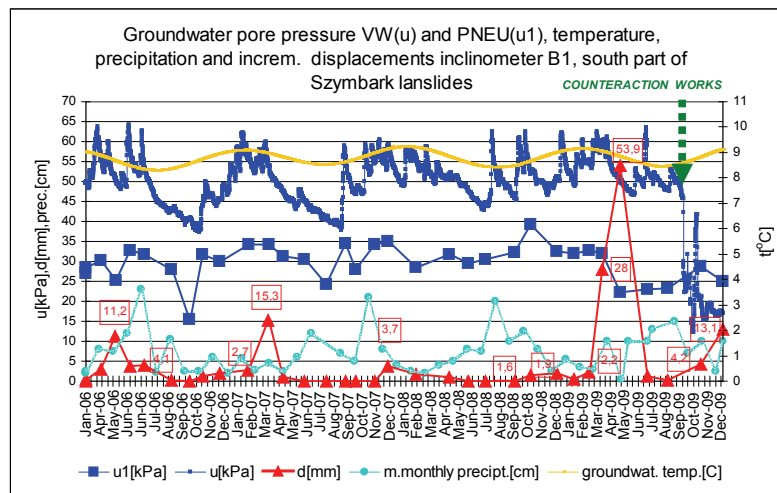
Fig. 4. Monitoring parameters plotted – Szymbark landslide

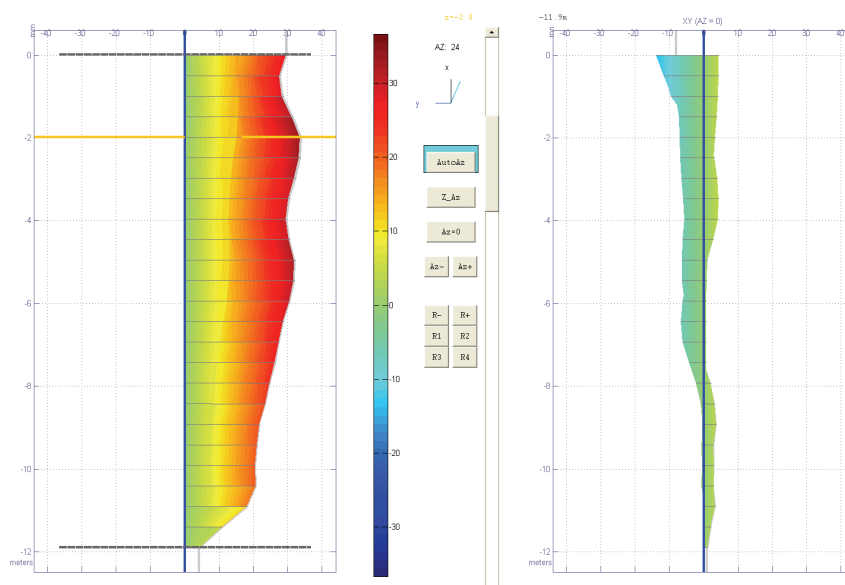
Fig. 5. Cumulative on-line displacements [mm]

installed in the area of landslides at Szymbark. The time of installation coincided with record high rainfall. The reading taken from the automatic weather station reached 100 mm/m² on June 2. Four field measuring stations were built over a public road Szymbark–Szalowa (Figs. 5–8). Innovative continuous inclinometer 3D systems consisting of tilt sensors every 0.5 m to depths of 12 m and 16 m were set up. They included a total of 66 tilt sensors which allowed much greater range of displacements to be measured compared with the standard inclinometers. This type of system could in some cases stand displacements of up to 3 m. Another automatic on-line “in-place” inclinometer system with 3 uniaxial sensors had a length of 14 m. Ground movement measuring devices were supplemented by three automatic pore pressure and groundwater level transducers and an on-line weather station. During the first 23 months

of operation of the system maximum displacement reached 20–32 mm. The total deformation was calculated from the equation: $D = \sqrt{(x^2 + y^2)}$ (Dunnicliff [11]). Registered on-line displacement reached 22–34 mm to the depth of 12–15 m. Real-time measurements will be conducted till the end of 2014.

road had to protect slopes from the influence of rainfall. After securing the road, the groundwater pore pressure decreased (48–30 kPa in Sekowa and 50–15 kPa in Szymbark). However, in Szymbark despite the partial stabilization, the displacement of the size of 13–20 mm occurred. They intensified especially after record rainfalls in May–June 2010, which caused flooding in neighbouring regions. The methods used for the stabilization reduced the risk and secured the threatened sections of public roads which was confirmed by monitoring measurements. The values of observed movements ranged from 26 to 138 mm. In some cases, they increased to more than 60 mm during stabilization works, which was often caused by the fact that these were carried out at the end of the year in adverse weather conditions. After remediation work the displacement usually had been typically reduced to \pm a few mm. The landslide in Szymbark with partial stabilization recorded displacement of 10 mm in the first year. However, after record rainfall movements rose in some places to 18 mm, which was detected in real time by an automatic early warning system (Figs. 5–8).

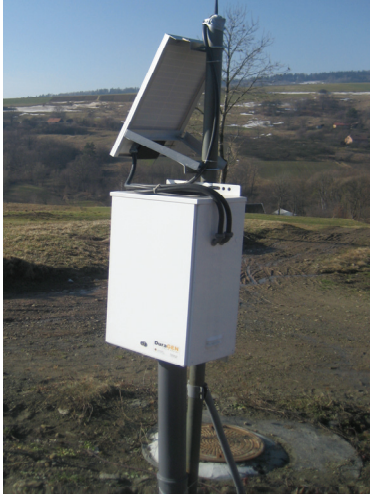
Fig. 6. Continuous 3D inclinometer on-line station

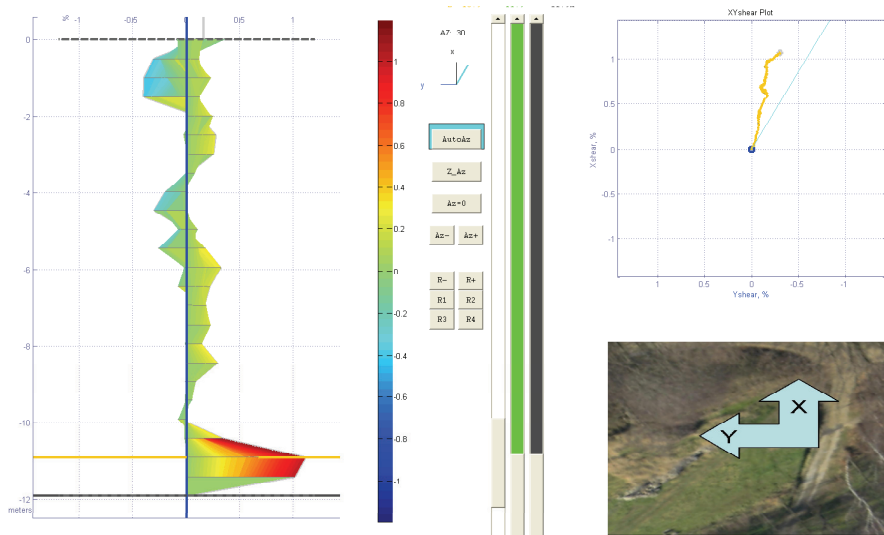
Fig. 7. Shear strain plot on-line

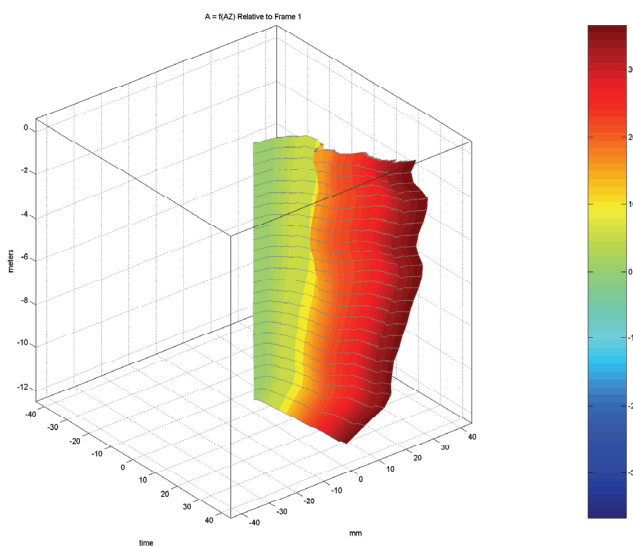
Fig. 8. Displacements on-line – 3D model

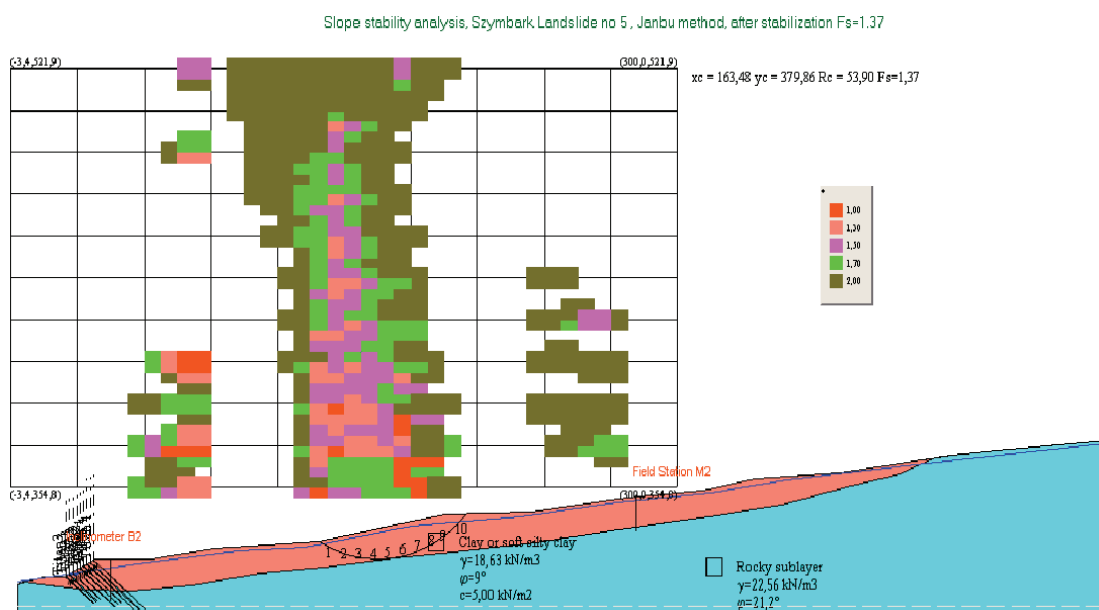
Fig. 9. FEM slope stability – Sekowa landslide

circular slip surfaces (Fig. 10). The stabilization methods proposed had been tested using conventional limit equilibrium methods LEM, with calculations based on the relative slope stability factor. However for the landslide in Sekowa, the value of F_s , calculated were slightly above $F_s = 1.13$ before stabilizing and $F_s = 1.58$ after it. After the remediation work the most probable slip surfaces were located always away from public roads. The expected displacements were also calculated using Finite Elements FEM methods taking the results of monitoring in the definition of the boundary conditions into account. Modelling detected that the total displacement expected at landslide in Sekowa could reach up to 12 cm without stabilization works (Fig. 9). The plot of the final FEM mesh without stabilization works indicated that the landslide was active and dangerous to the public road.

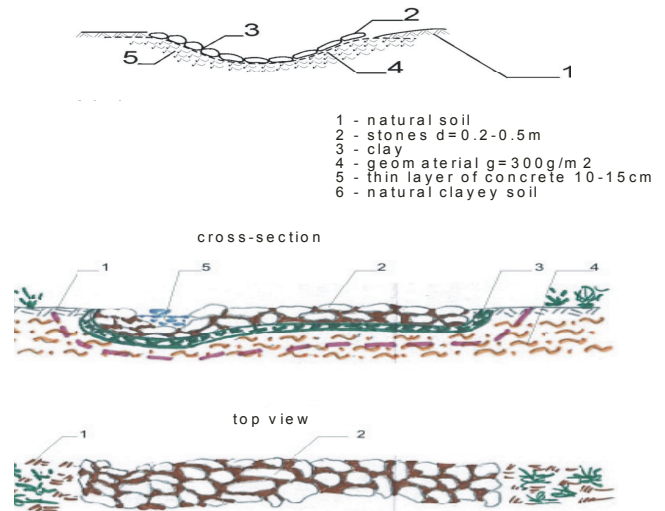
Fig. 12. Surface drainage – Sekowa landslide

age system, which has a total length of 300 m, took the rainwater away from the landslide area into the river through a new culvert under the road (Figs. 12, 13). However during stabilization, after intense rainfalls mass movement activation of up to 60 mm was observed. After remediation works, the size of the observed movement will hopefully be reduced to ± 5 mm within a five years' period. The values of the groundwater pore pressure which were equal to 45 kPa before the stabilization works reduced to approximately 30 kPa. The depth of the groundwater level was reduced from 1.3–1.8 m to 2–2.2 m. The conclusions from the monitoring measurements and the control of stabilization are shown in Table 1.

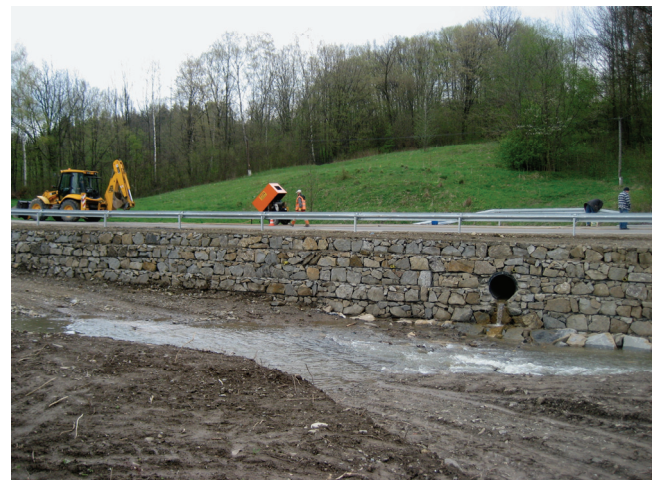
Fig. 13. Stabilization works at Sekowa landslide

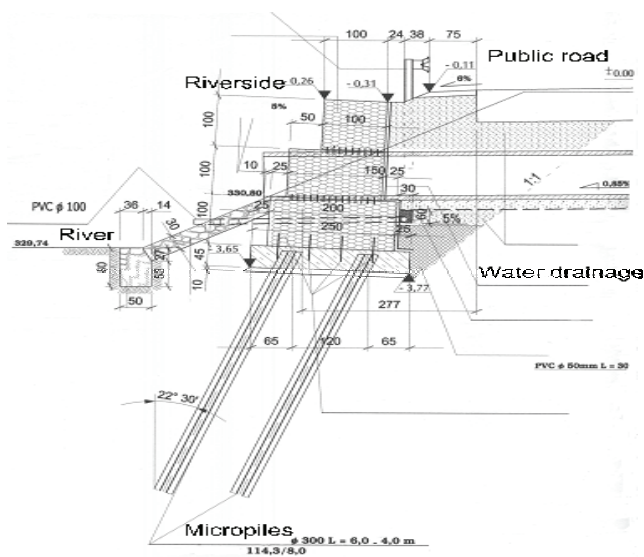
Fig. 11. Retaining wall along the river – Sekowa landslide

plementation of effective stabilization work. These included landslide depth, size, directions of displacements, the strength parameters of colluviums as well as bedrock and groundwater conditions. Slope protection contributed to the decrease of risk to public roads and to the improvement of stability conditions. Monitoring measurements allowed the factors which activate the landslide processes to be interpreted. Various methods of stabilization were used. For example, a gabion retaining wall founded on 300 micropiles to a depth of 6 m at a distance of 200 m along the river was built for the Sekowa landslide (Figs. 11, 13). The central part of this landslide retaining wall constructed along the length of over 30 m was set on 60 micropiles at a depth of 11 m in three rows, 300 mm in diameter. The first row was tilted at an angle 11° , the two others were made vertically. The upper part of the micropiles was connected by a special supporting construction of reinforced concrete. The surface drain-

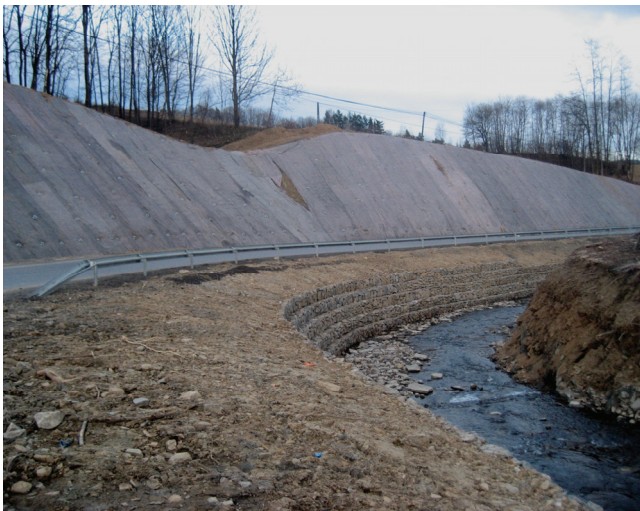
Fig. 14. Landslide in Szymbark after partial stabilization

For landslide in Szymbark, several concepts of stabilization or temporary protection were considered due to the large size of the area and the risks posed (Fig. 14). The remediation implemented allowed for the partial stabilization of the landslide head. For this purpose the anchors of up to 20 m in length were installed in the bedrock. Anchors and high tensile Geobrigg wire mesh supported the landslide head part. Partial stabilization works also included a gabion retaining wall along the Bystrzanka River. The surface and internal drainage system (horizontal drains and drainage wells), and two new culverts under public

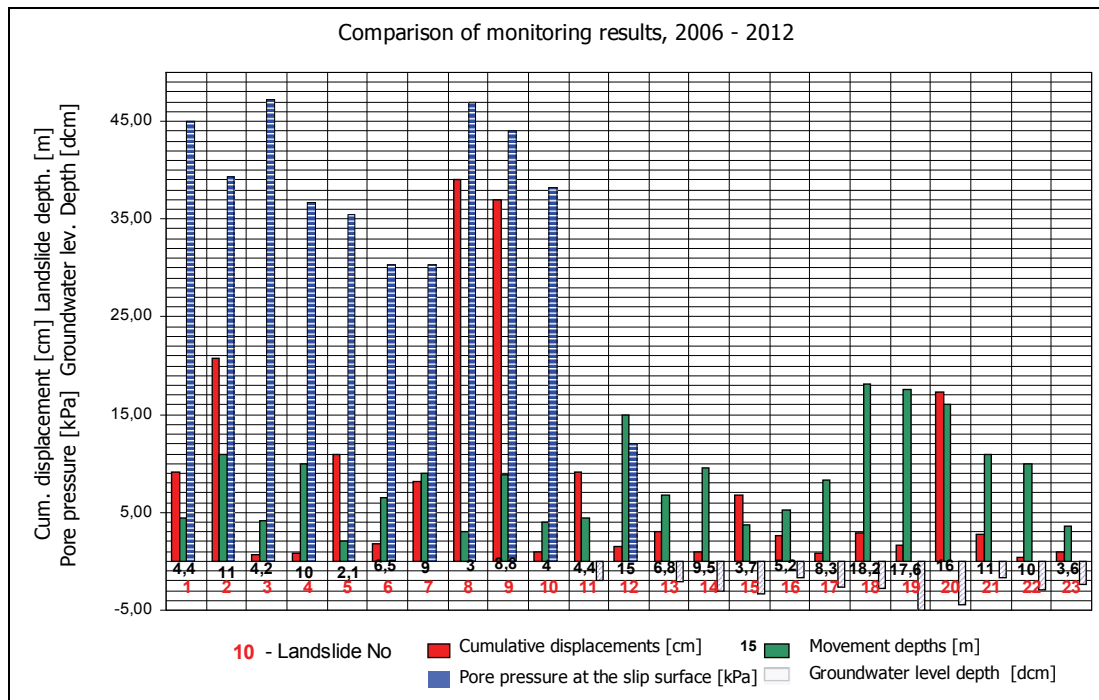
Fig. 15. Comparison of the monitoring results in 23 landslide locations

pressure in the range of 15–65 kPa. A comparison of monitoring results is shown in Fig. 15. The displacements were observed to a depth of 11.5–16 m and reached a size of 22–34 mm while pore pressure values of 48–65 kPa were also noted. The results of the monitoring measurements were included in the analysis of stability by LEM and FEM methods for slopes before and after stabilization works. In May 2010 after record high precipitation, displacement increased to more than 11 cm within 1 day in some areas. Stabilization methods were fully effective on the landslide in Sekowa. In the four-year time period after stabilization the displacement observed reached only a few millimetres. At the large and dangerous landslide in Szymbark a partial remediation limited the scope of movements. However, partial stabilization works could not be fully effective after extremely high rainfall. It was particularly noticeable in May 2010. The results of the research showed that large and active flysch landslides were difficult to stabilize. Remediation projects should therefore be carried out according to local geotechnical conditions in a reasonably long period of monitoring time (minimum 12 months). This is particularly important because of the huge cost of remediation works. Implementation with various site-specific investigations and monitoring methods and models can result in a more reliable diagnosis of possible options of stabilization and provide information about potential hazards. The implementation of new techniques for real-
