CORROSION DAMAGE INVESTIGATION OF SILVER-SOLDERED STAINLESS STEEL ORTHODONTIC APPLIANCES USED IN VIVO

The aim of the conducted study was to evaluate corrosion damage in silver-soldered stainless steel rapid palatal expansion Hyrax appliances.

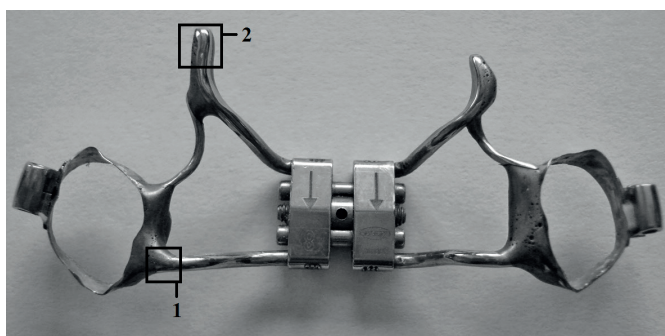
Fig. 1. The Hyrax device used for 2 months; 1, 2 – described in the text solders

Two silver-soldered stainless steel rapid palatal expansion appliances were investigated after *in vivo* application. The devices were worn intraorally for two and six months (Fig. 1, Fig. 2), respectively. In order to remove organic debris, the samples were rinsed in room temperature ethyl alcohol in an ultrasonic cleaning machine (InterSonic, IS-2). The appliances were examined and photographed in a scanning electron microscope (Hitachi S-3000N). Concentrations of the alloys elements were determined by using energy-dispersive X-ray spectroscopy (Thermo Scientific NORAN 4460D-1UUS-SN instrument).

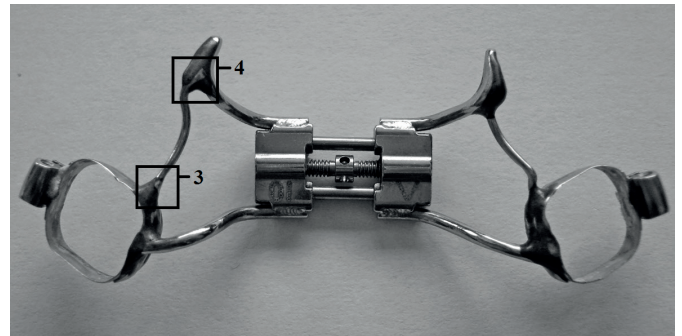
Fig. 2. The RPE appliance used intraorally for 6 months; 3, 4 – mentioned in the text solders

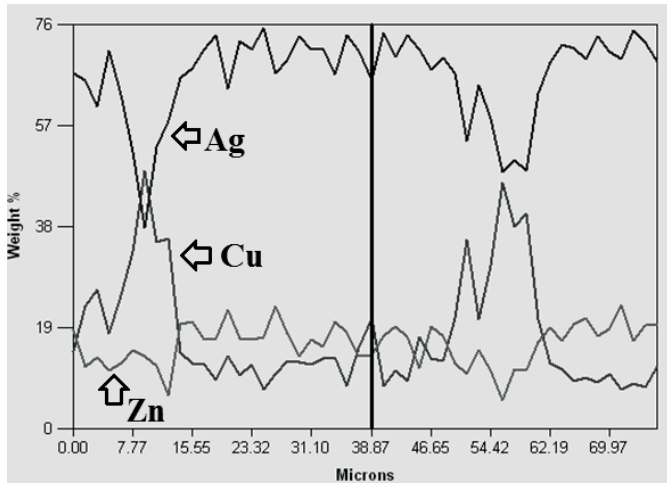
It is worth noting that solders of the RPE appliance after 6 months in service reveal lower Cu and Zn mass content than samples used intraorally for 2 months (Table 2). What is more, linear EDS analysis (Fig. 4) of solder 1 showed differential elements composition in the material interface. Corrosion pits were singled out as Cu-rich areas, whereas their zinc amount was remarkably reduced. The Ag content remained at an almost even level.

Fig. 3. Linear EDS analysis of solder 1

In linear EDS analysis (Fig. 3), the examined corrosion pitted solders showed local variations of chemical composition. A similar preferential dissolution of silver solder, containing 22% Cu, 17% Zn, 56% Ag and 5% Sn, has been observed by Vahed et al. [10]. It is known that one-element rich particles result in a micro-galvanic effect, which leads to selective corrosive damage development. Vahed et al. [2] suggest that corrosion processes nucleation is expected to occur first at the stainless steel interface due to the heat-sink effect of the stainless steel and the heterogeneous sites provided by the pre-existing surface, as shown in Fig. 5b.

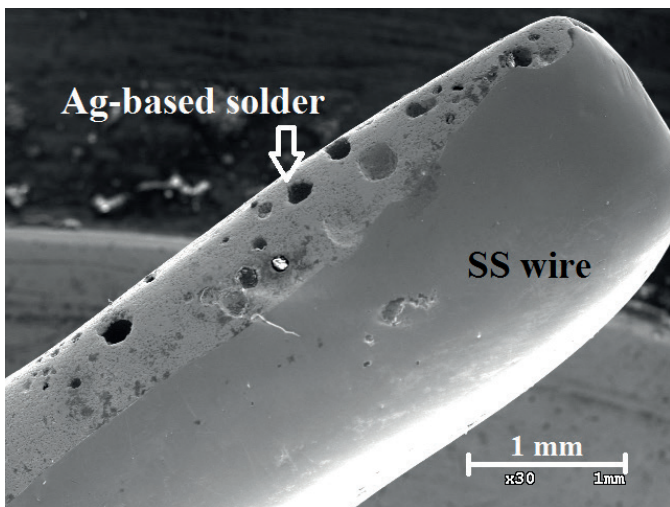
It was observed that corrosion damage was considerably greater in appliances used for 6 months rather than 2 months (Fig. 4, Fig. 5, Fig. 6). Unlike appliances used for a shorter amount of time, solders of the Hyrax expansion device after 6 months in service showed a predisposition to come away from the steel (Fig. 6). This might cause immediate failure of the appliance and a premature need to repair the device.

Fig. 4. RPE appliance after 2 months in service, solder 2, magnification 30×, SEM photograph. Visible severe corrosion pits in the solder material and non-corroded wire

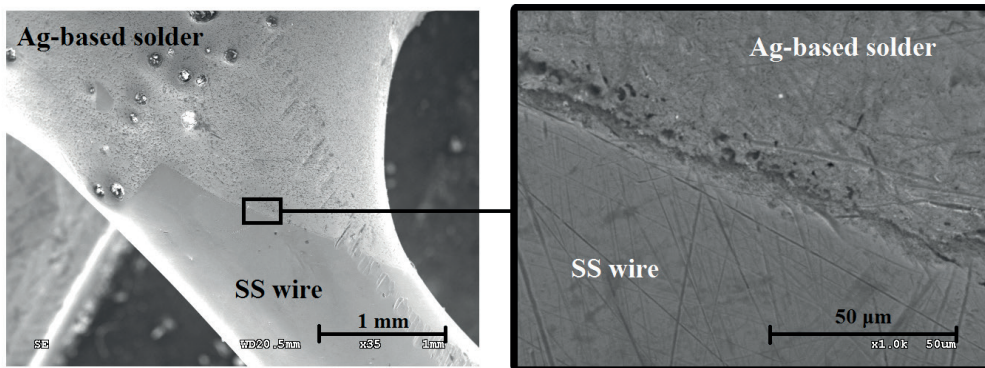
Fig. 5. Hyrax expansion device after 2 months of use, solder 1, magnification 30× (a) and 1000× (b), SEM photographs. Solder shows no tendency to coming away from the steel, although at the magnification of 1000× there is a noticeable characteristic for galvanic corrosion pitted boundary between the materials

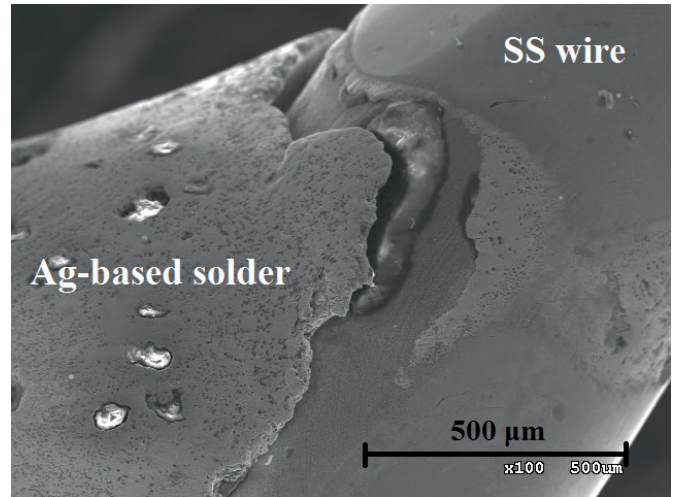
Fig. 6. Hyrax device after 6 months of intraoral use, solder 3, magnification 100×, SEM photograph. Observable tendency to loosening up the bimetallic junction caused by solder corrosion

processes are intense and lead to severe damage, like loosening of soldered joints in a short amount of time. Due to the observed damage, the authors suggest further studies into ultrasound laser welding in orthodontic applications.
