D. NIEMIEC*[#], G. MOSKAL*, A. JASIK*

THE INFLUENCE OF NiCrAlY COATINGS ROUGHNESS ON OXIDATION KINETICS DURING STATIC OXIDATION TEST AT TEMPERATURE 1000°C AND 1100°C

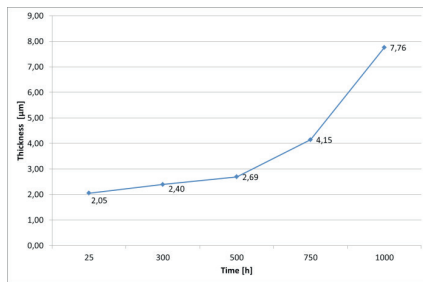
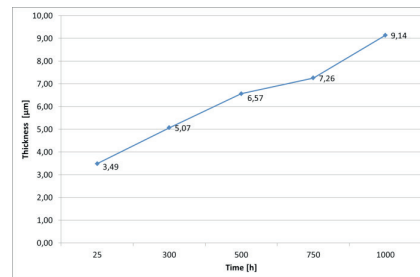
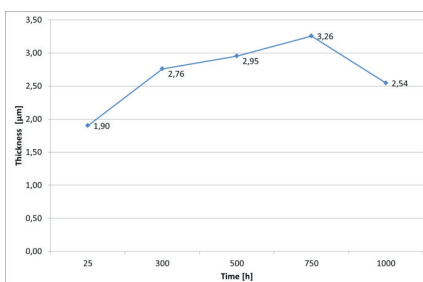
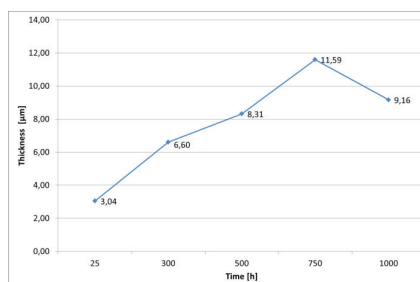
The thickness of oxide layer in the depression of the roughness profile of the bond-coat at a temperature of 1000°C

The thickness of oxide layer in the depression of the roughness profile of the bond-coat at a temperature of 1100°C

The thickness of oxide layer in the peak of the roughness profile of the bond-coat at a temperature of 1000°C

The thickness of oxide layer in the peak of the roughness profile of the bond-coat at a temperature of 1100°C

Fig. 1. The kinetics of growth of the oxide layer thickness in the depression of roughness and in the peak of roughness profile of bond-coat a temperature 1000°C and 1100°C

The tests were performed in the two furnaces in air. The samples were heated in the furnace (5°C/min) up to a temperature of 1000°C and 1100°C. Samples were removed from the furnace after 25, 300, 500, 750 and 1000 hours. In Fig. 1 shows the average thickness measurement of oxides layer in the depression and in the peak of bond-coat profile of roughness the tests performed at 1000°C and 1100°C. After 25 hours of the test, irrespective of the temperature of oxidation process can be seen that the oxide layer is thicker in the depression of the roughness profile than at the peak. In the following test, the oxide layer formed in the peak of the roughness profile is thicker than the layer formed in the depression of the profile. The samples were oxidized at 1100°C are noticeably thicker oxide layer and increase its thickness is steeper from samples for which the test was run at 1000°C. With the passage of time is an increase in the thickness of the oxide layer. The kinetics of this process is greater in the peak of the roughness profile of the bond-coat. In the case of an oxide layer formed on the tops of the profile after 1000 hours

test, showing a sharp drop in temperature regardless of the thickness of the oxidation was carried out. This is due to the oxide layer falls off part of the TGO.

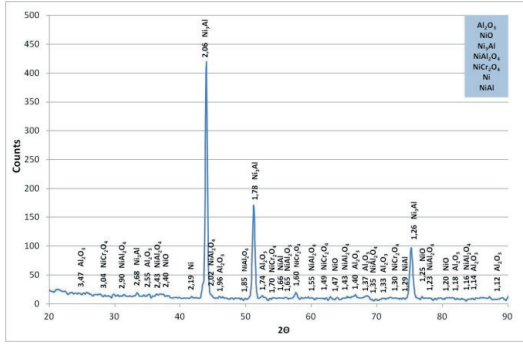
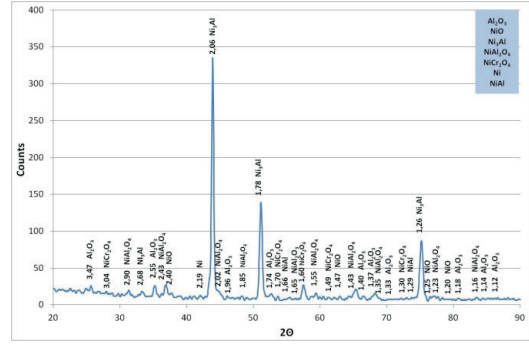
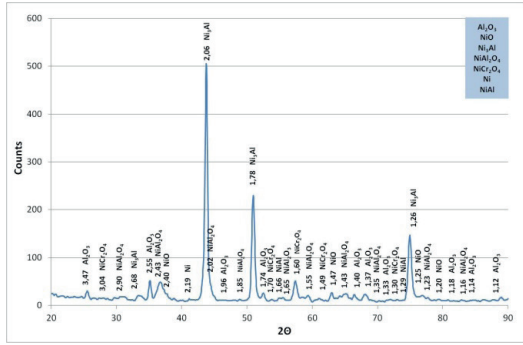
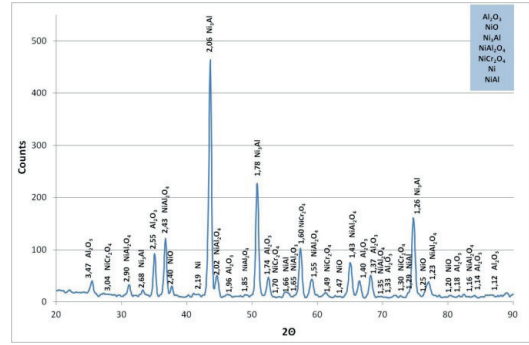
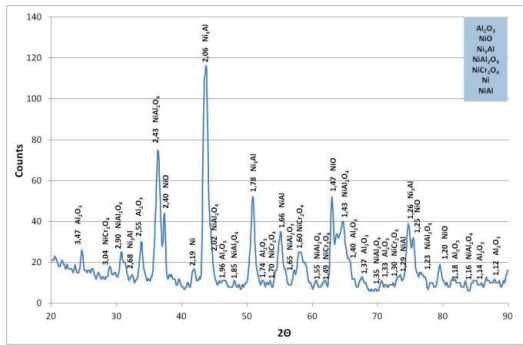
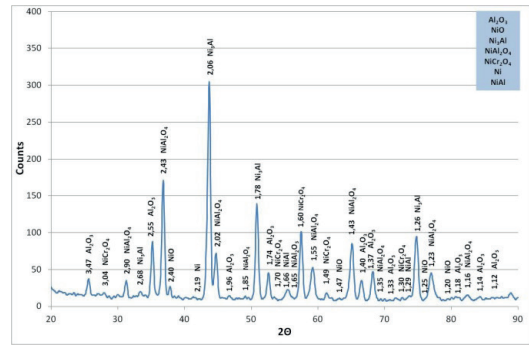
Fig. 2. XRD diffraction patterns of coated by grinding process after 25,500 and 1000 hours at temperature 1000°C and 1100°C

Fig. 2 presents an analysis of the phase composition of the samples after 25, 500 and 1000 hours at temperature 1000°C and 1100°C oxidation obtained using the XRD method. The samples removed from the furnaces after 25 hours, regardless of the test temperature is dominated by strong reflections Ni₃Al phase. In the case of staying the sample at 1000°C can further be noted the presence of oxide phases reflection: NiAl₂O₄ and NiCr₂O₄. After 500 hours of testing at 1000°C appeared reflections of the phases: NiAl₂O₄ and NiCr₂O₄. In the sample held at a temperature of 1100°C appeared relatively high reflections of Al₂O₃ phase. In both cases, dominate reflections of Ni₃Al phase. After the next 500 hours of testing in both samples is dominated by strong reflections Ni₃Al phase and weaker reflections: NiAl₂O₄, NiCr₂O₄ and Al₂O₃ phases. Reflections oxide phases are much stronger in a sample staying in the furnace at 1100°C. The analysis of the distribution of elements on the surface of 25, 500 and 1000 hours of oxidation is presented in Fig. 3,4 and 5. For samples residing in a furnace at a temperature of 1000°C can be seen as regular distribution of elements on the surface, in particular Ni, Cr and Al. Surface oxidation of the samples treated at 1100°C a noticeable formation of local large clusters that have a tendency to extend with the passage of time. Areas with a high content of Al indicate the presence of Al₂O₃. In the case of the samples subjected to oxidation at 1100°C it can be seen that the focus of the Al₂O₃ occurs around areas where there are large quantities of both Ni and Cr. This indicates the formation of this area of oxide type: NiCr₂O₄ and NiAl₂O₄.

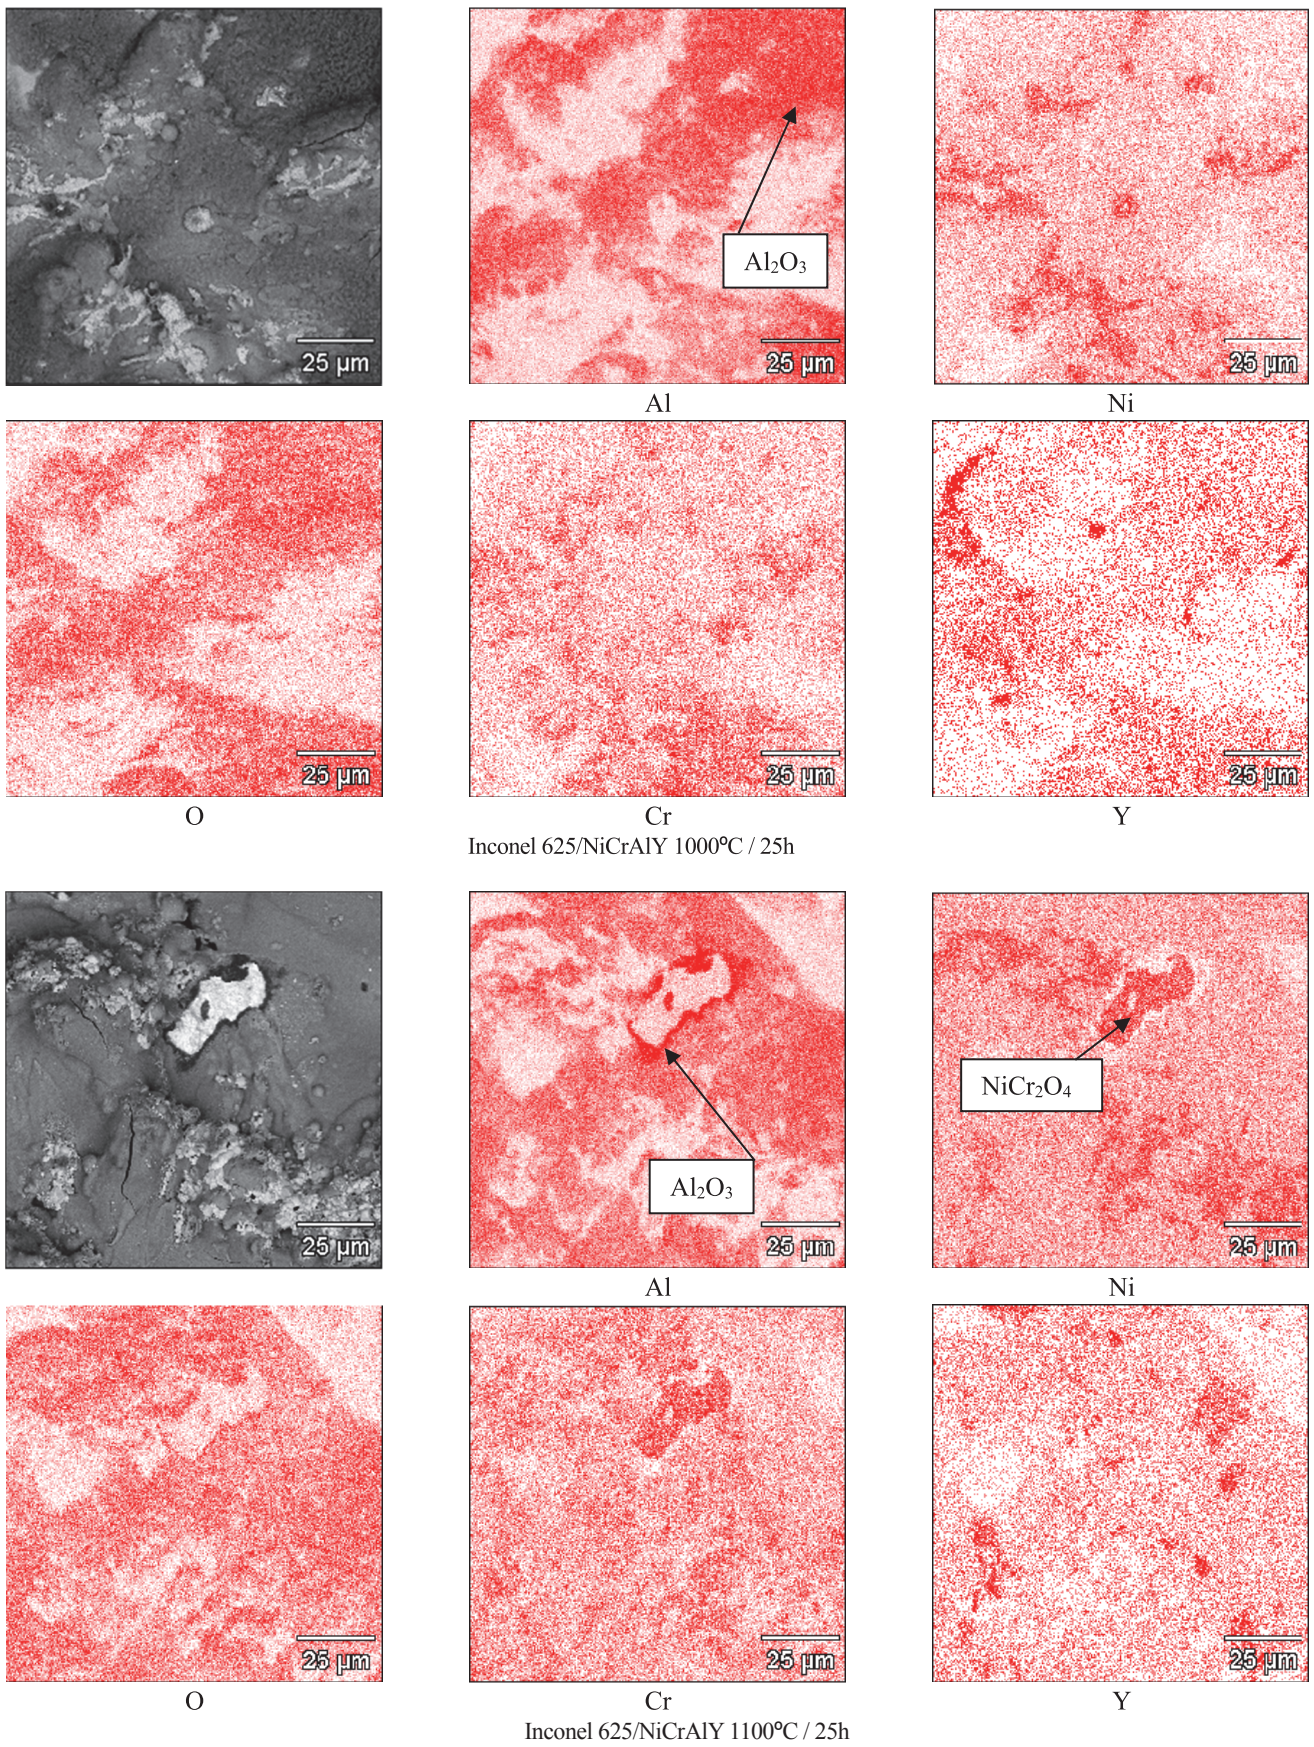
Fig. 3. Mapping of selection elements of as-sprayed after 25 hours at temperature 1000°C and 1100°C

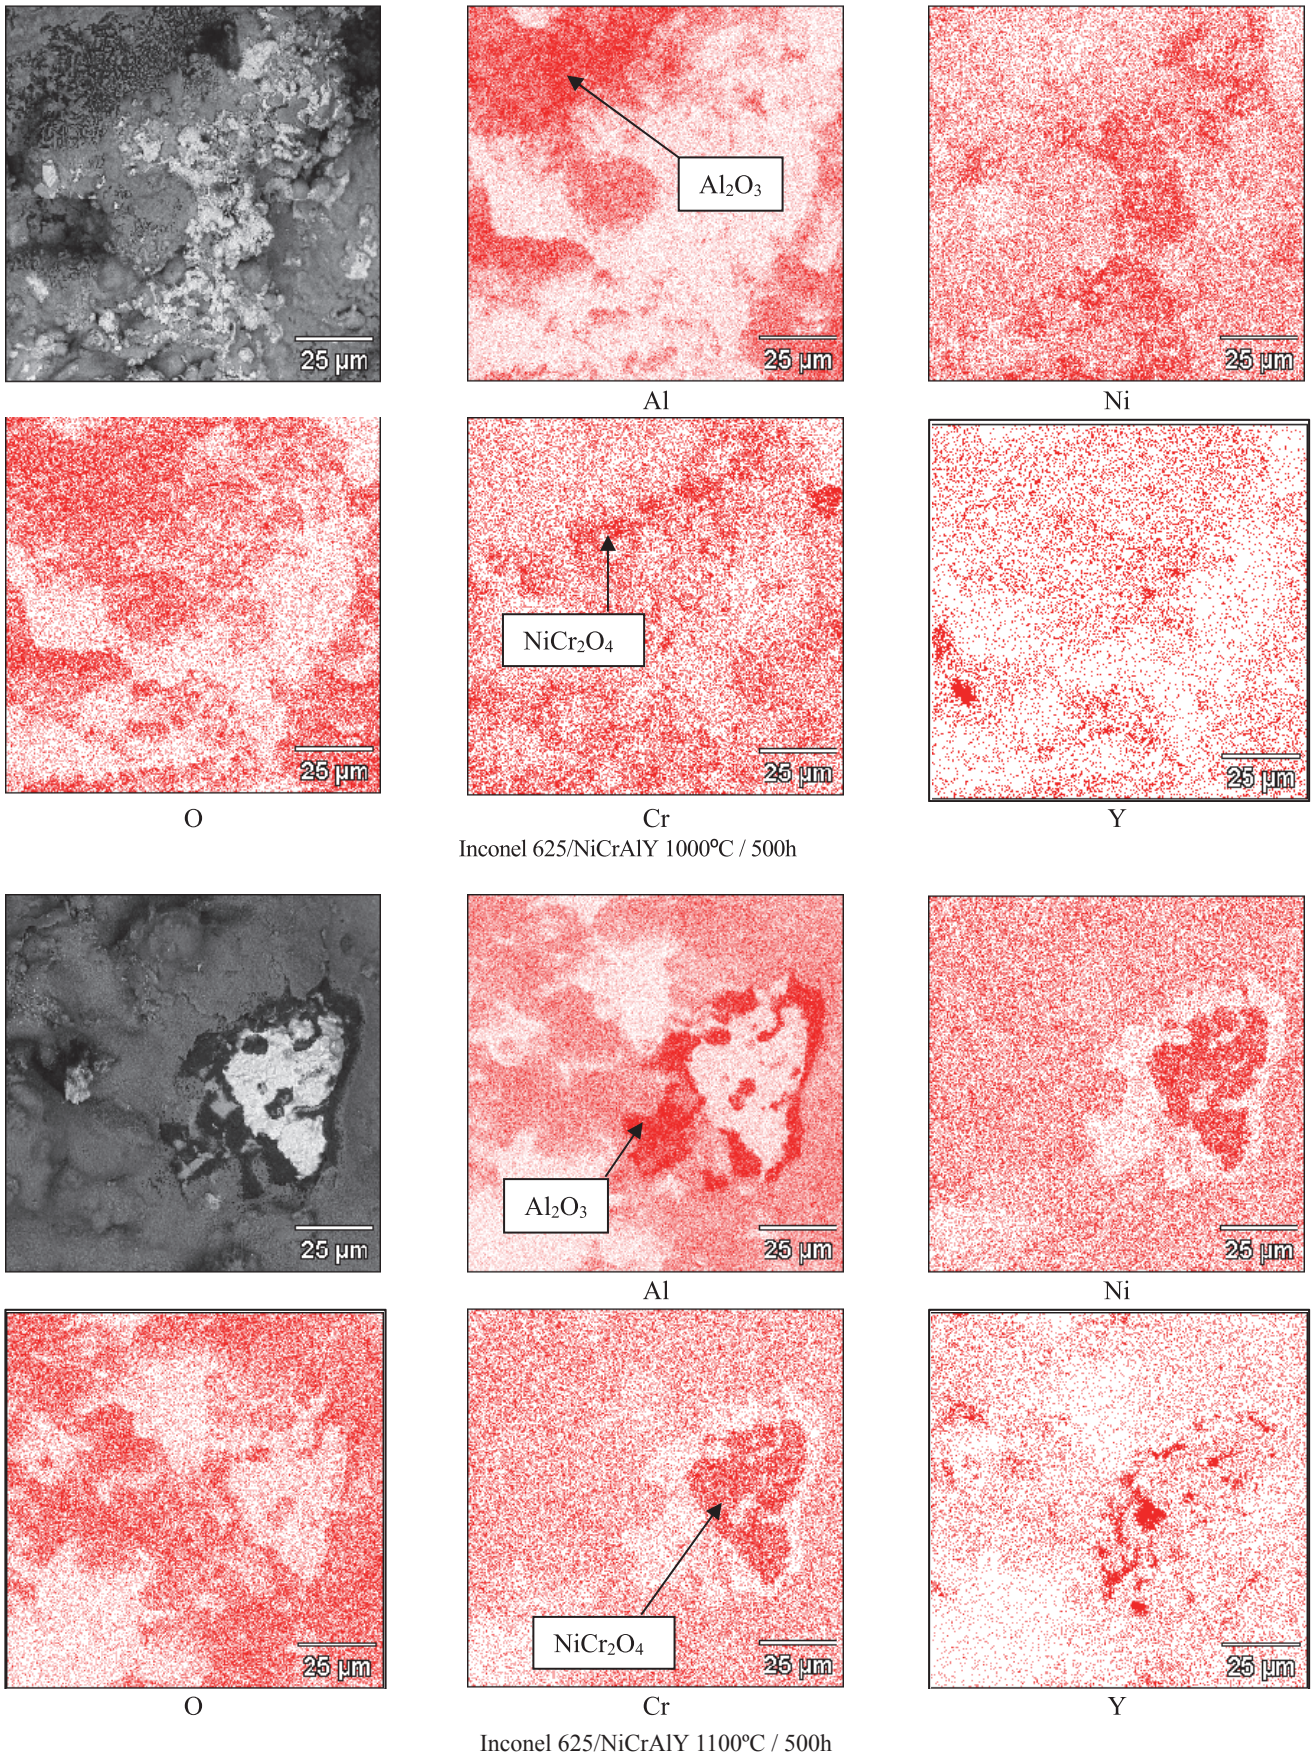
Fig. 4. Mapping of selection elements of as-sprayed after 500 hours at temperature 1000°C and 1100°C

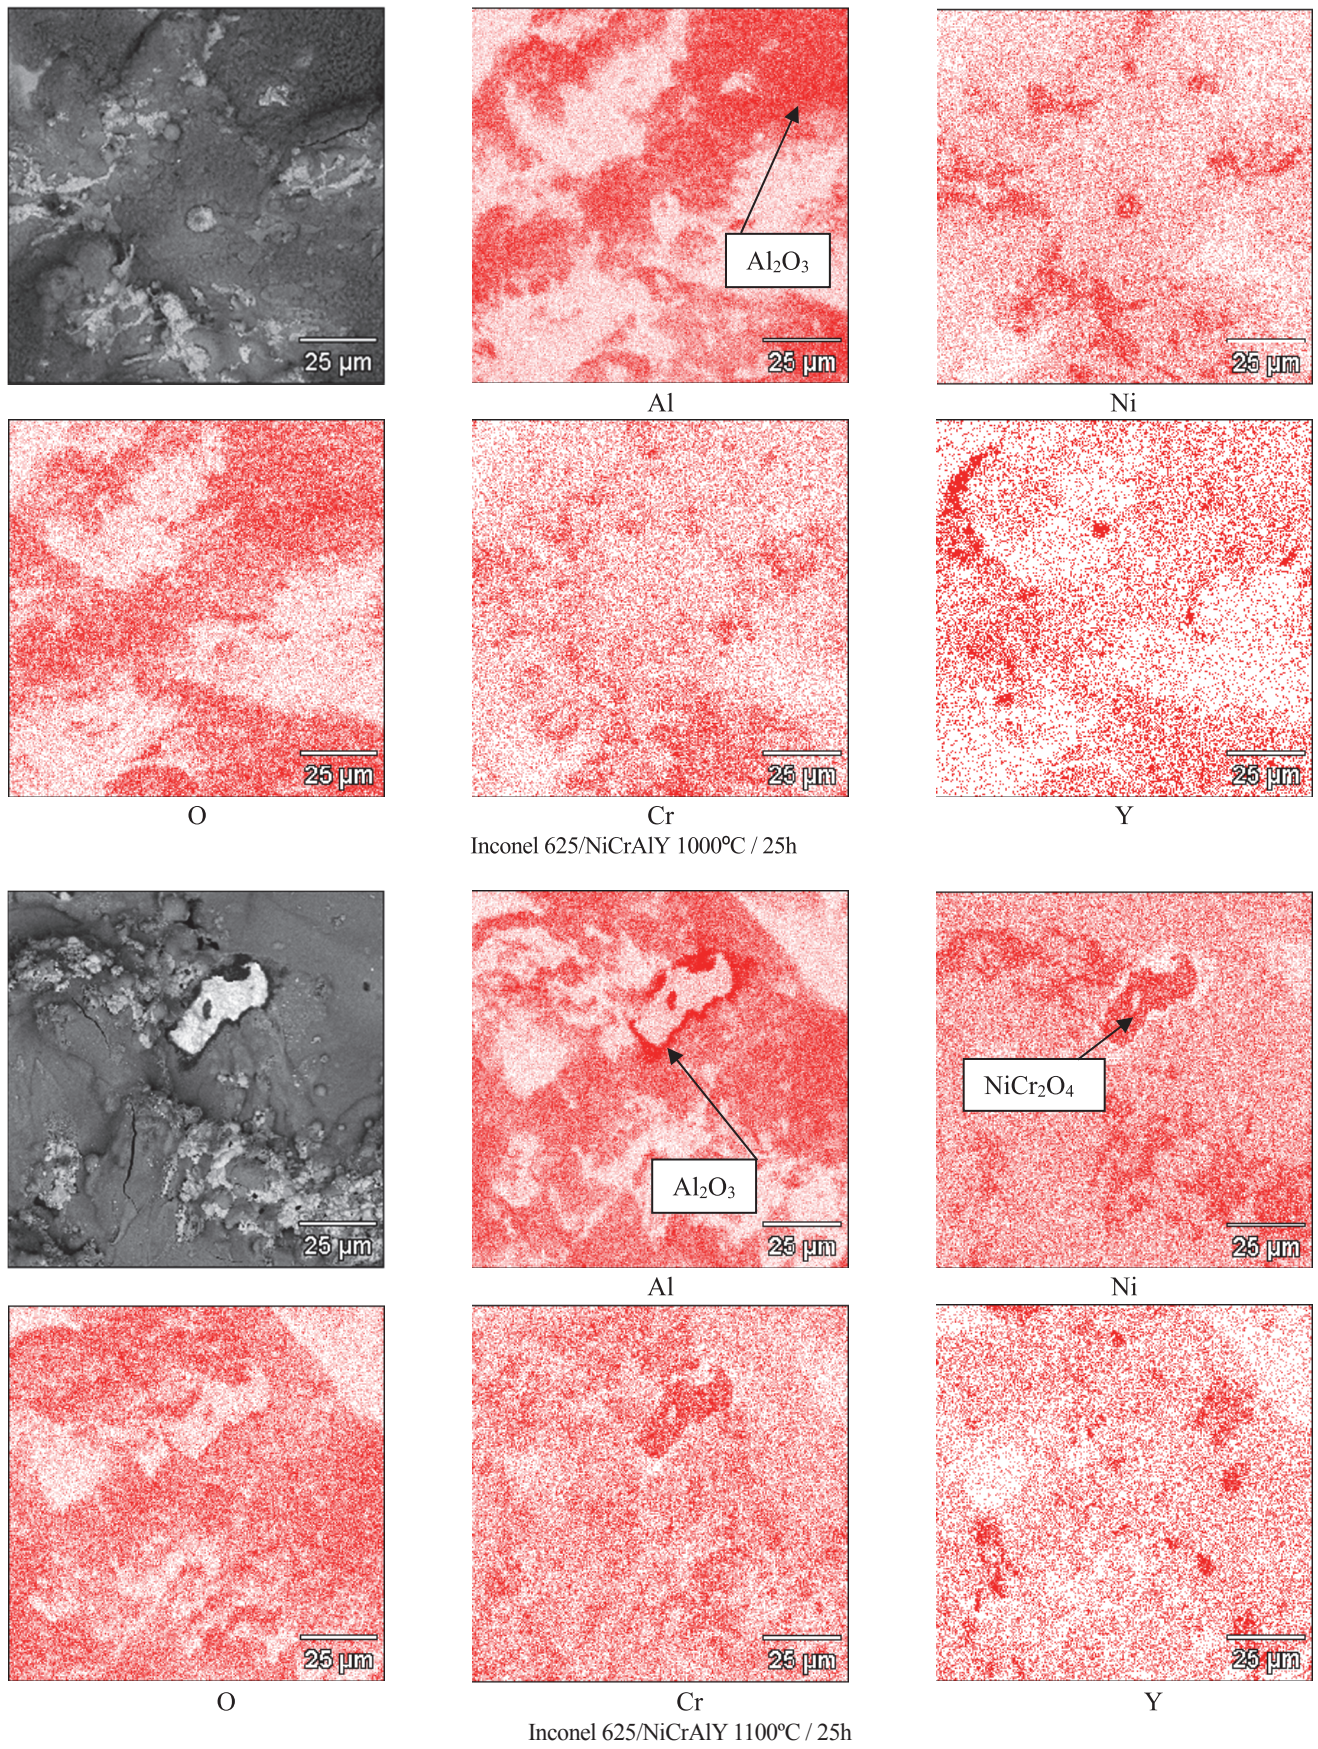
Fig. 5. Mapping of selection elements of as-sprayed after 25 hours at temperature 1000°C and 1100°C

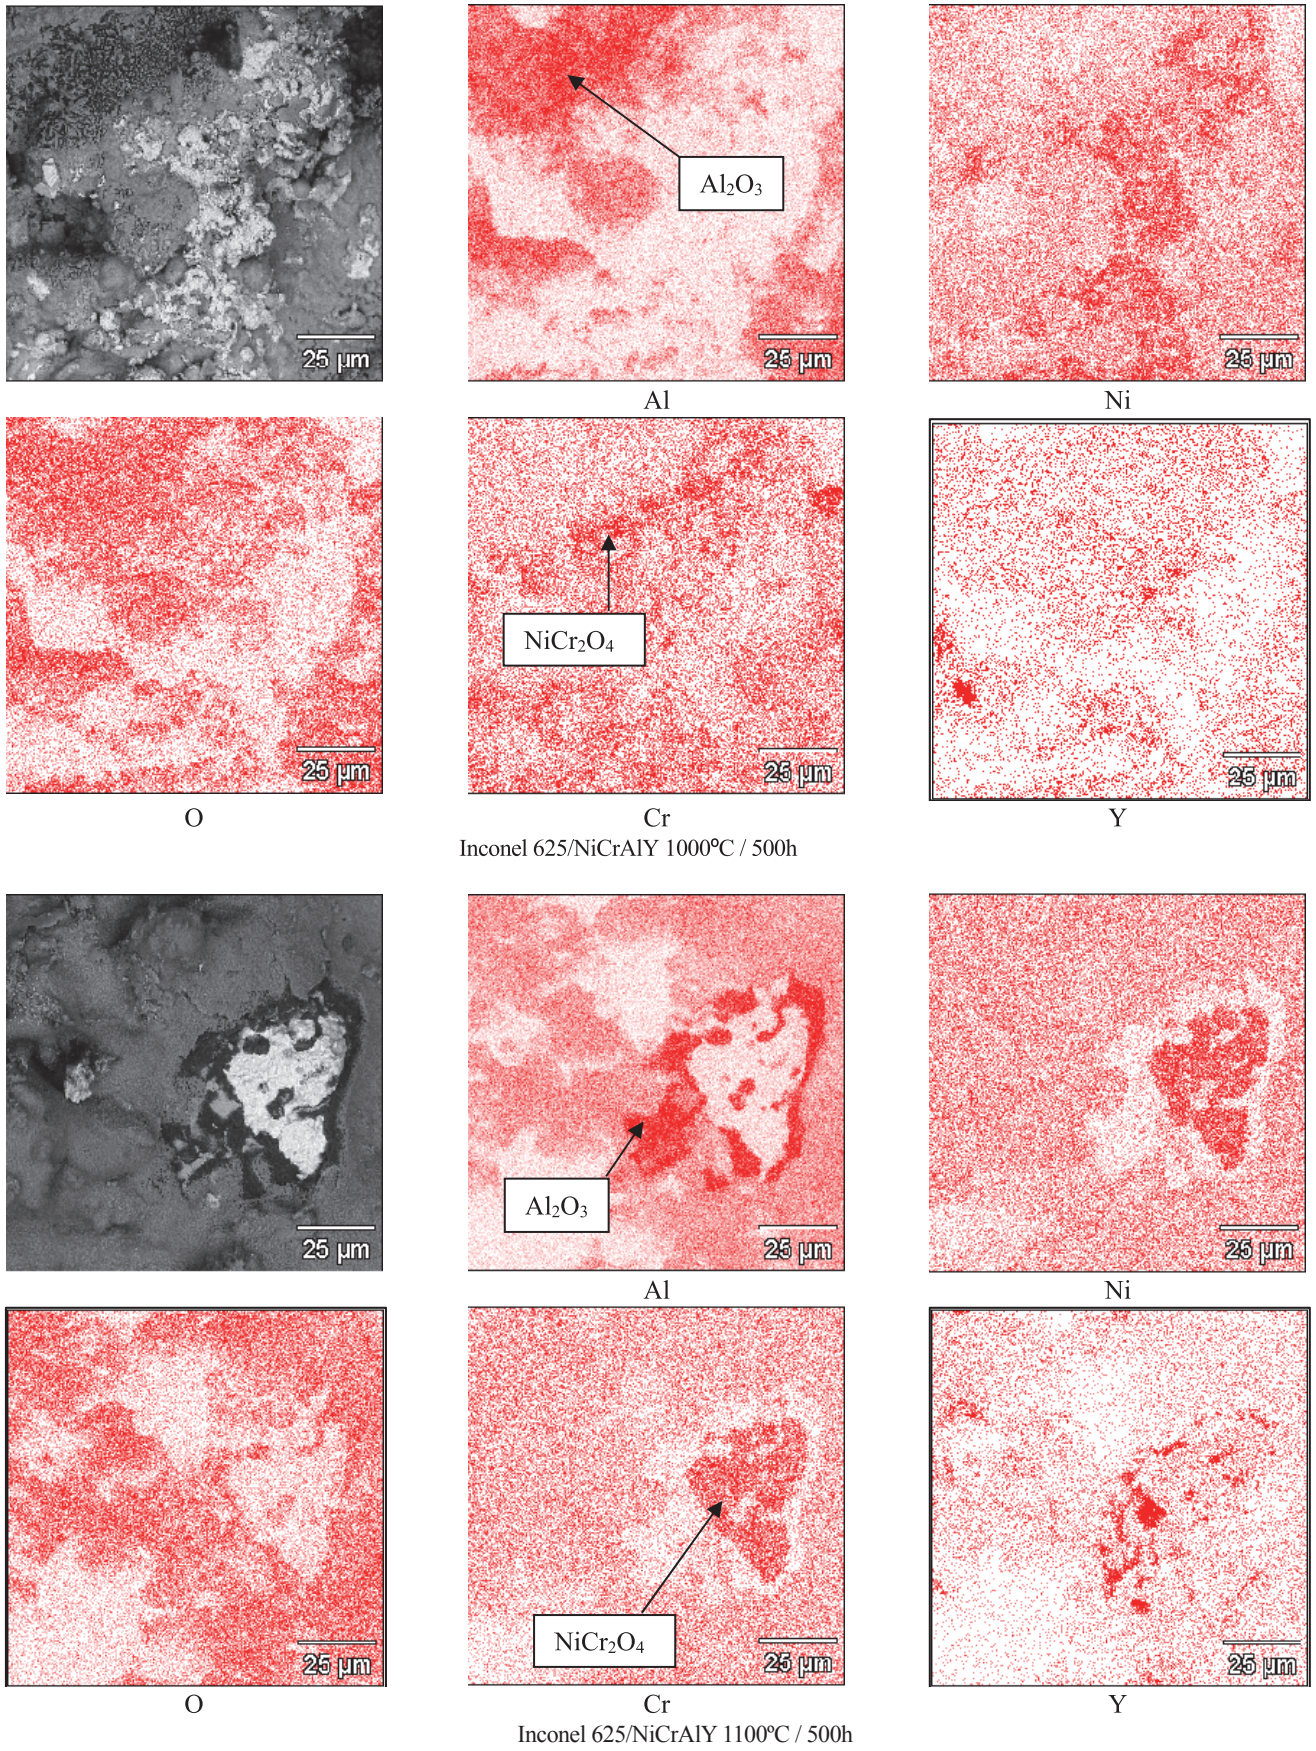
Fig. 6. Mapping of selection elements of as-sprayed after 500 hours at temperature 1000°C and 1100°C

The microstructure of the oxidation layers, depending on the residence time in the furnace the sample is presented in Fig. 6. After 25 hours, the test shows formed the island-like of oxide layers. Along with the process it is evident that the oxide layer is formed on the entire surface of the layer. An oxide layer formed by oxidation at 1000°C is more compact than the layer was formed at 1100°C. An oxide layer after 500 and 1000 hours residence at 1100°C is heavily cracked as a result of the stress generated [12,13].

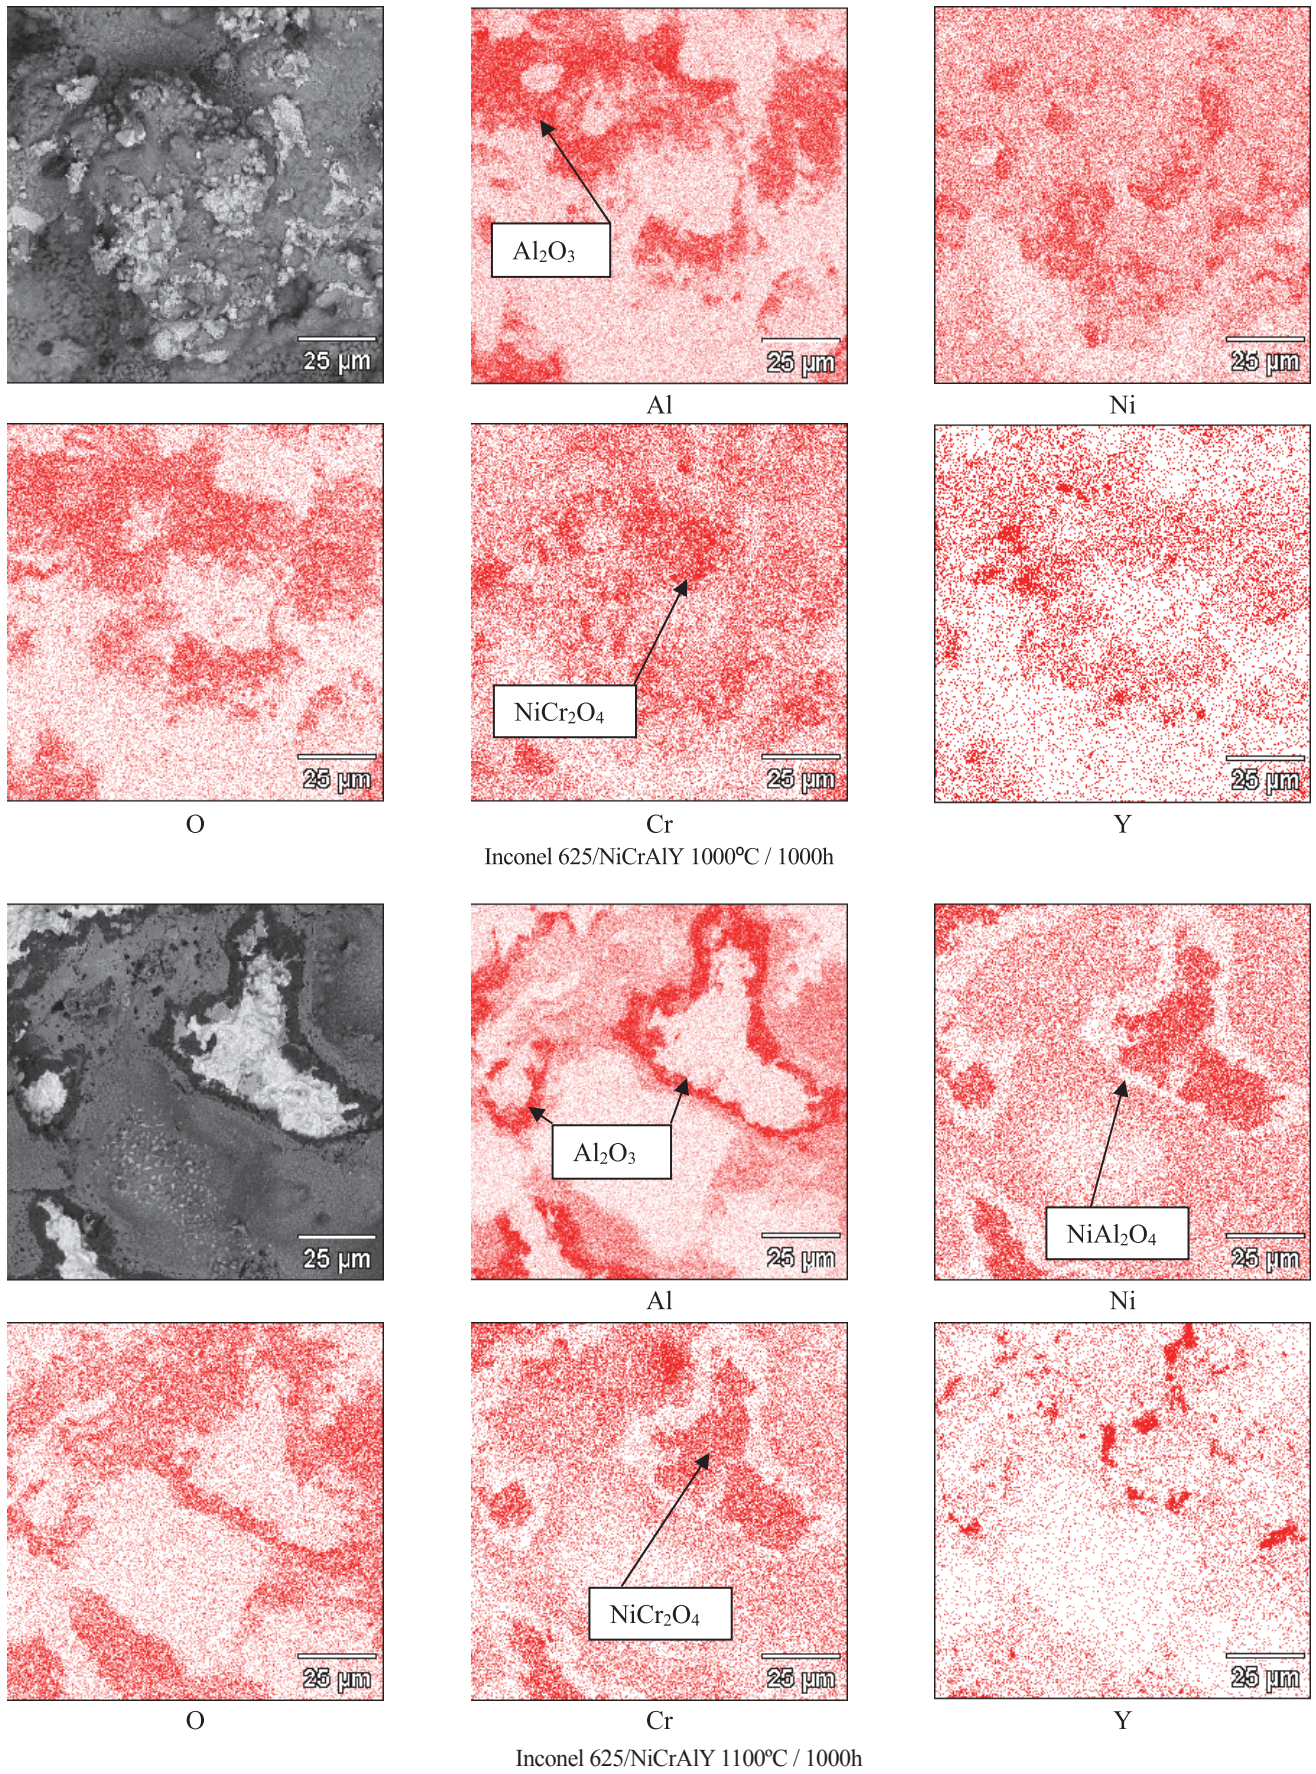
Fig. 7. Mapping of selection elements of as-sprayed after 1000 hours at temperature 1000°C and 1100°C

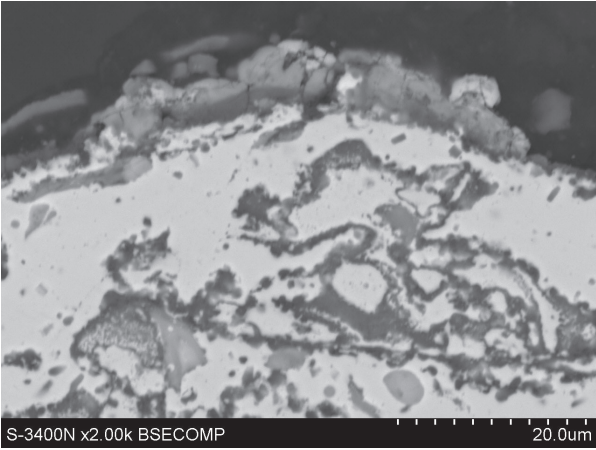
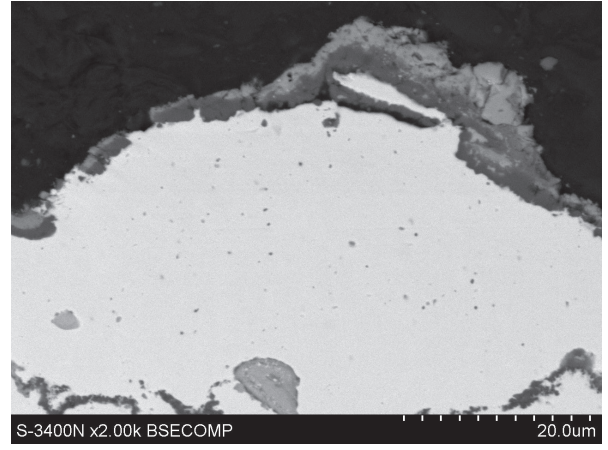
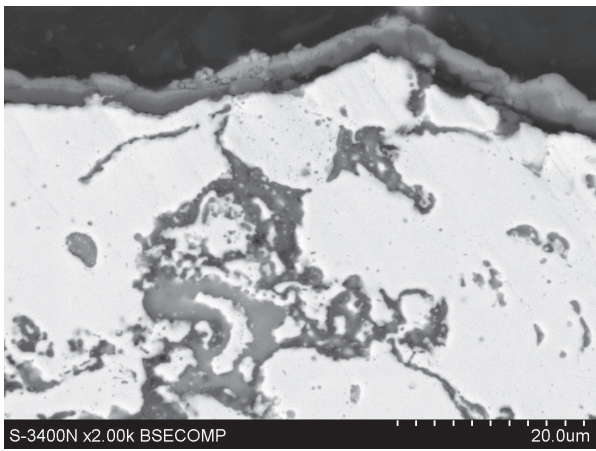
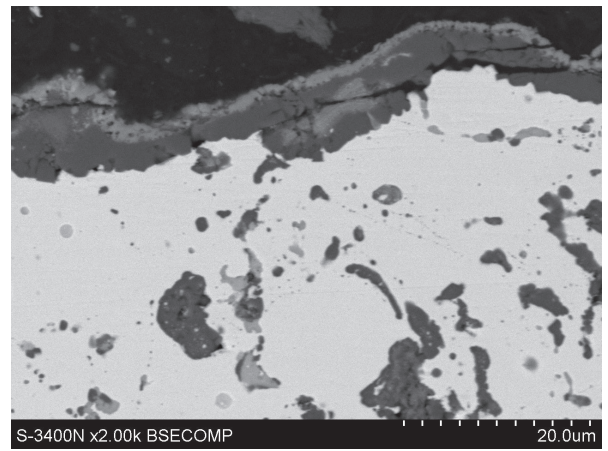
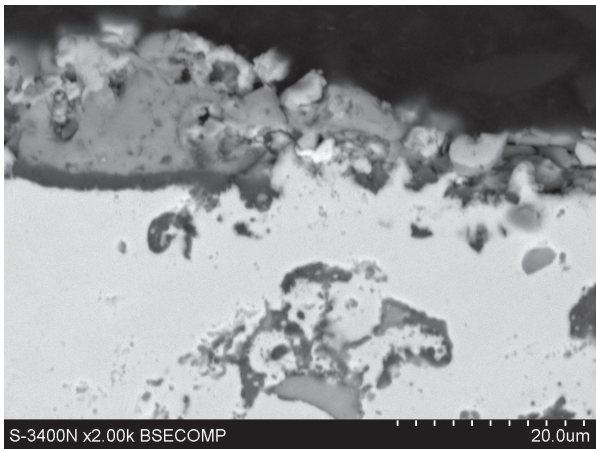
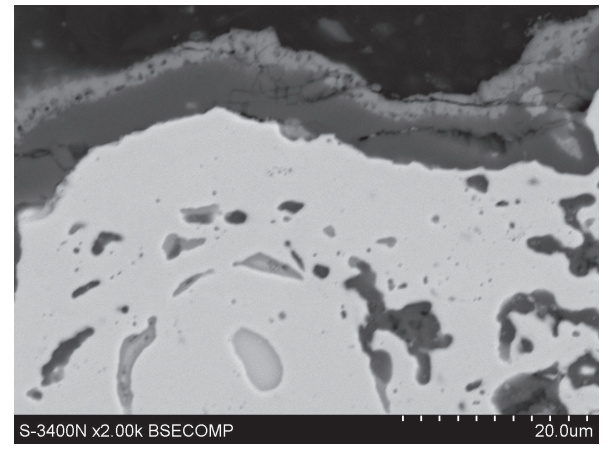
Fig. 8. Morphology of oxides temperature 1000°C and 1100°C layer on as-sprayed after the test at C
