**POSTĘPY W INŻYNIERII MECHANICZNEJ  
DEVELOPMENTS IN MECHANICAL ENGINEERING**

**EVALUATION OF INTERNAL QUALITY  
AT MANUFACTURAL CORPORATION**

**Summary:** This work is focused on evaluation of internal quality in manufactural corporation. Huhn PressTech Ltd. is a company producing metal products as results of pressing process, construction units and other components used in automotive industry. The aim of the article is to review the process of internal quality evaluation method on daily basis. Constantly growing demand on metal chipless machining replaces the older chip`s technology. This paper aimed to clarify, how the company performs fault evaluation and what is done for their correction. To explain the procedure of evaluation in detail and demonstrate the solution, there were artificially made parts 3333 and 5555 in the company. The result is called Quality Alert.

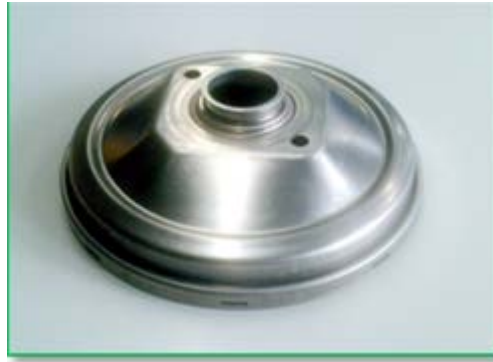
Fig. 1. Cover

Products are made on transferred and processed machines. On transfer machines, there are units moved along the transfer on production line type Raster 630t. The example of a big unit is in Fig. 1. The small pieces, such as

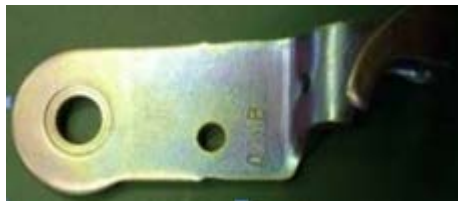
Fig. 2. Control lever

control lever or cable support, are made by processed machines. The example of a small piece is in Fig. 2.

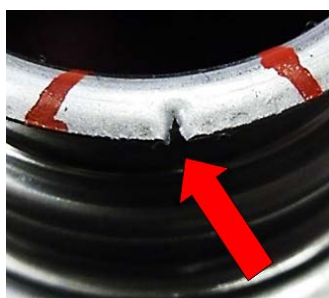
Fig. 5. Cover (crack)

Operators of pressing machines and workers of 100% control are ordered to separate units if there were found minimally 10 n. i. o. pieces of unit with the specific type of fault (burr, crack...). These pieces are separated with description (the number of unit, the amount of units), marked fault on the surface and placed nearby pressing machine (in red box) that produces this unit. On the workplace of 100% control, it is placed in the container which is given for this order. It is important to take a photo of the unit, the date code and the fault and it has to be admitted to defined cell – Fig. 5. If the unit, addressed to photo documentation of the fault, is not placed on pre-defined place, it is needed to closely specific defined fault. For example, the dialog with the operator who made the mistake or controlled it on the workplace of 100% control and report it to the cell could be useful. Examples of faults from photo documentation:

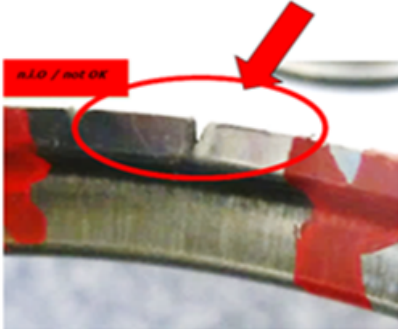
Fig. 8. Quality Alert

The result of internal quality process is the Quality Alert where are reported information about customer, description of produced unit, description of fault with photo documentation and the sign of drawer with the date of drawing. The drawer is in charge of operators interacting with the unit training what also important aspect for zero faultiness is.

Customer	7898-85765-5485	Part name	Bed
Part no.	12345-3333	Issue	-
Concern no.	Internal notice	Special characteristics	-
Receipt date	29.3.2015		
Concern name:	Crack		
Failure effect at customer	Mismatch of customer request		
Bemerkung Pozn. : Comments	Pieces found by 100% control in HPT. Pressing machine - MW 800 t Date of producing. - 28.3.2015 Date code - 09BE Amount n.i.O - 6ks.		
Defect description
